Shotcrete Rehabilitation of a Vancouver, BC Historic High Rise Building

by R. Heere, D.R. Morgan,
N. McAskill,
and T. Knowlton

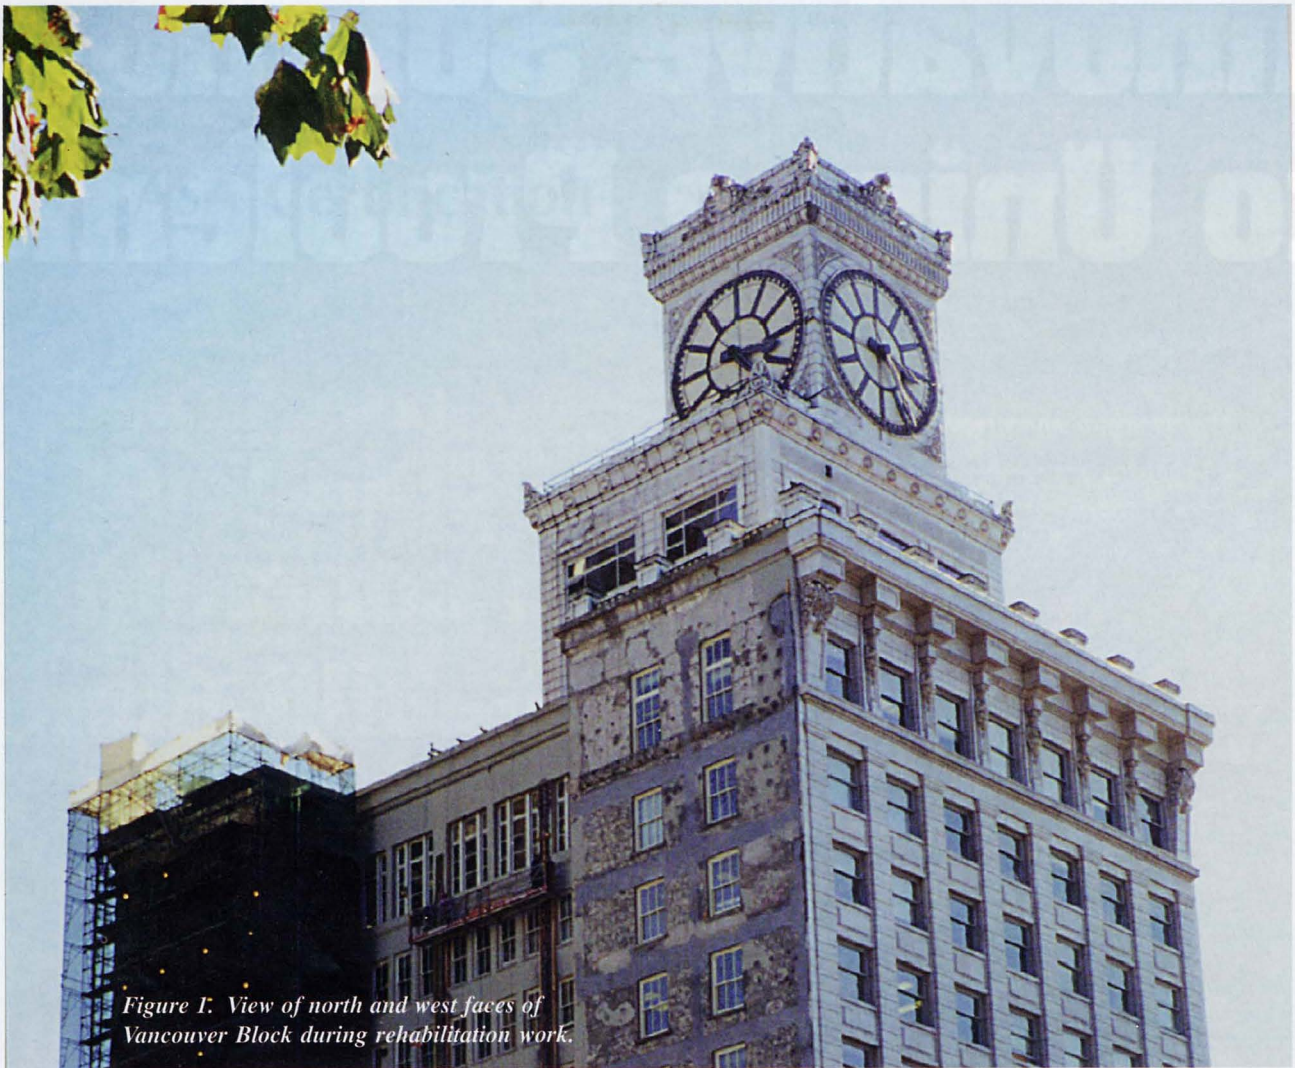
Figure 1. View of north and west faces of Vancouver Block during rehabilitation work.

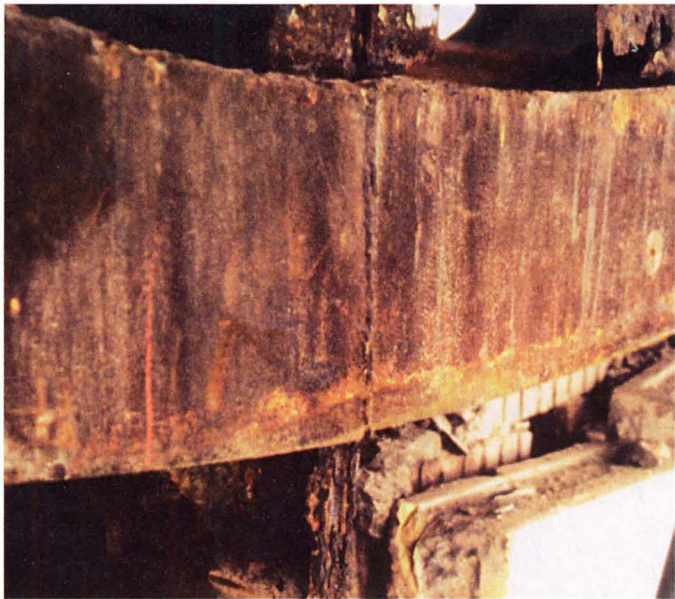
Exploratory removal of brick cladding in selected locations confirmed non-uniform corrosion activity across the facades. While the investigators encountered pristine steel with undisturbed mill scale on the surface of beams and columns in some locations, in other locations severe corrosion pitting, knife edging, and even complete loss of I-beam flanges to corrosion was recorded. The overall degree of corrosion was sufficiently severe to warrant hiring of a structural consultant to plan the retrofit procedures. Figure 2 shows an example of severe corrosion in a steel column.

Figure 2. View of corrosion in a steel column prior to repair.

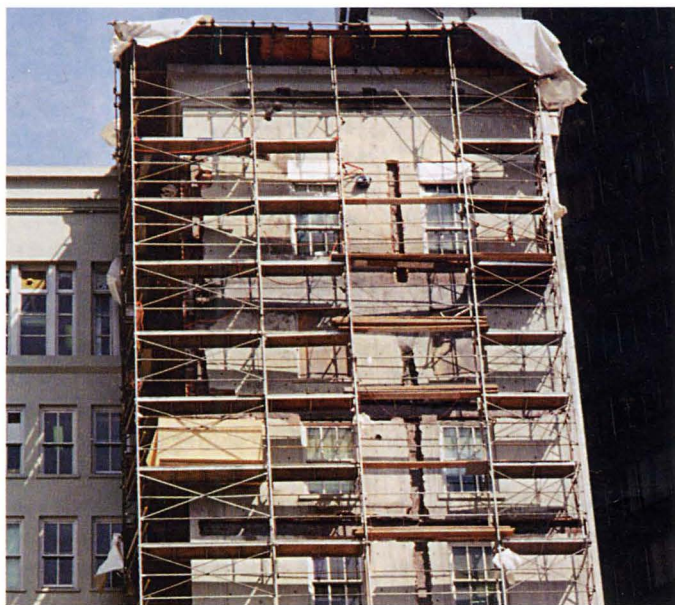
time they were prepared for reinforcement. Figure 3 shows the removal of brick masonry on the south side of the building.

Figure 3. Installed scaffolding and removal of brick masonry on a column line on South face of building

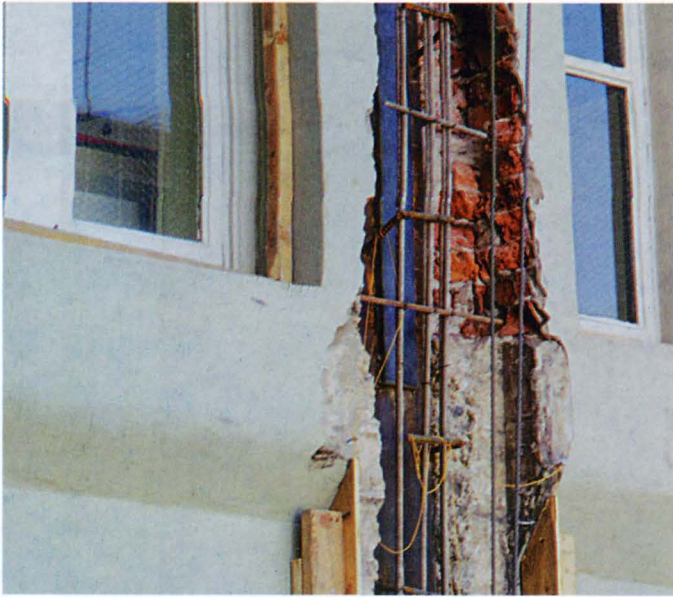
Figure 4: View of a prepared column ready for shotcrete application. Note installed new steel plate and rebar.

The requirement to conduct all repair work from the outside of the building required some innovative designs and construction technology for reinforcing the structural steel elements. In brief, after exposing the structural steel elements and removing corrosion products by needle scaling and sandblasting, customized steel profiles were welded to the webs of those beams and columns in need of reinforcement. Figure 4 shows a prepared column with installed new steel plates and rebar prepared for shotcreting.

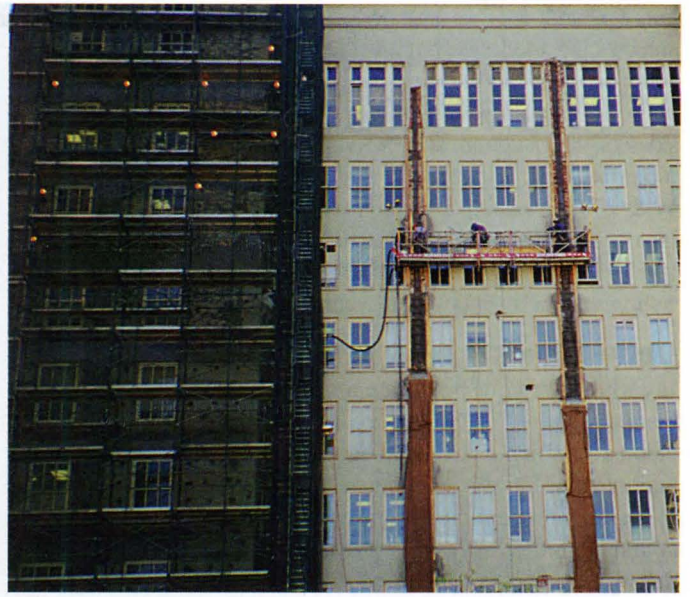
Figure 5: Remedial work being conducted from a swing stage on north face of building. Note burlap wet cure of completed shotcrete repair.

To address this problem, the shotcrete work on the north face was executed using the wet-mix shotcrete process. The shotcrete contractor chose small-line wet-mix shotcreting equipment capable of pumping shotcrete the required 15 stories high (50 m) and over approximately 70 m (230 ft) horizontally. An adjacent 3-story high parking structure provided a suitable elevated working position for the pump, reducing some of the challenges of delivering shotcrete to all floors of this high-rise structure. The wet-mix shotcrete process produced significantly less dust and rebound compared to the dry-mix process employed previously. The use of dry-bagged premixed shotcrete and careful attention to work preparation and scheduling helped overcome the reduced flexibility of the site mixed wet-mix shotcrete method in this repair application, which required a stop-and-go procedure.

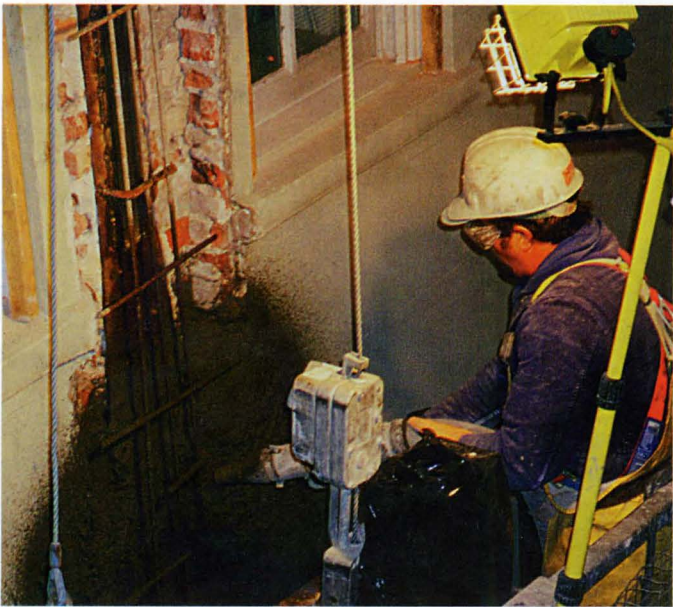
Figure 6: Close-up view of shotcrete application on column line.

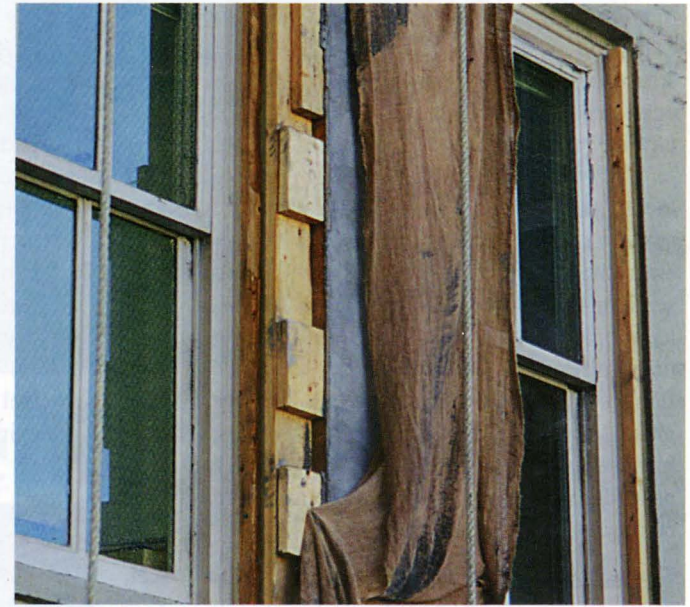
Figure 7: A look at the moist curing of shotcrete

After cutting and trimming to line and grade and receiving a final trowel finish, the shotcrete surface texture blended well into the texture of the surrounding existing stucco finish. Quality control testing by the materials engineering consultant confirmed excellent hardened properties in the shotcrete. The shotcrete achieved 28-day compressive strengths of between 40 and 50 MPa (5800 and 7250 psi) and values of 4% boiled absorption and 9% volume of permeable voids in testing conducted to ASTM C692. Due to a good moist curing regime with saturated burlap, the shotcrete repairs remained mostly crack-free, though some hairline cracks appeared at shotcrete-brick interfaces. Figure 7 shows shotcrete in column moist curing under burlap. This shotcrete is expected to have excellent long

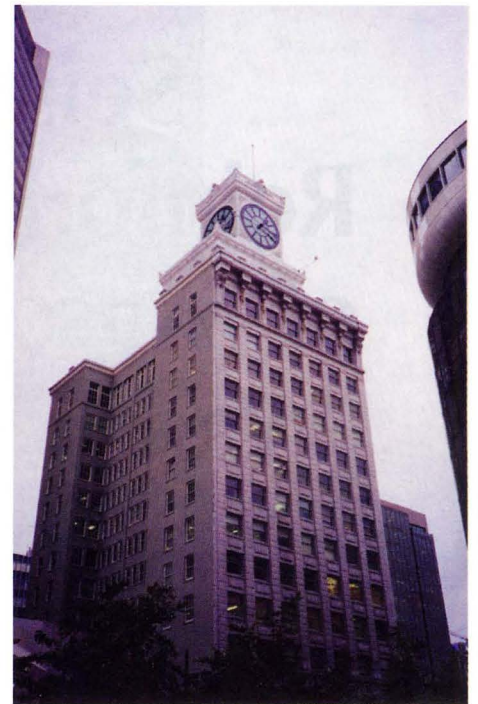
Figure 8: View of north and west faces of Vancouver Block building after completion of shotcrete repairs and application of an elastomeric coating.

After finishing the structural repair and the shotcrete work, the building received a new elastomeric paint coating. Figure 8 shows the completed north side of the building, after painting. All work was conducted with the structure fully occupied and used as an office building. The building has now been rehabilitated to close to its original impressive appearance and should be able to withstand the attack of many more of Vancouver's rainy seasons.
