Use of Dry-Mix Shotcrete to Repair a Lighthouse Structure

by Martin Gendreau,
Eng. MSc.,
Denis Beaupré,
Eng. PhD.,
Pierre Lacombe,
Eng. MSc., and
Jean De Montigny,
Eng. MSc.

This paper presents a description of the repair work carried out in 1996 at the Haut-Fond Prince lighthouse structure located in the St. Lawrence River, 8 km (5 mi) from the coast of Tadoussac, Quebec, Canada. The damaged section of the structure in the tidal zone was repaired using dry-mix shotcrete. Due to the particular field conditions (freezing-and-thawing cycles, ice erosion and impact, submersion of the repair zones only minutes after the application of shotcrete, etc.), the mixture used contained high early strength cement, silica fume, steel fibers, a liquid air-entraining admixture, and a powdered set-accelerator admixture. Removal of deteriorated concrete, preparation of the surface, replacement of the reinforcement, specifications for the shotcrete produced, as well as the application procedures are described in this article. A certification session was held to verify the skills of the nozzlemen. Only those qualified were authorized to apply shotcrete on the structure.

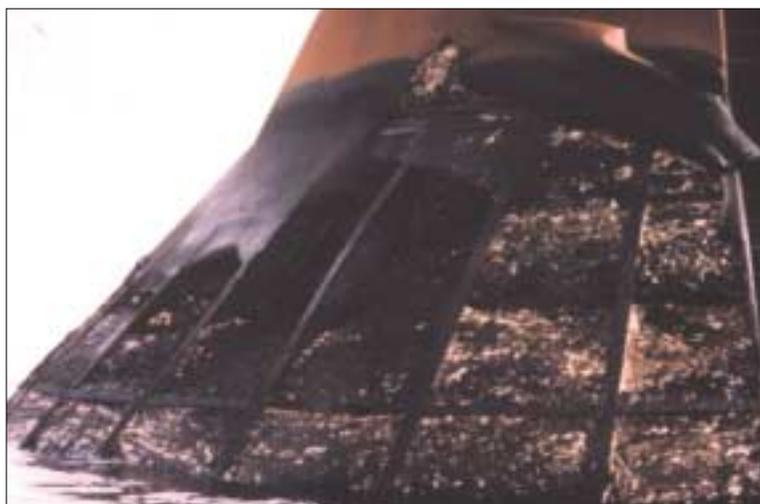
Situated in the tidal zone of the river, the repaired section of the structure showed damage on the steel laps and the concrete forming the pier base. This damage was caused by the high pressure of ice grinding against the surface. The covering made of steel plates 12 mm (0.5 in.) thick was deteriorated and the concrete was damaged by ocean currents, ice movement, and freezing-and-thawing cycles. Some sections of the concrete were deteriorated up to 1.5 m (5 ft) deep. Figure 2 shows a section of the Haut-Fond Prince Lighthouse in its deteriorated state before its rehabilitation.

Figure 2: View of the structure before the repair work.

For both technical and economic reasons, the Canadian Coast Guard, owner of the lighthouse, chose shotcrete to repair the structure. The repair work consisted of removing the damaged steel plates, removing the deteriorated concrete, and applying shotcrete to reinstate the structural integrity of the lighthouse. The repair work was carried out during Fall 1996.

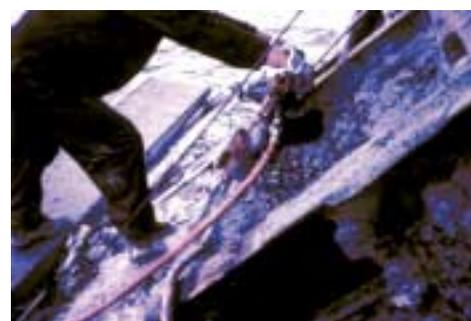
Figure 3: Removing deteriorated concrete.

were removed and afterwards, the contractor used pneumatic chipping equipment to remove damaged concrete (Fig. 3). The equipment mass was limited to 27 kg (59.5 lbs) to prevent damage to the concrete forming the shotcreting surface. Heavier tools could have induced additional cracks in the concrete base of the structure, which could have adversely affected the quality of bond between the old concrete and the shotcrete.

The specifications required the removal of the deteriorated concrete until sound concrete was exposed. The minimum demolition depth was fixed at 100 mm (4 in.) from the surface of the

structure to ensure a sufficient shotcrete thickness to obtain an adequate anchorage of the shotcrete to the structure. At different places, concrete deterioration was observed from as much as 1 to 1.5 m (3.3 to 4.9 ft) deep.

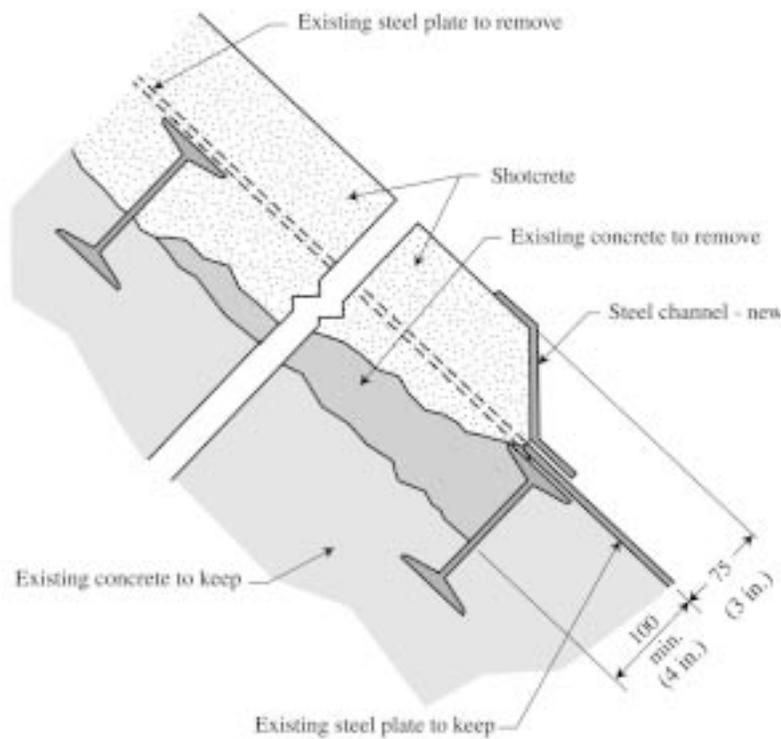
Figure 4: Details of the repair work.

Connecting steel frames had to be replaced due to their state of deterioration; therefore, steel bars were welded to the beams to provide suitable anchorage for the shotcrete.

Figure 4 illustrates the detailed surface preparation. A new steel channel was installed on the perimeter of the repair zone. This was first used as a framework for the shotcreting operations, then later kept as protection against ice pressure due to the angle of the channel.

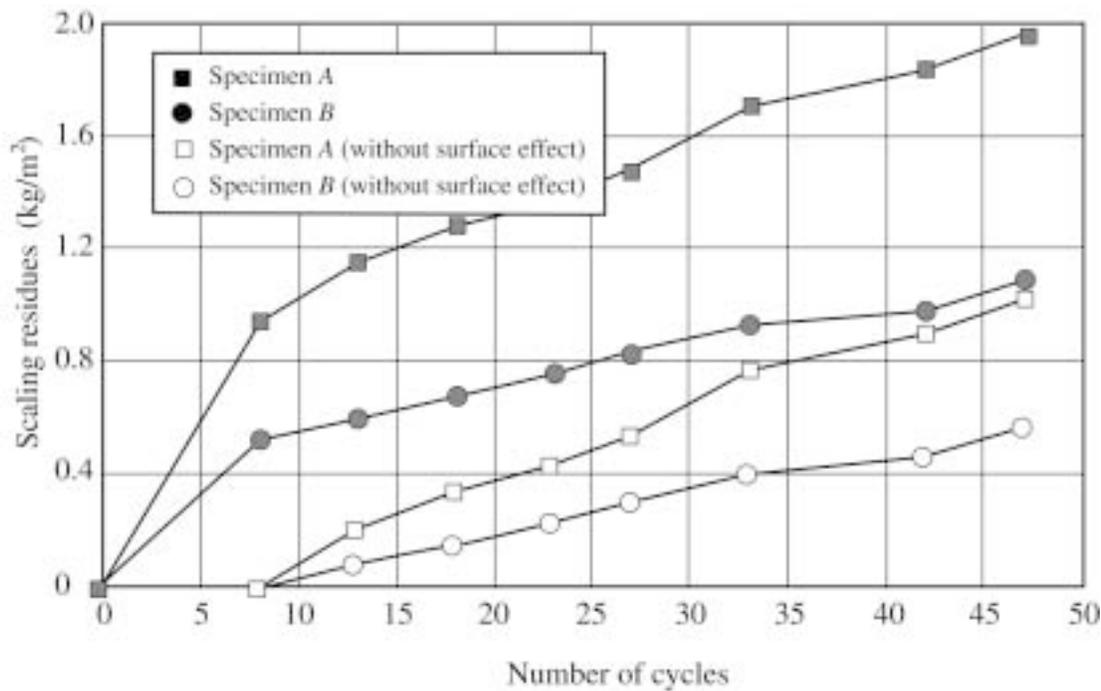
Figure 5: Scaling losses with and without the first freezing-and-thawing cycles (ASTM C 672).

The scaling test results are presented in Table 2 and the scaling loss curves are presented in Fig. 5. The results show a rapid loss in mass during the first freezing-and-thawing cycles. This surface deterioration is probably due to the lack of curing and the gun-finish surface of the shotcrete specimens. Figure 5 also shows the scaling losses without the effect of the first freezing-and-thawing cycles. It can be seen that the shotcrete produced for the repair project is durable in terms of scaling resistance.⁴

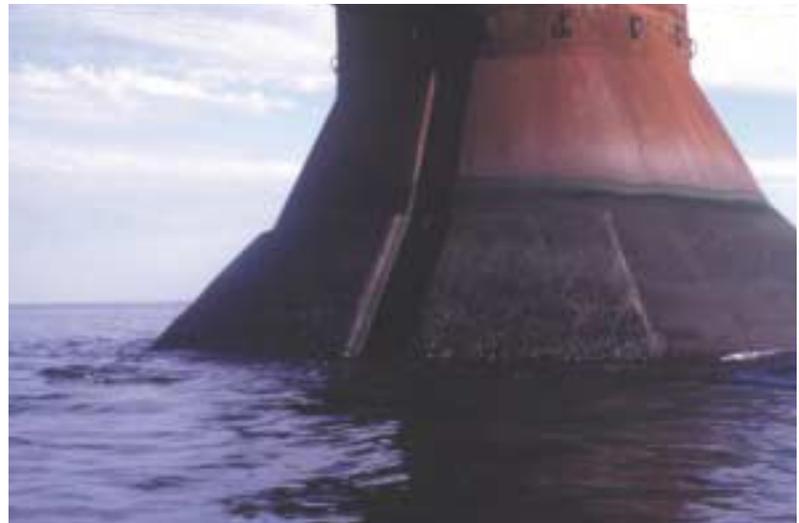
Figure 6: View of the structure one year after the repair work.

Four years after construction, a visual examination of the structure was performed to evaluate the behavior of the repair. The shotcrete used as a repair material showed excellent resistance to damage from freezing-and-thawing cycles, erosion, and impact from ice (Fig. 6). It is believed that the design and supply of a well-adapted shotcrete mixture, according to this repair project specification, and the quality work performed by the shotcrete crew are responsible for the success of this rehabilitation.
