Grain Silo Rupture Repair

by David Drake

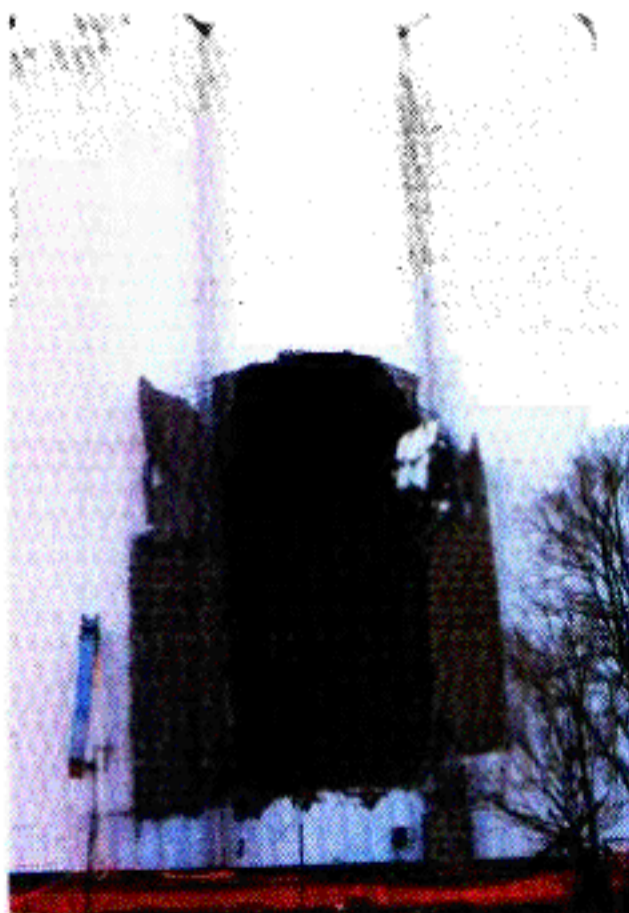
Bartlett & Co. faced a huge cleanup job at its 6.9 million-bushel rail terminal in Wichita, Kansas in the fall of 1999. A grain silo 30 ft (9.1 m) in diameter and 130 ft (40 m) tall holding roughly 150,000 bushels (5300 m³) of high-protein wheat ruptured, creating a hole in the side measuring 35 ft wide by 65 ft high (11 m by 20 m). The result of the wheat running out of the silo created a vacuum inside the slipform concrete tank, sucking the roof down into the tank.

An investigation showed the cause of the rupture to be misplaced reinforcing bar, too few reinforcing bar laps, laps not staggered properly on each course, and reinforcing bar placed too close to the outer edge of the concrete, resulting in a "zipper effect" failure.

Figure 1 (left): Ruptured grain silo after grain spill clean-up.

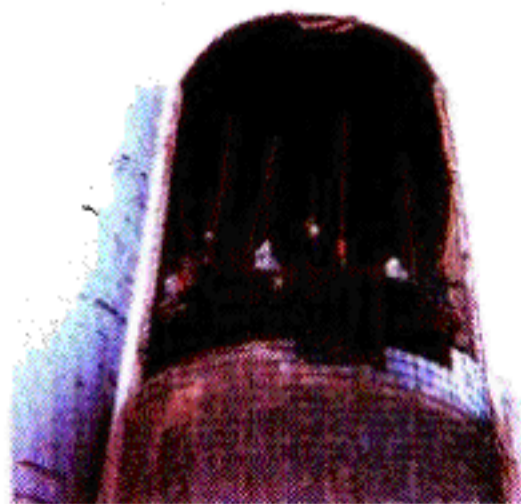
Figure 2 (below): Reconstruction of the silo wall.

Before a new internal liner could be installed, repairs to the wall had to be completed. The repair was done in three sections to ensure safety and stability. Workers drilled and epoxied 4 ft (1.2 m)-long No. 5 reinforcing bar on 12 in. centers (300 mm) into the existing tank wall on each side and across the top and bottom of the hole. Then they installed vertical and horizontal reinforcing bars on 12 in. centers (300 mm) coinciding with the epoxied reinforcing bar.

Next workers tied forming to the backside of the reinforcing bar. They used a lightweight perforated metal form, rigid along its length but flexible across its width, allowing it to bend to fit the radius of the new tank wall. The big advantage of using this type of form is that it is left in place and shotcreted from the other side, eliminating the labor and time involved in stripping forms.

After workers completed the first section of reinforcing bar and forming, 3 in. (75 mm) of dry-mix shotcrete was applied to the outside of the form, covering the reinforcing bar. Once all three sections were finished, another inch of dry-mix shotcrete was applied and hand finished to a rubber float texture. This type of texture was desirable because the tank was to be painted after the shotcrete curing process was complete.

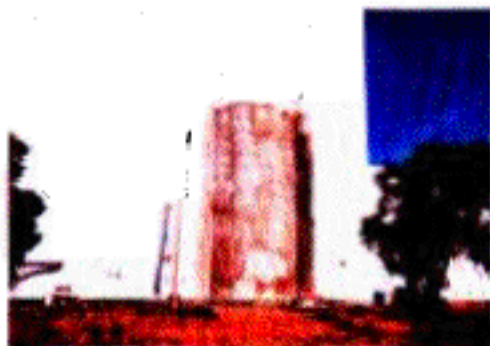
Figure 3 (above): Final repair work prior to painting

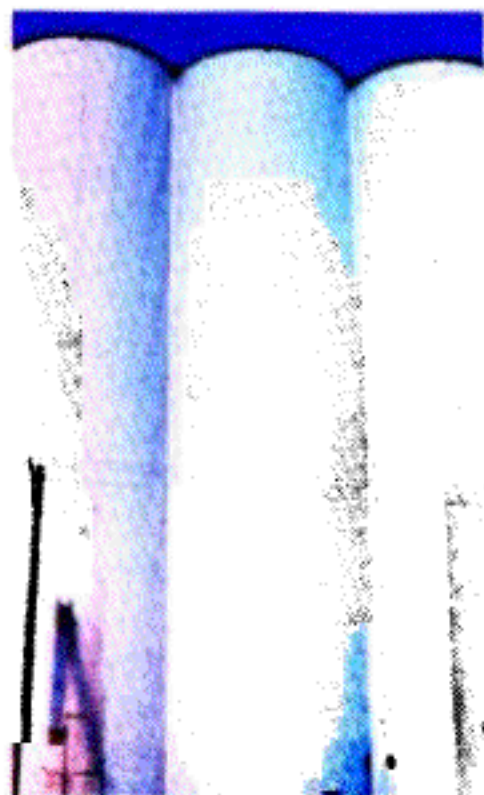
Figure 4 (right): Final result.
