# Use of Synthetic Fiber-Reinforced Dry-Mix Shotcrete for the Rehabilitation of a Wharf in Northeast Quebec, Canada

by Pierre Lacombe, Martin Gendreau, and Yann Ropars

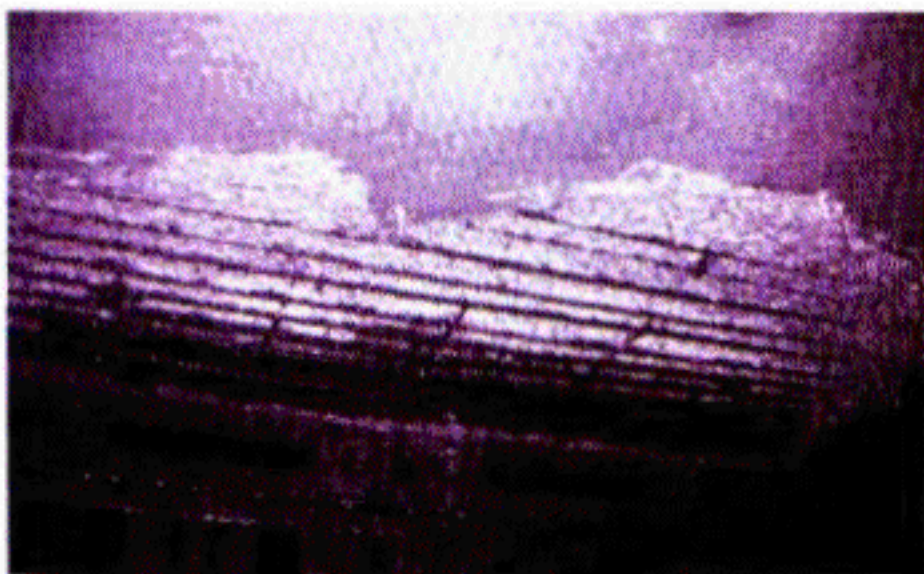
Considering the presence of exposed steel (steel beams) inside the Wharf, it was decided to open the structure. A systematic inspection undertaken in 1996 showed that almost all the precast concrete elements constituting the transfer slab of the structure had deteriorated. The surface of the concrete slab was damaged at the junction with the steel sheet piles, and severe corrosion of the reinforcing steel bars in the precast elements was reported (Figure 4).

Figure 4. Transfer slab deterioration

It was determined that the ice action that forms inside the Wharf during winter was the main cause of deterioration. The concrete transfer slab was installed directly on transverse steel beams, which serve as braces for the cofferdams. Because this reinforced concrete slab was not equipped with stirrups to reinforce their edges against lateral stresses, steel plates attached to the slab were welded on the steel beams, which kept the transfer slab in place.

Considering that the transfer slab is located in the high-tide area, the water freezes between the cofferdams and its edges. Furthermore, with the tidal cycles in this part of the St. Lawrence Gulf, the number of freezing-and-thawing cycles is most pronounced during the high-tide season. The water located in the upper part of the Wharf also tends to freeze when it tries to move to the bottom section of the structure, passing through the junction of the steel cofferdams and the concrete slab.

When the water freezes, the steel cofferdams dilate and create a lateral pressure on the reinforced concrete slab. The concrete's reinforcement is not designed to resist such stresses and fails in a horizontal pattern. The damage has expanded over the years toward the center of the slab. This has also been confirmed by observation of the failure of many bolts coupling the cofferdams to the transverse beams.

These repair works were the remedial solution to the structural damage to the concrete. In order to prevent a repeated deterioration pattern from developing, however, rubber plates were installed between the steel cofferdams and the repaired sections. The development of horizontal stresses in the concrete slab during freezing cycles could thus be prevented.

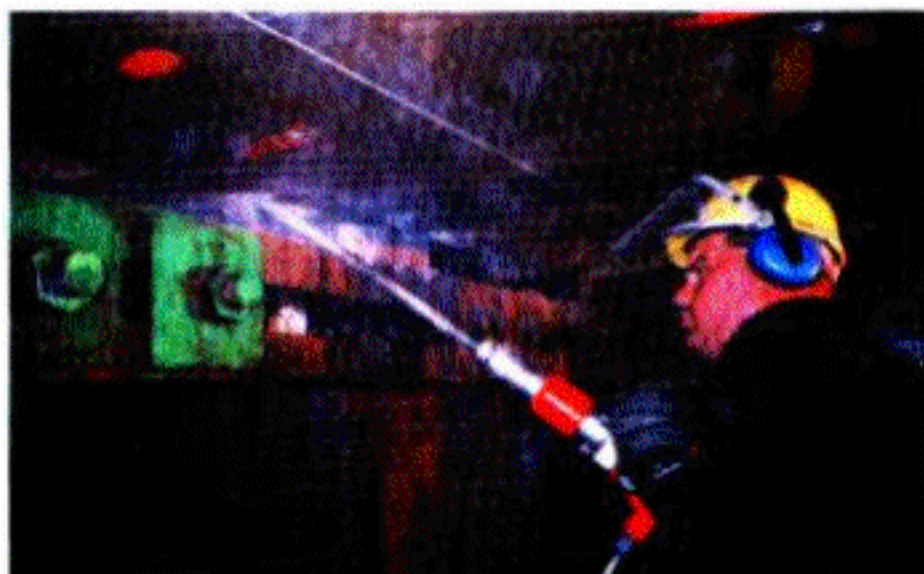
Figure 5. Demolition operations

The contractor decided to use low-mass chipping hammers that allowed the demolition of many sections of the transfer slab at the same time (Figure 5 and 6). The chipping hammer's maximum mass was restricted to 7 kg (15.4 lbs) to reduce the risk of damaging the existing concrete.

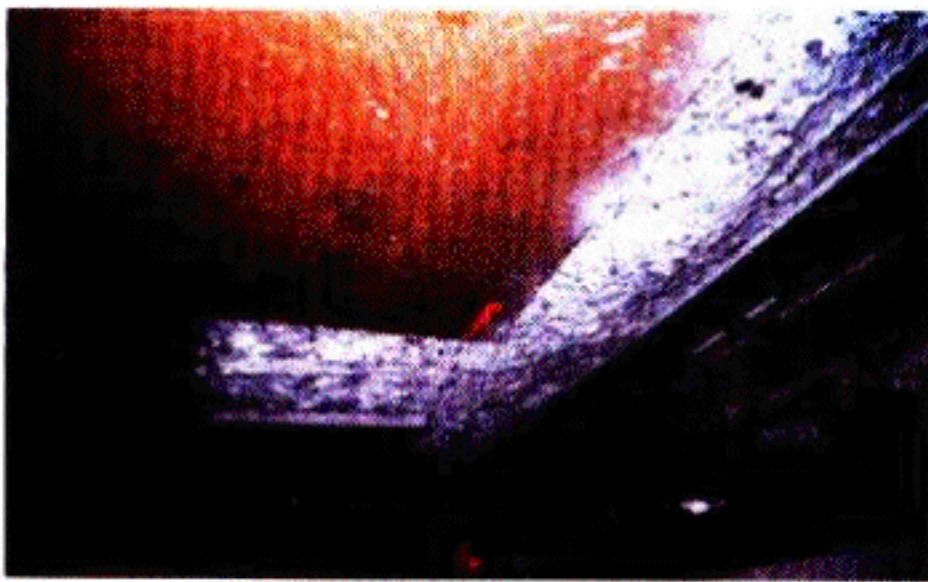
Figure 6. Ongoing demolition operations.

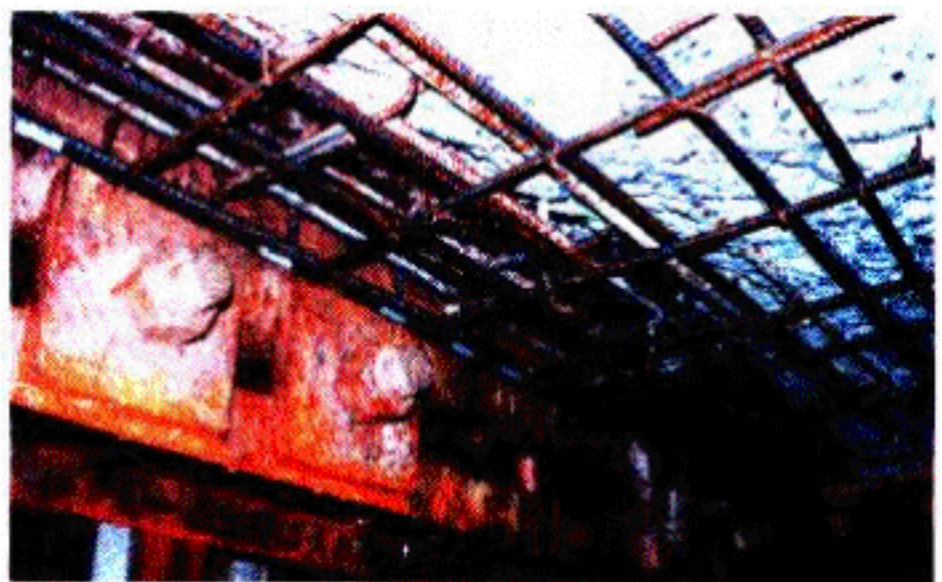
Figure 7. A ready-to-be-shot section.

Finally, to remove all loose and microfractured concrete, the demolished sections were cleaned with a water pressure jet. Figure 7 shows a repaired section prior to shotcreting operations.

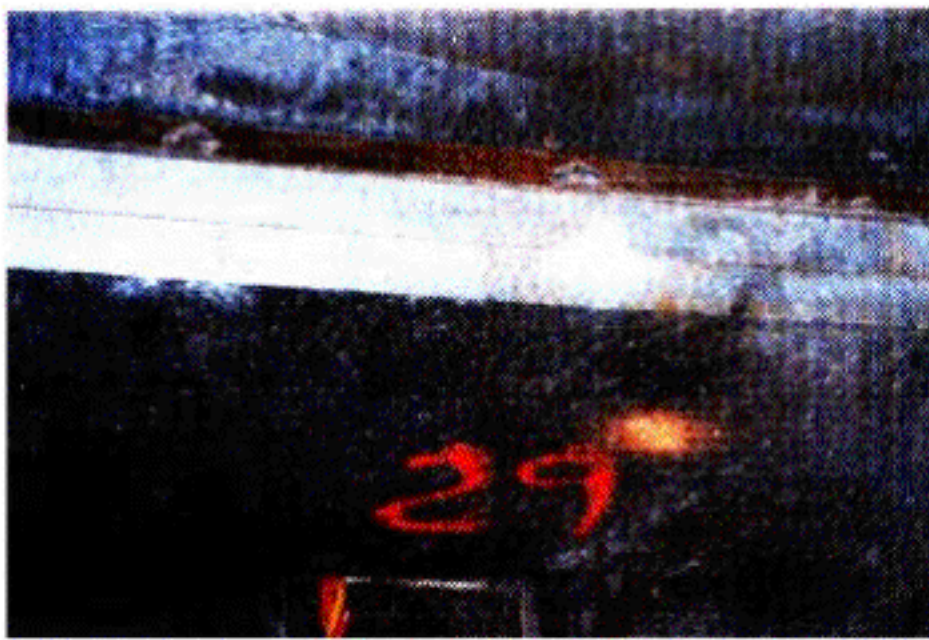
Figure 10. Section after rehabilitation.

Due to the tidal cycles, which limited the shotcreting periods and the use of labor bridges to support the nozzlemen, the dry-mix shotcrete operations were difficult (Figure 9). Between each shotcrete application, the concrete surfaces were cleaned with a smooth pressured water jet to remove seaweed and other unsound residues, as well as salt water, which could reduce the bonding of the shotcrete. Even with such difficult job-site conditions, the repair works were performed within the scheduled time frame and were found to be adequate to reinstate the structural integrity of the Wharf (Figure 10).
