# Thick Section Overhead Repair and Strengthening of a Concrete Pier: A Viable Shotcrete Solution

history describes in detail the process used to successfully install shotcrete overhead on a damaged pier, for repairs and strengthening up to 48 in. (1.2 m) deep.

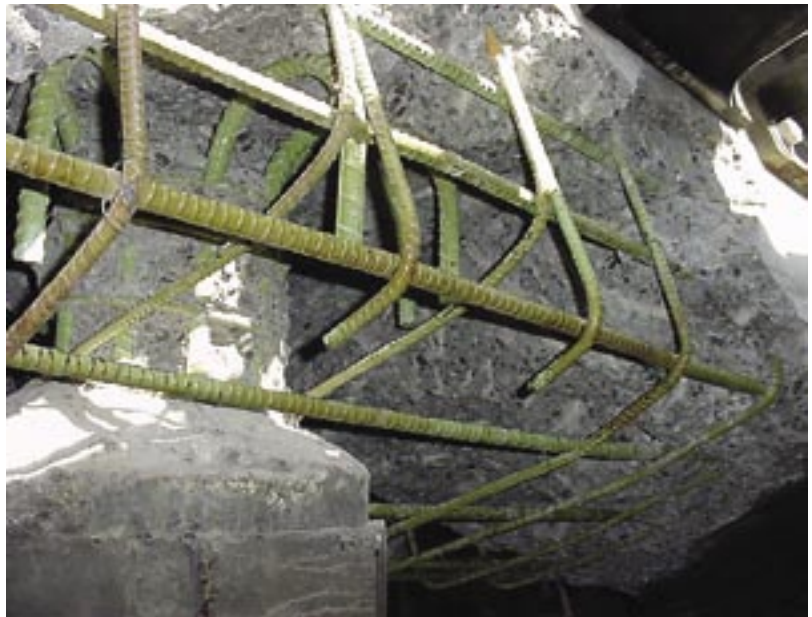
In late 2001 the loading pier was damaged in a storm. The high wind velocity of the event caused a vessel berthed at the pier to violently bump into the windward side of the concrete structure. The unique loading caused extensive damage in the precast pile to cap connections as the bumping movement tried to force the cap off the top of the pile. Essentially, the cap was forced up and away from the pile as the pile remained fixed. This caused large spalls around and on top of the pile in the cap section (Fig. 1). In some connection locations, the damage involved several cubic yards of concrete. The locations most affected by the damage were the outboard caps. Interestingly, even though the deck of the pier was estimated by workers present to have been pushed approximately 12 in. (305 mm) to the leeward, virtually no damage was discovered in the precast piling by divers or above water inspectors. After the structure was completely inspected and damage recorded, the owner's structural engineer prepared a repair and strengthening design plan.

*Fig. 1: Impact damage induced spalls in pile cap*

The structural engineer's repair plan required the removal of all loose and or damaged concrete at the connections. Reinforcing, if damaged, was to be replaced. The design called for additional reinforcing to be epoxy grouted into place at the bottom of the existing caps to provide a thickened section in the location of the damage. The enhanced section continued longitudinally 12 in. (305 mm) past the furthest damage at each of the 12 repair locations. This additional reinforced thickness was intended to provide supplemental strength to the pile/cap connection upon completion of the repairs.

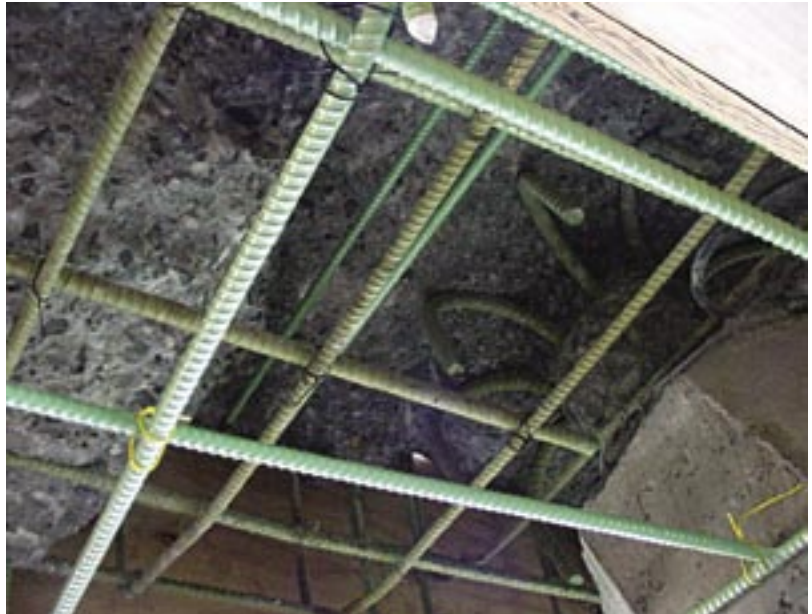
*Fig. 2: Prepared spalled area ready for shotcreting*

As part of the normal QC/QA procedures associated with shotcreteing, test panels were shot as well as the aforementioned overhead test shoot against the existing substrate concrete. The test panels were cored and the samples evaluated. The overhead test shoot was also cored and tested. All tests values exceeded design requirements, enabling the installation to move forward. Prior to installing shotcrete, the damaged areas were chipped to remove broken, unsound concrete; epoxy coated rebar was installed; the areas were water blasted under high

pressure; and edge forms were set (Fig. 2). The shotcreteing progressed on schedule. During the course of the installation, daily test panels were shot. The panels were field cured and later cored. The cores were tested by the owner's lab for compressive strength and boiled absorption values. The test results are listed in Table 1.

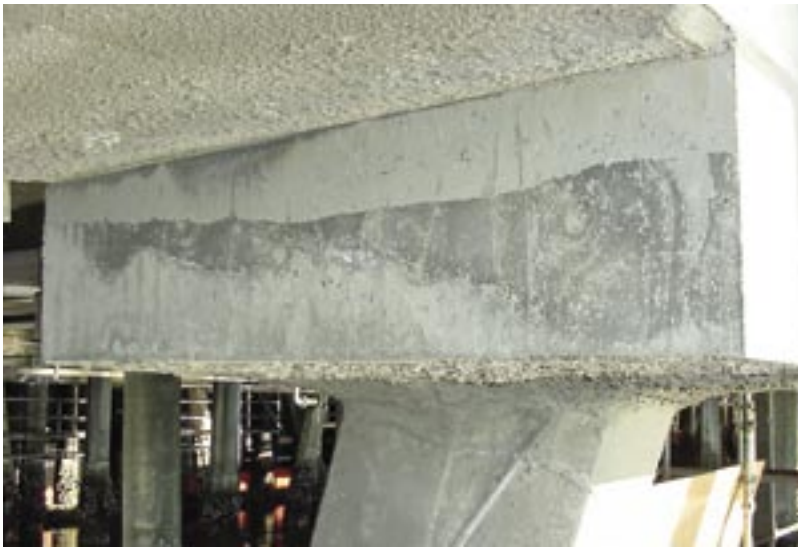
Fig. 3: Shotcrete repaired pile cap

The shotcrete was installed in lifts of about 6 to 8 in. (150 to 200 mm) in depth. The lifts were allowed to set before additional shotcrete was applied. Care was taken to insure over-spray and rebound did not build up on the reinforcing steel exposed below the multiple shotcrete lifts. Once installed, the shotcrete areas were cured sufficiently to alleviate any early shrinkage problems. The edge forms were removed after initial cure and the repair areas inspected for any cracking and sounded for delaminations (Fig. 3). One cap repair location was being shotcreted as a barge was docked. Unfortunately, the barge was docked with sufficient momentum to cause a large horizontal deflection of the pier—the deflection described by workers as nearly knocking them off their feet. Post-installation evaluation at the affected cap showed a few locations of horizontal cohesive ripping of the green shotcrete. The wider of these ripped areas were chipped out to determine the depth of the fracture, and the smaller, narrower rips were sealed and epoxy injected. Additional testing revealed that in all cases, the rips penetrated into the cap shotcrete no more than about 5 in. (130 mm). The chipped out fracture areas were cleaned and hand patched with a repair mortar. Inspection of the other repair areas revealed no other issues.
