# Concrete Repair and Restoration at Franklin Falls Dam

by David Jamieson and Joseph Colucci

**T**he Aulson Company of Methuen, MA, completed a major concrete removal, shotcrete repair, and restoration project for the U.S. Army Corps of Engineers (USACE) at the Franklin Falls Dam, a 60-year-old structure in Franklin, NH.

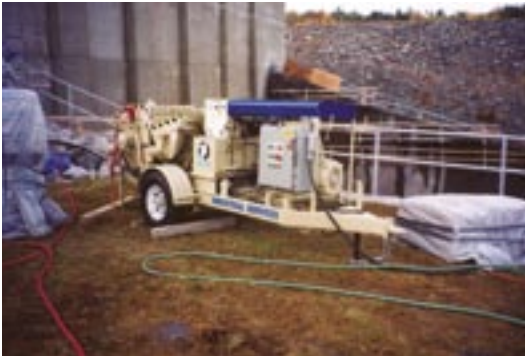
*Aulson's electric swingtube pump*

Aulson Project Manager Jim Marston chose to use an electric swingtube pump (refer to photo) that mixed the silica fume-enhanced structural shotcrete and dumped it forward into the pumping chamber before moving it several hundred feet through steel pipes and rubber hoses to the repair area (refer to photo).

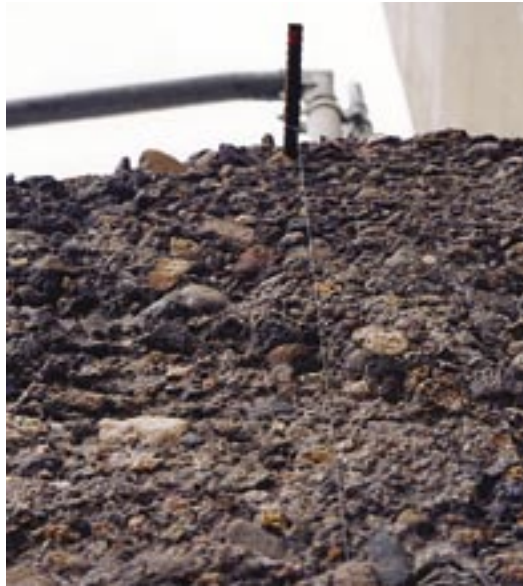
*Surface prep via hydrodemolition method. Shoot wires stretched across area before wet-mix process shotcrete application*

The surface was prepared by water-jetting using high-velocity pumps leaving a rough profile to receive the shotcrete (refer to photo). The surface was then abraded with sand, washed thoroughly, and allowed to reach saturated surface dry (SSD) condition; then the product was immediately applied. This prevented the carbon dioxide in the air from contaminating the surface by forming carbonic acid at the bond line. Testing by either coring or hammering revealed a strong bond between the substrate and the silica fume-enhanced structural shotcrete mixture.

Thin, high-strength wires were stretched from top to bottom on the repair and adjusted by a turnbuckle system to provide an elevation guide during the shotcrete application process (refer to photo). The crews even rebuilt the face of the repair, which was around a curved area. The shotcrete was applied up to the top of the wires that were approximately 2 ft apart. The excess was cut out with a Fresno float (refer to photo). The surface was finished with a magnesium float. A light broom finish was applied to leave a lightly textured surface (refer to photos).

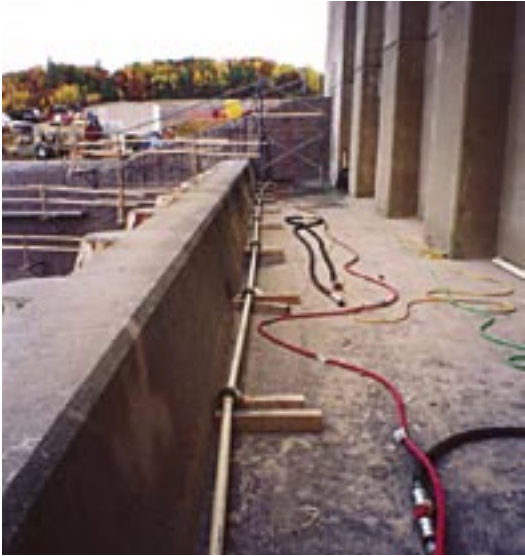
*Shotcrete product pumped approximately 300 ft*

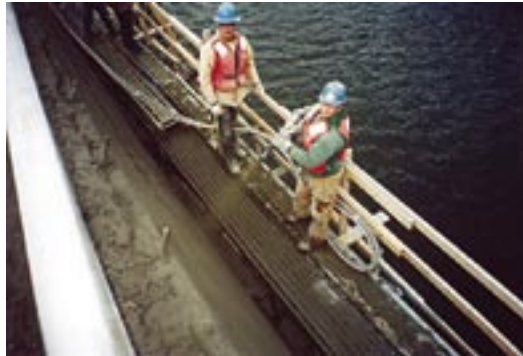
*Wet-mix shotcrete application with less than 5% rebound*

Marston estimated the rebound to be less than 5%.

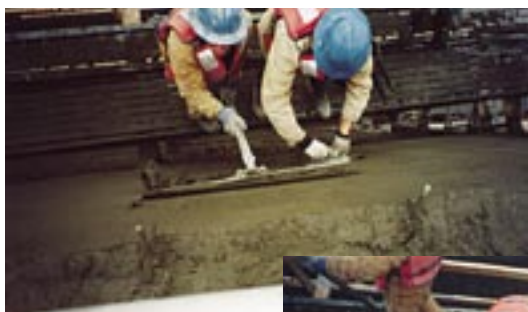
*(left) Rough cutting to shoot wires with Fresno float*

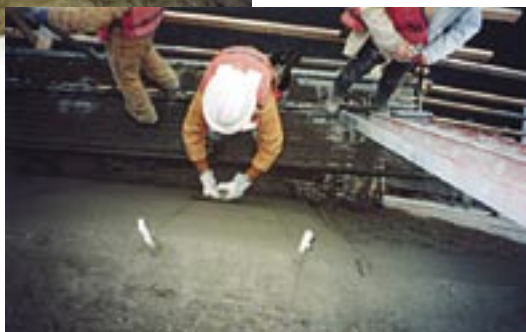
*Final shaping to shoot wires*

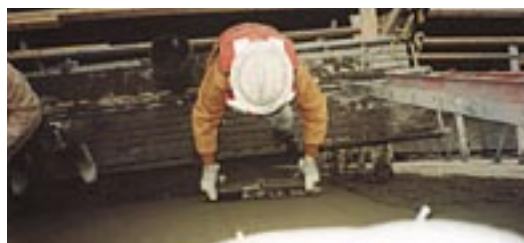
*Light broom finish after surface shaping of shotcrete*
