Shotcrete Repair of WWII Concrete Hulks

by Neil McAskill and Roland Heere

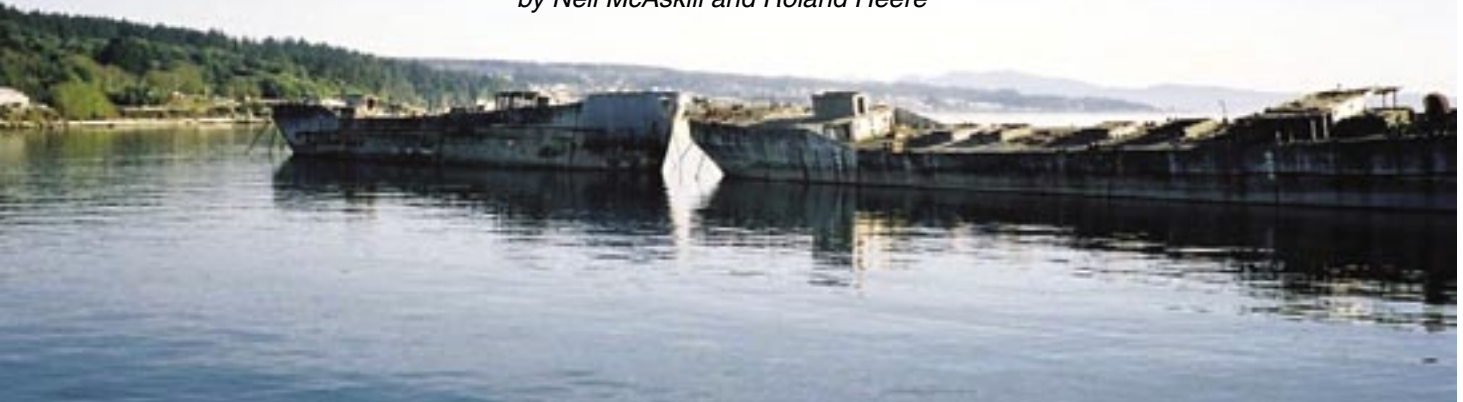
Fig. 1: Two of the 10 hulks in breakwater

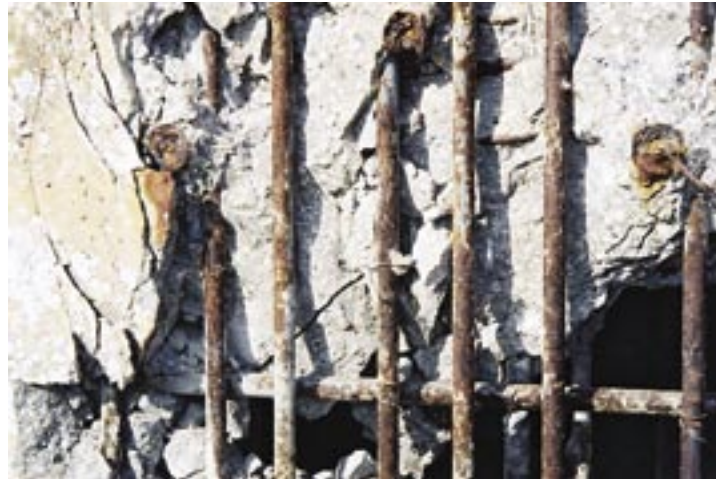
to their continuous exposure to a harsh marine environment, the repairs described herein were actually necessitated by impact damage to the hulls rather than the visible but slow deterioration caused by the corrosion of reinforcing steel. In some cases, the damage resulted from multiple impacts as barges repeatedly collided with a hulk in a sequence of events. In other cases, damage is related to a single impact. Because punching shear cones in this particular lightweight concrete appear to develop rather shallow slopes of about 1:7, damaged surface areas were much larger on the inside of the hulks than on the (impacted) outside.

Fig. 3: Highly fractured concrete in the early stages of preparation

To remove all damaged and bruised concrete from the perimeter of the patch and to clean any corrosion from the reinforcing steel, a 5000 psi (35 MPa) water pressure washer with sand injection was used. Before cleaning, the corrosion of the reinforcing steel in the damaged areas varied from heavy corrosion scaling to no corrosion with the original mill scale still on the reinforcing steel.

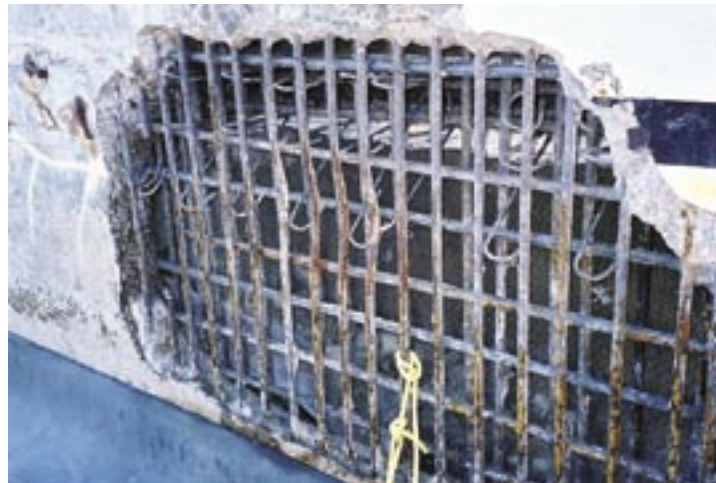
Fig. 4: Mesh forming used. Note the gaps around the edges

reinforcing mat. The mill felt restrained the shotcrete well in the middle of the patch where it was easily tied to the reinforcing steel. However, it could not be fixed adequately at the edges to restrain the impacting shotcrete. To address this, light gage expanded metal lath was cut to shape, rolled up, inserted through the openings in the reinforcing steel grid, and unrolled inboard of the

reinforcing steel. The mesh was then tied to the reinforcing steel with tie wire. Standard plastic reinforcing chairs kept the lath at a suitable clearance from the reinforcing steel. The expanded metal lath, however, did not adequately restrain the impacting shotcrete, allowing paste to pass through while retaining some of the coarse aggregate. Ultimately, the force of the impacting aggregate even broke the relatively light gage mesh, creating holes that both shotcrete paste and aggregate could easily pass through. Further, restraining the edges proved as difficult as with the mill felt. The next attempt at forming used strips of plywood cut in widths varying from 4 to 8 in. (100 to 200 mm). The length of the strips was dimensioned to correspond to the width of the repair opening on the inboard side of the hull. The strips were predrilled and tie wire was attached. The plywood was then threaded through the reinforcing grid, positioned, and tied to the reinforcing steel. Plastic chairs were used as spacers to provide appropriate cover for the inside reinforcing steel. This method of forming, while tedious, provided the best results.

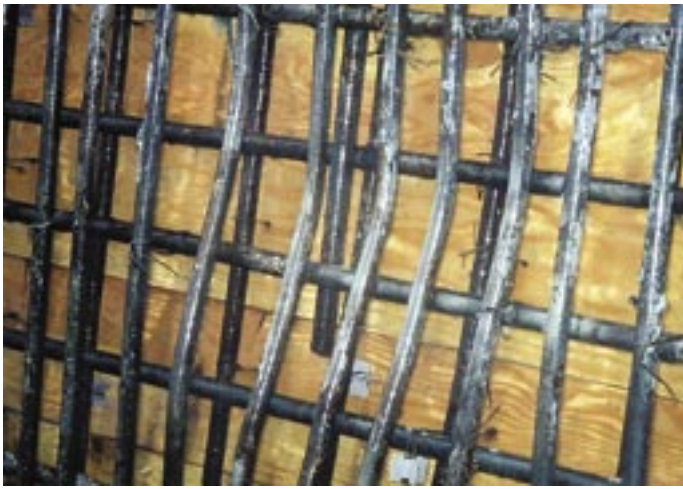
Fig. 5: Plywood backing material in place. Note the chairs and the sandblasted reinforcing steel. The bent bars are the result of the impact

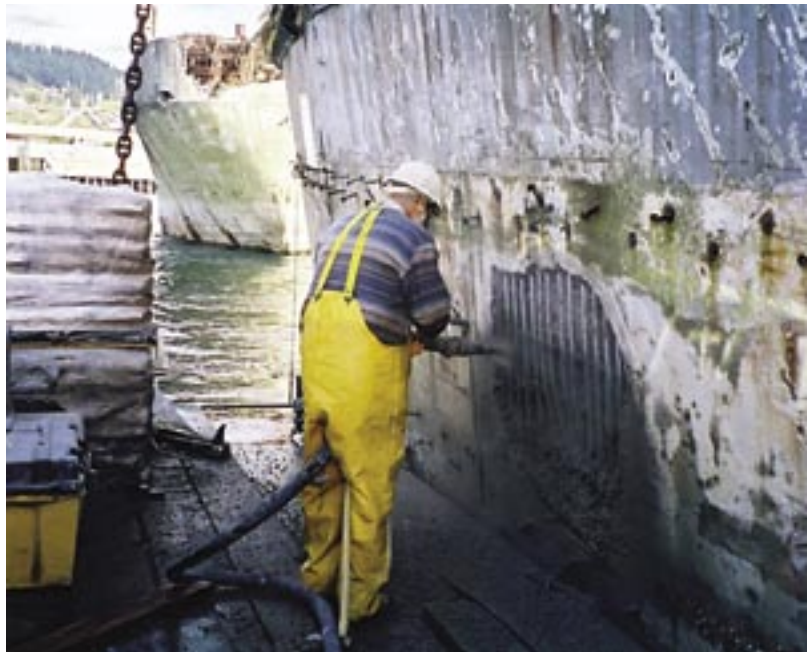
Fig. 6: Illustrates the shooting of a patch (right)

Shotcrete was applied using the wet-mix process. The perimeter of each patch was shot first to fill the feathered area on the inside of the hull. After the edges were filled and tapered outward at a 45 degree angle (to shed rebound), the patch was then filled in a single lift. Care was taken to consolidate the shotcrete behind the grid of reinforcing steel. The high silica fume content in the mixture allowed the material to be placed at a slump of about 3 in. (80 mm), which was sufficiently plastic to enable good encapsulation of the reinforcing steel without sagging. When the patching shotcrete approached the intended level of the finish, its surface was screeded with a straightedge or cutting rod, depending on the size of the patch. Additional material was applied as needed. Alternating shooting and screeding resulted in very little cutting waste. After screeding, the shotcrete was finished with a steel trowel.

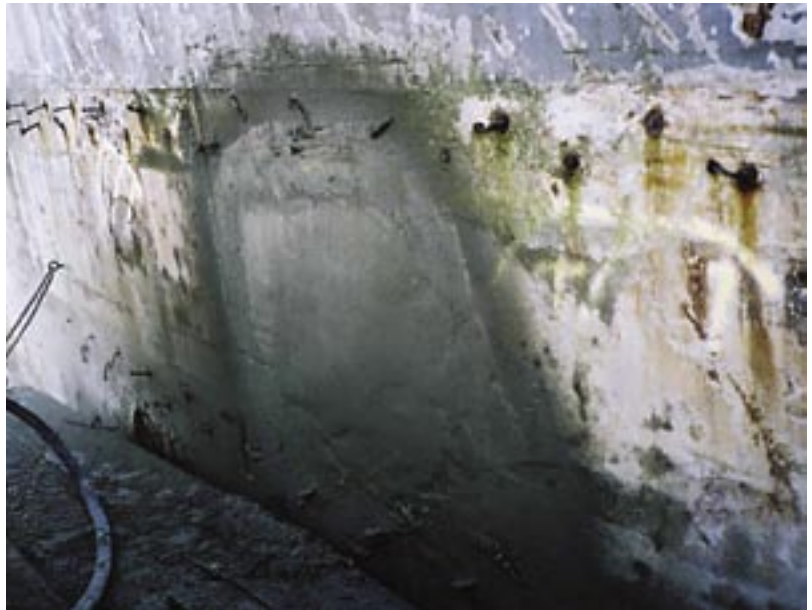
Fig. 7: The finished patch

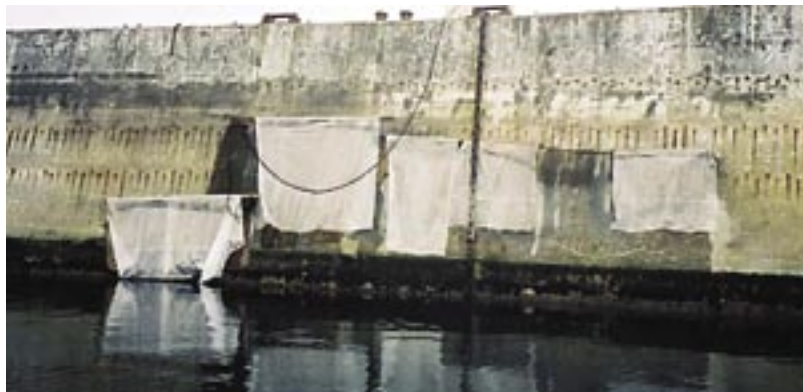
Fig. 8: The curing regime in place. Note the proximity of the waterline to some of the patches

Larger patches were moist cured for a period of 3 to 5 days. Curing water was supplied from totes placed on the deck of the hulk and fed by garden hose to soaker hoses placed under the burlap and plastic sheeting. This curing assembly was held in place by wooden 2 x 4's fixed to the concrete hull with quick bolts drilled into the concrete. The water totes required refilling daily during the curing period.

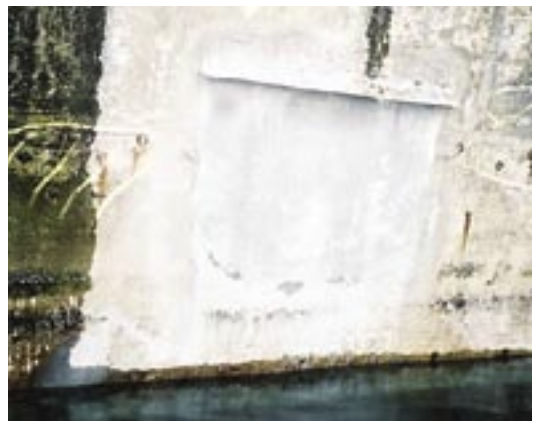
Fig. 9: The gutter used over the patches when rain was encountered

During periods of rainy weather, work focused on preparing patches that were sufficiently high enough above the waterline that immediate placement of shotcrete was not necessary. When these opportunities were exhausted, however, gutters were installed over patches to protect them from water running off the deck. Any free water was blown off with compressed air before applying shotcrete. It is interesting to note that the most effective gutters were created with shotcrete while the runoff was temporarily diverted with a jet of compressed air from a blow pipe.

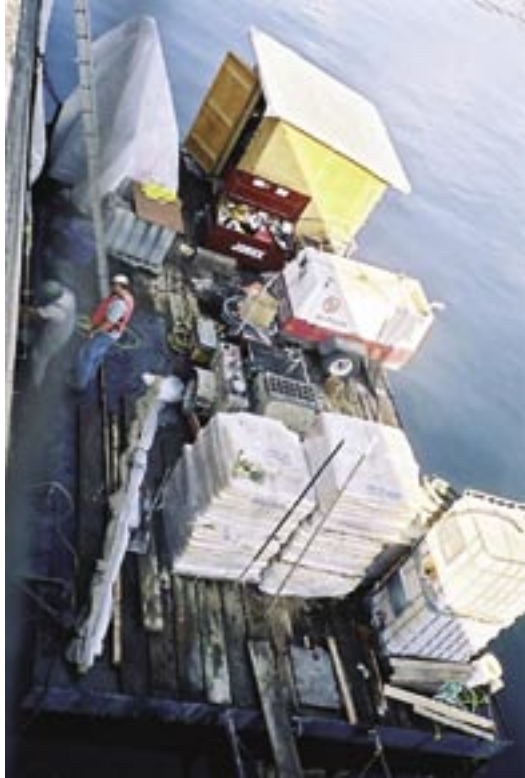
Fig. 10: The layout of the work barge

All of the preparation and repair work was carried out from a 20 x 40 ft (7 x 14 m) steel barge. The barge carried a tool shed and job box for small tools, a 185 CFM (5 m³/min) air compressor, a concrete mixer/pump, about five pallets of premixed bagged shotcrete mixture, and about 1000 U.S. gal. (3785 L) of water contained in 250 U.S. gal. (946.25 L) totes. Prior to the start of shotcrete operations, additional totes were placed on the deck of the hulks and filled with water to provide a source of curing water. Finally, scaffolding was constructed on the barge to provide access for preparation and application of shotcrete as necessary for higher patches.
