Structural rehab in Portugal...

The Setenave Dry Docks Rehabilitation

by Ivan Ramalho de Almeida, Thomaz José Ripper Barbosa Cordeiro, and José Paulo Veríssimo Maia Costa

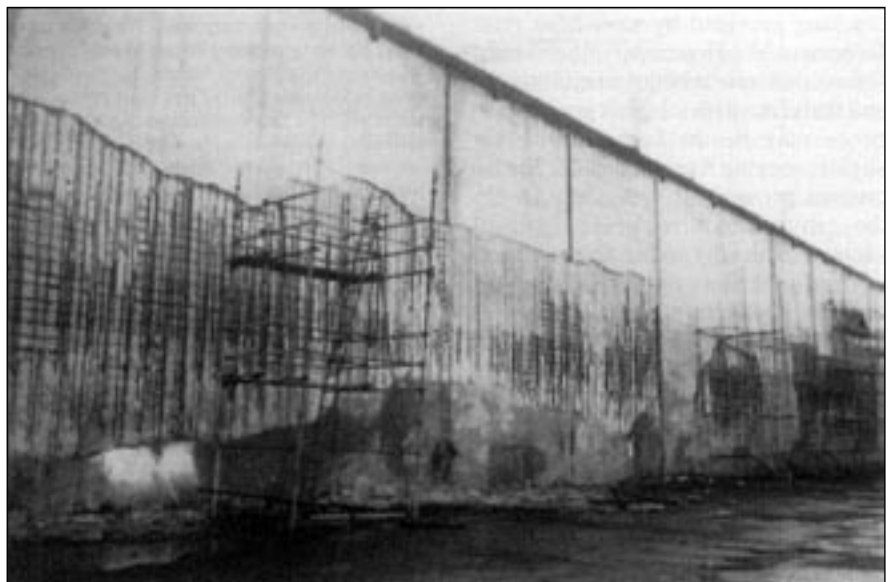
Setenave is a general designation for a shipyard built in the early seventies, at the right shore of the Sado River, south of Lisbon, in Portugal. In 1991, an important structural rehabilitation of the reinforced concrete walls of the Setenave dry docks was performed. Repair was required to overcome the problems of generalized reinforcement corrosion, then evidenced by disaggregation of very large areas of the concrete cover (Fig. 1).

Simple visual observation of walls evidenced the intensity of structural concrete disaggregation (which reached more than 10 m² at some places) and the resulting exposure of corroded reinforcement. A preliminary quantification of damaged areas supplied the following data:

Fig. 1: Concrete disaggregation

Based on the investigation results, it was concluded that the generalized reinforcement corrosion inside the walls of Setenave dry docks and the resulting scaling of the enveloping concrete was mainly caused by the presence of a high level of chlorides. The chlorides easily penetrated the concrete by diffusion up to the reinforcing bars, due primarily to the extraordinary porosity and permeability of the concrete, resulting from the high w/c of the mix.

- removal of deteriorated concrete up to 10 cm (4 in.) mean depth, going behind the reinforcement some 3 cm (1.2 in.). This work was carried out with light pneumatic hammers;
- replacement of reinforcement bars;
- cleaning of reinforcement bars and worked surfaces by successive sand-blasting, water blasting, and air blasting performed with the shotcreting equipment;
- reconstitution of the structure with CSF concrete by shotcreting, with dry-mix, two-chamber equipment (Fig. 4);
- shotcrete curing under continuous wetting up to an age of seven days; at younger ages when the docks were flooded, a curing film was applied. Curing started as soon as the shotcrete began to set.

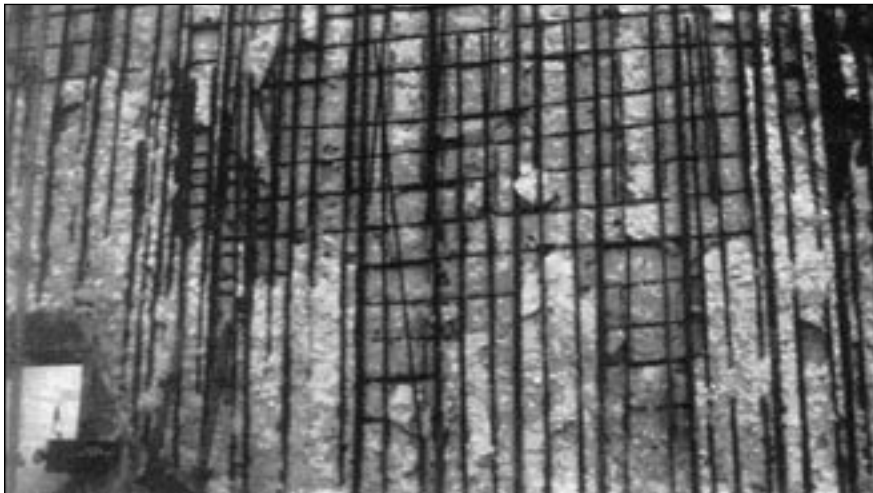
Fig. 3: Corroded reinforcement

- removal of all contaminated concrete up to 30 mm (1.2 in.) behind the reinforcement;
- cleaning of all corroded reinforcement and providing new bars to supple-

ment those whose cross section was reduced (Fig. 3); and

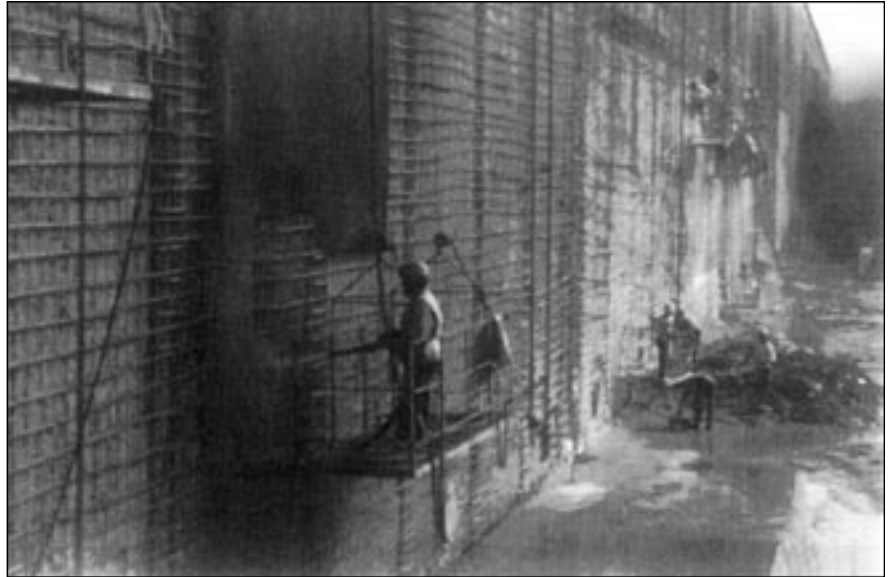
Fig. 4: Shotcreting in progress

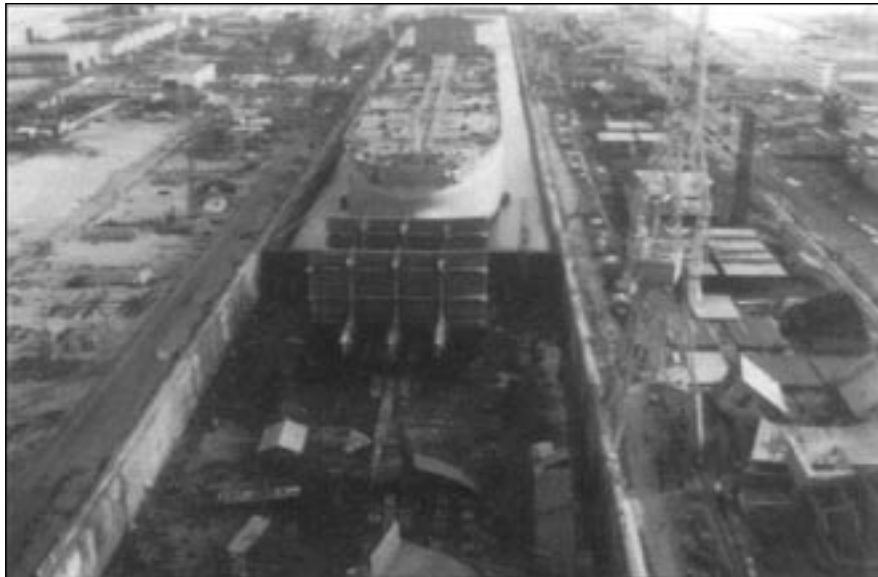
Fig. 5: The docks, again in operation, after the rehabilitation
