Confirming Shotcrete Quality On Site

by Steven H. Gebler and George W. Seegebrecht

Examining the Cause of Low Core Compressive Strength

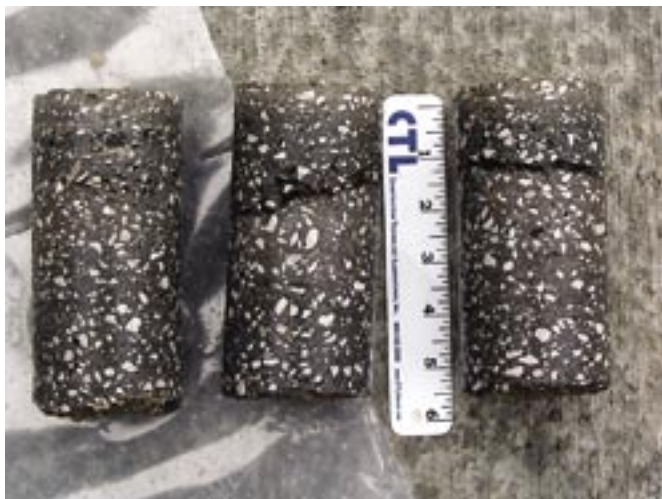
The cores exhibited considerable voiding as shown in Fig. 1. The voiding was significant in two regards. First, the voids reduced the unit weight of the shotcrete, which resulted in a corresponding strength reduction. Second, the location of the void immediately below the surface would

Fig. 1: Wading pool cores indicated significant voiding approximately 1 to 2 in. below the surface

likely have adversely affected the performance of the tile system yet to be installed.

To determine the cause of these low strengths, core samples underwent petrographic examination to evaluate the shotcrete properties. Petrographic analysis found a w/cm estimated to be surprisingly higher than desired: approximately 0.60 versus the approved mixture design value of 0.45. This high w/cm was unusual for shotcrete, because such a high ratio would likely result in sloughing of the material when applied.

Together the high w/cm and the degree of voiding reduced compressive strength to the degree indicated by the average core strengths.

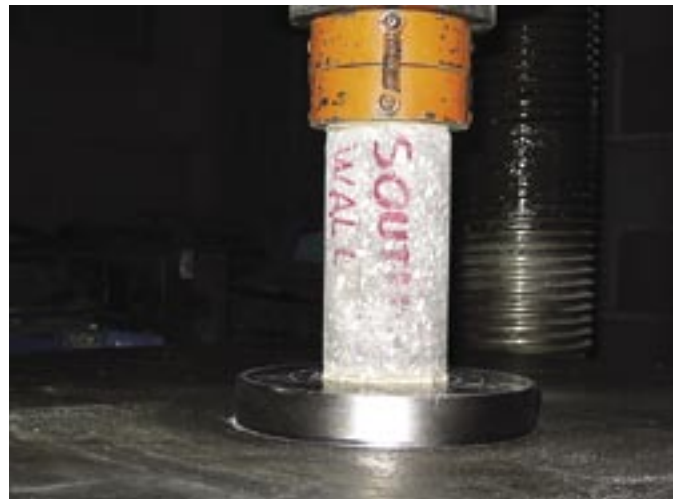
Fig. 2: Typical shotcrete core from pool during compression testing

Cores were then tested in compression in accordance with ASTM C 42 (see Fig. 2). Core compressive strength averaged 2100 psi (14 MPa), just 47% of the specified 4500 psi (31 MPa). This strength did not comply with the specification. A greater concern, however, was that higher strengths (lower water-cementitious material ratio [w/cm]) were needed for long-term durability in the high-sulfate soils found in the southwestern states.

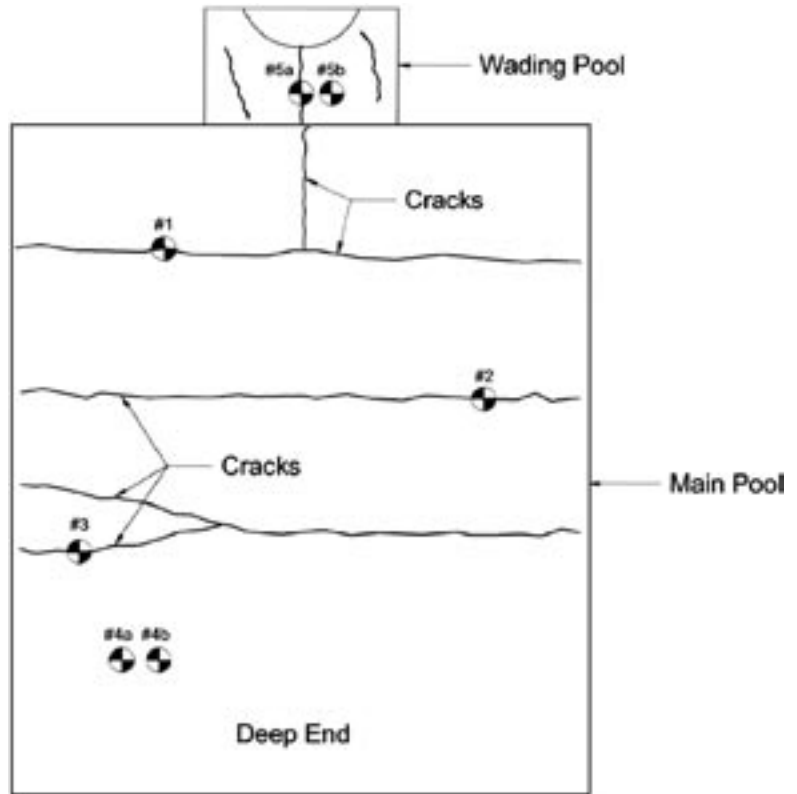
Approximately 2 years later, CTLGroup also conducted an on-site inspection of the pool in question, to observe its condition and mark areas for later extraction of cores (see Fig. 3 and 4). Subsequently, cores were extracted for examination.

- The contractor had been denied access to the shotcrete pool liner after the application, which resulted in the pool being improperly cured. This circumstance led to the development of nonstructural drying shrinkage cracks in the pool liner;
- The lack of curing also hindered the strength development of the shotcrete. Higher strengths would have been attained had the shotcrete been adequately cured. Even so, core tests confirmed that compressive strengths met the contract and project requirements;
- The cores extracted from the new pool liner under the author's supervision were graded in accordance to ACI 506.2-95, Specification for Shotcrete. The Core Grade ranged between 1 and 2, indicating in-place structural-grade shotcrete that meets the requirements of ACI 506.2-95.

Fig. 3: Schematic of New York apartment pool showing observed cracks and core locations

The investigator's report stated that the non-structural cracks in the new pool liner could easily be repaired and, with a final application of a marcite coating, could render the pool usable. The owner hired a very knowledgeable shotcrete expert who confirmed CTLGroup's findings.

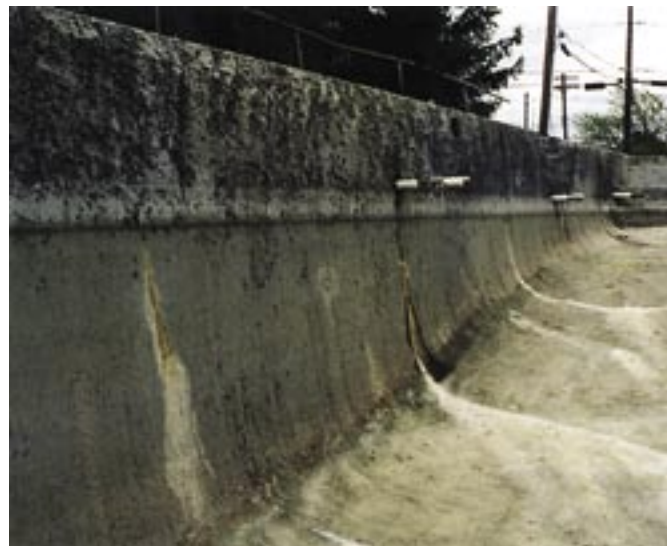
Fig. 4: Cracks observed in main pool of New York apartment complex

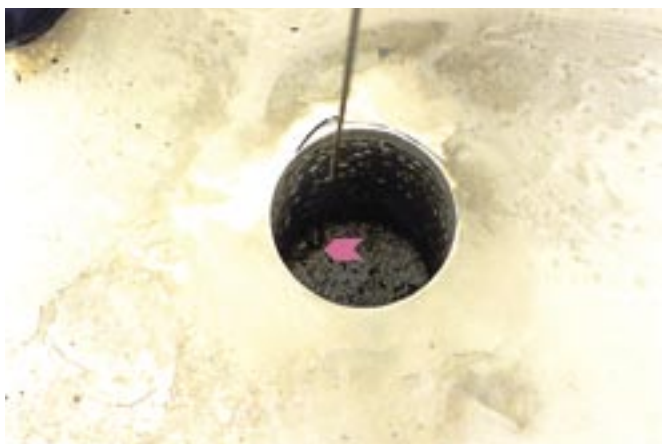
paint and liner. Observation of the cores disclosed a crack in the shotcrete shell directly under the crack in the liner. During coring, the operator could feel when the core drill had reached the bottom of the shotcrete shell. On removal of the core, a water-filled space was found between the shotcrete shell and the original concrete shell. No cracks were found in the original concrete shell. The spaces between the two shells, at the core holes, varied from 1/32 to 1-1/4 in. (0.8 to 32 mm) (see Fig. 5). The shotcrete appeared to be sound and of good quality. The direction of the cracks within the cores ranged from vertical to horizontal to angled. Phenolphthalein applied to the cores indicated that essentially no carbonation of the shotcrete had occurred, meaning that the shotcrete was relatively dense and compacted.

Fig. 5: Wire probe inserted into the space between the original substrate concrete and shotcrete shell

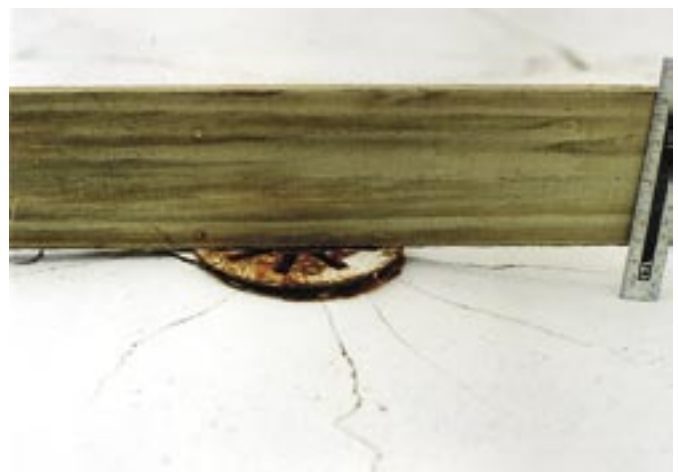
Water Inlets—All the water inlets appeared to have been pushed up from the floor level. The liner around each of the water inlets also sloped up to the inlet, with cracks radiating from the inlet (see Fig. 6). Most of the liner in these areas had been replaced with epoxy mortar, indicating that the original plaster liner had failed in the same manner and that the failure occurred even after application of the epoxy mortar. In other words, the shotcrete shell was continuing to move, and something had pushed the water inlets higher than their original position in the pool floor. Given that the 1-1/2-in.-diameter (38.7 mm) PVC distribution pipes were embedded in the shotcrete shell floor and the main distribution pipes were embedded in a chase in the original pool floor, it was clear that the water distribution system had been disrupted.

Fig. 6: Measuring movement of water inlet above floor level

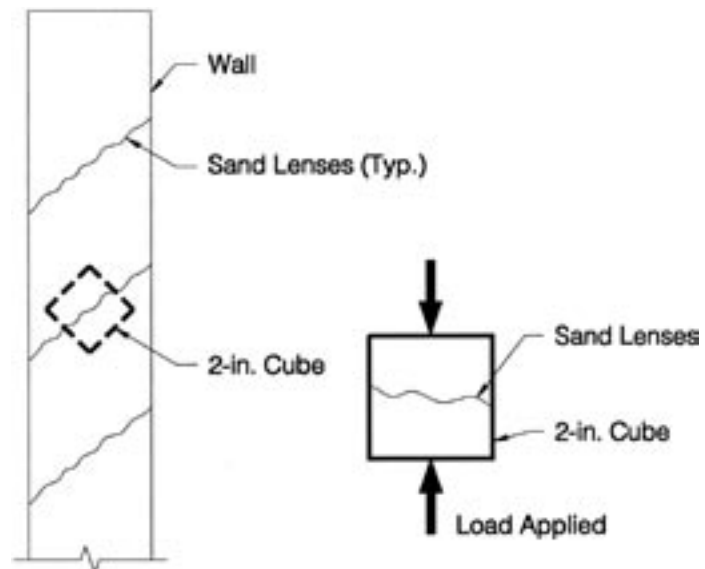
Prior to CTLGroup's involvement, the shotcrete contractor's investigators improperly conducted compressive strength testing. In their testing, they applied the compressive load normal to the sand lenses (see Fig. 7). The sand lenses were oriented at approximately a 30- to 40-degree angle relative to the pool walls. By testing normal to the sand lenses, which is contrary to ACI and ASTM shotcrete documents, these consultants arrived at an erroneous high strength.

Fig. 7: Improper strength tests, with compressive load applied normal to sand lenses, yielded erroneously high strengths
