Santee Cooper Shotcrete Repair in Moncks Corner

by W.L. Snow, Sr.

Reproduced with permission from the November 1991 edition of Concrete International—the magazine of the American Concrete Institute

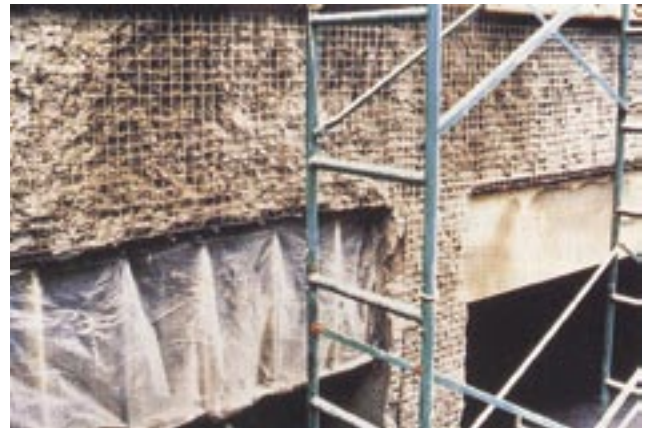
Surface area prepared for shotcrete placement

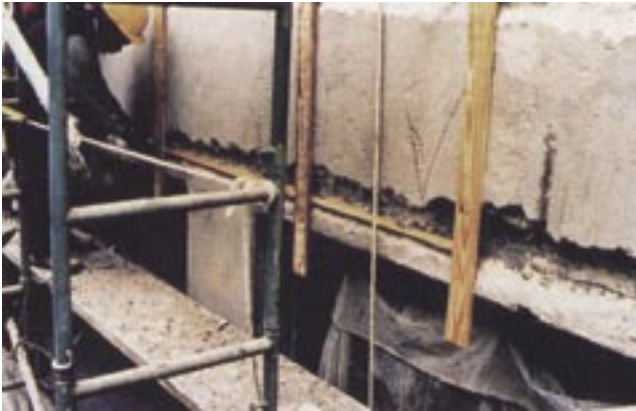
Interior forms for reveals

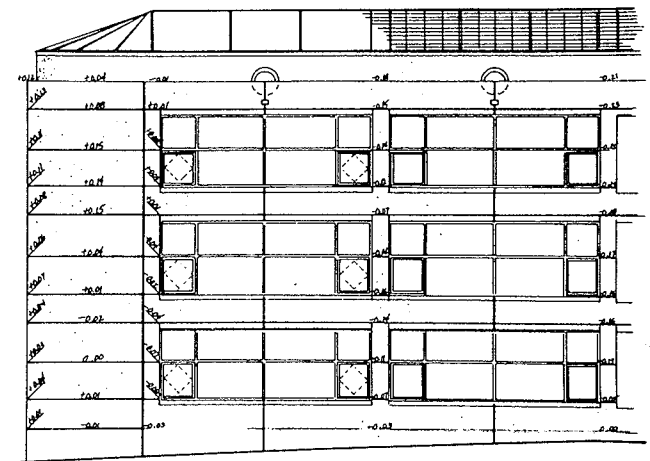
Elevation drawing showing deviations from plane

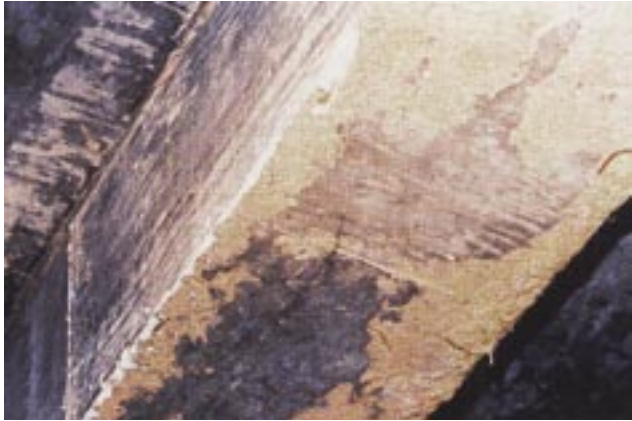
Underside of beam with sawdust before repair began

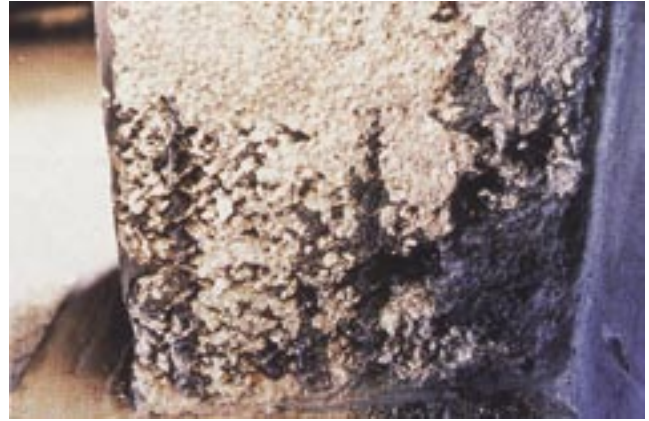
Honeycombed column-to-beam connection before repair

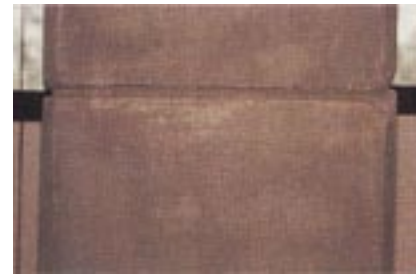
Completed column with reveal

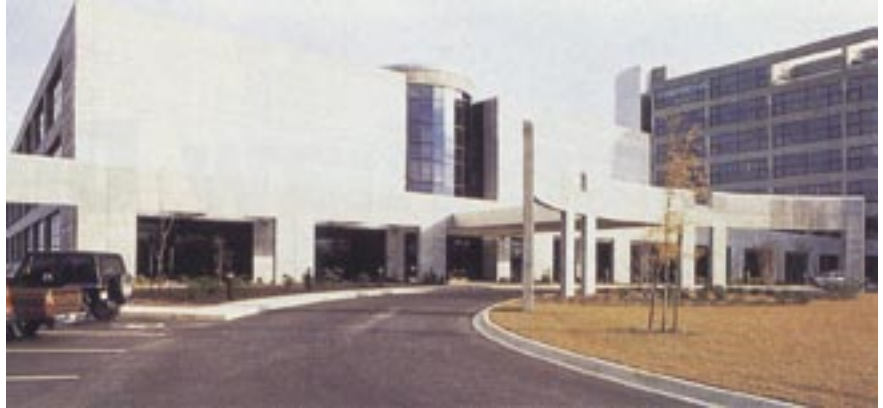
Completed Santee Cooper headquarters annex
