Placing Dry-Mix Shotcrete Under Extreme Winter Weather Conditions

by Howard Robbins

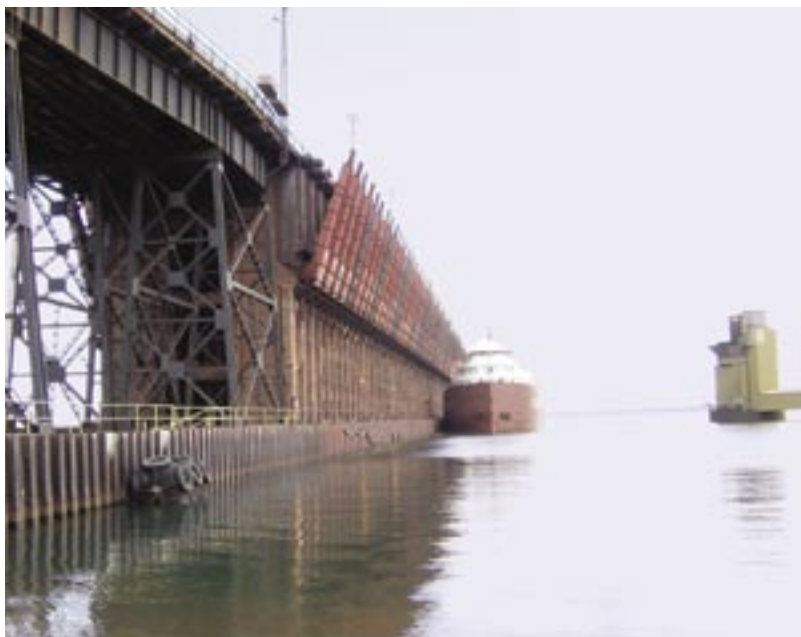
Overview of ore dock concrete support columns with barge taking on ore

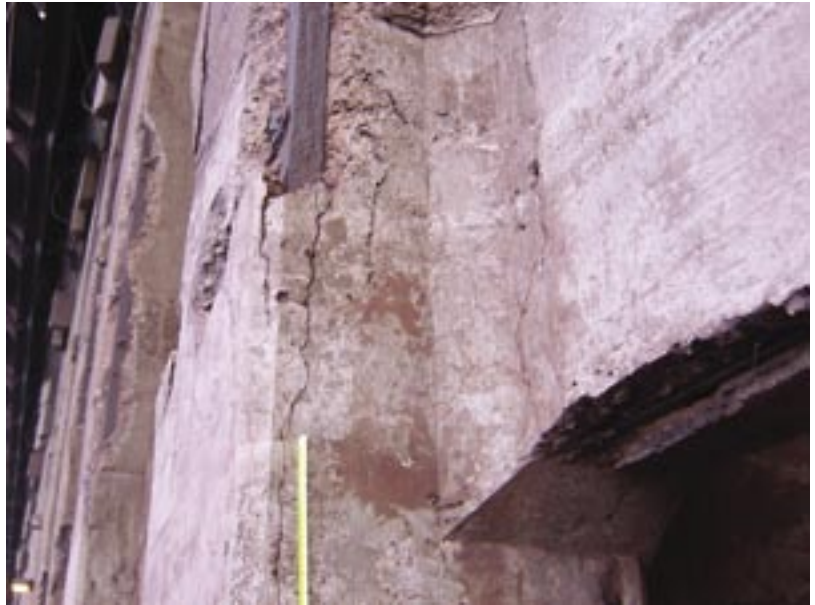
Close-up of damages to concrete support column and cracked concrete beam

After the workspace was enclosed and weather protected, work began with the demolition of the deteriorated, spalled, and damaged concrete columns and struts. To replace original reinforcing, Truesdell installed structural steel lacing bars and other conventional steel at various locations. Existing reinforcing was the original 93-year-old square steel bars and angle iron. Approximately 40 lineal ft (12 m) of crack repairs were completed at each column using high-pressure epoxy injection. Finally, shotcrete was placed to repair the damaged beams and columns and provide adequate cover over the steel reinforcing. Approximately 10,000 lb (4537 kg) of dry-mix material was placed at each column location.

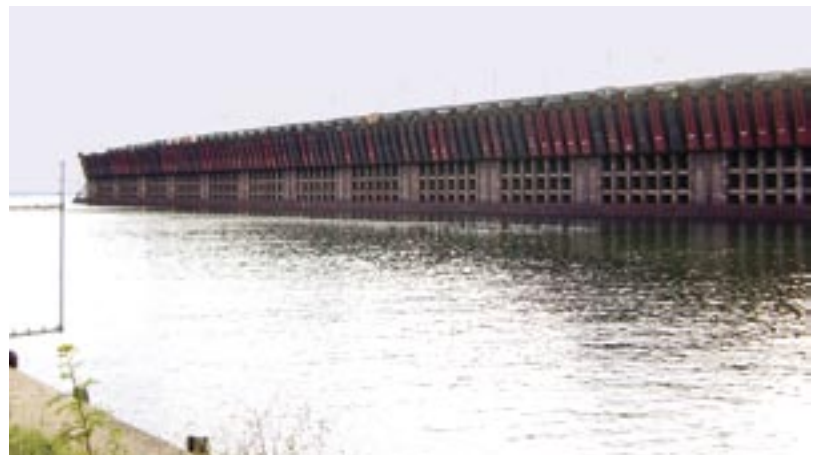
One side of dock showing sequence of columns needing extensive repairs

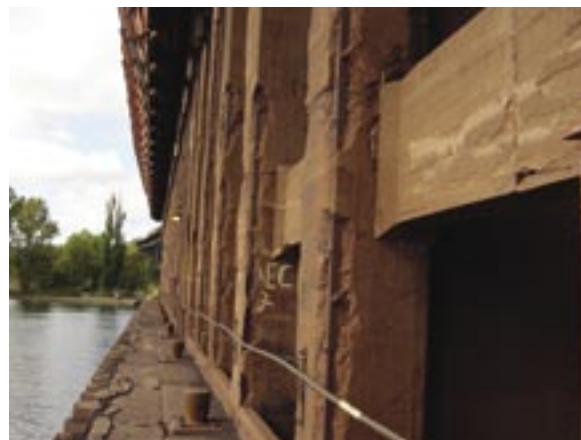
The effects of 93 years of wear and exposure to the elements
