Bad Benchmarks

Workmanship Issues in Swimming Pool Dry-Mix Construction

by Ron Lacher

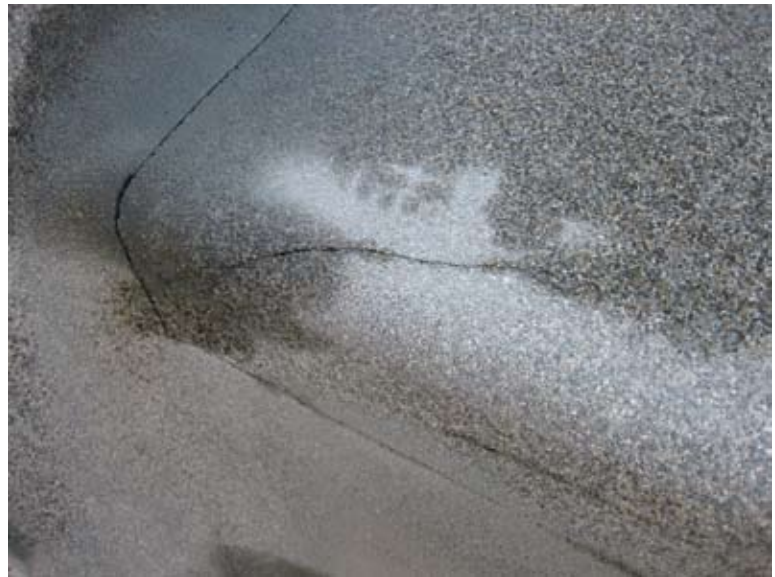
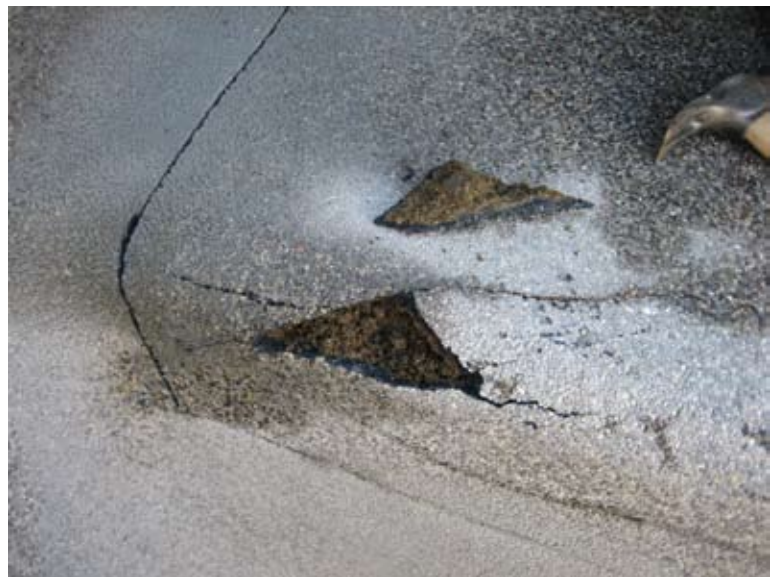
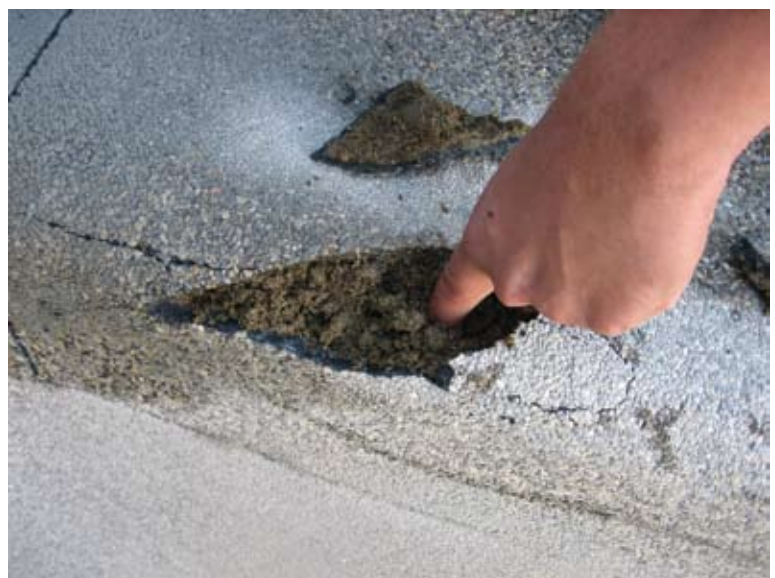
Saw-cutting the damaged area of this spa bench made it possible to flick off a piece of the plaster and discover the disaster lurking beneath the hard shell. It's rare even in cases of step or bench failure to find shotcrete so sandy that you can plunge a finger into it with ease

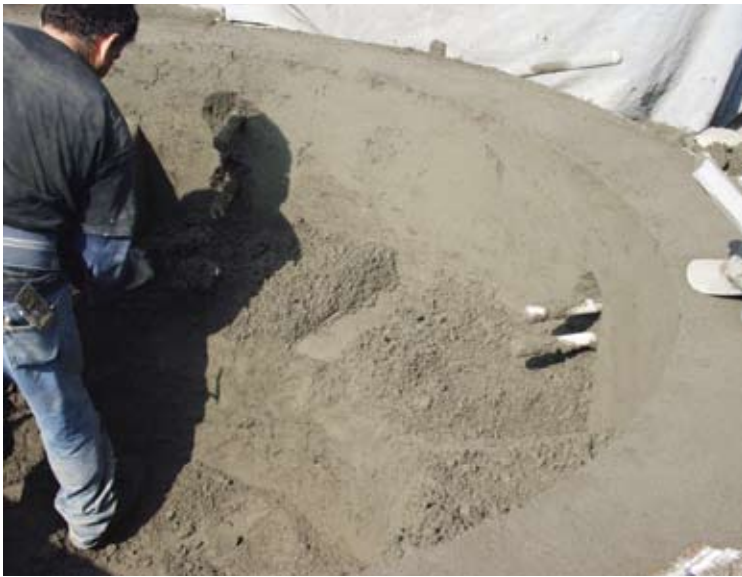
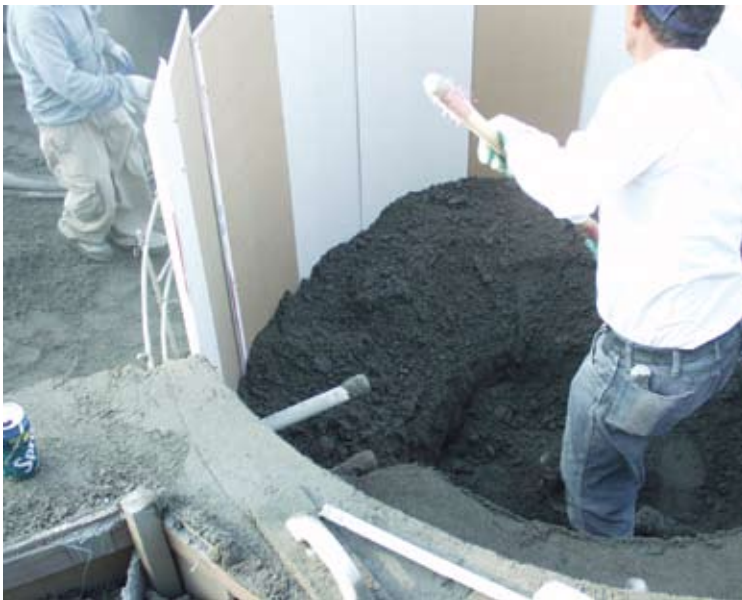
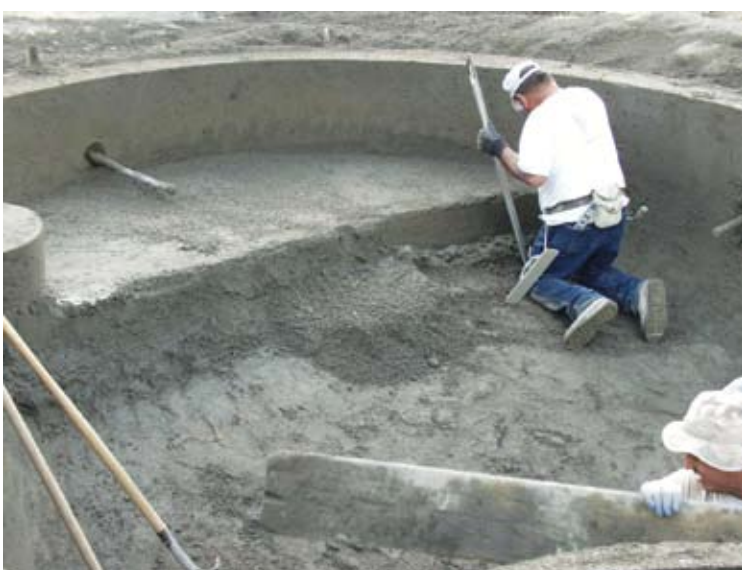
The origin of the problem seems obvious: it has to do with the use of gunite rebound in shaping steps and benches. This material has no structural value in a pool shell: It should be gathered up and discarded—no exceptions!

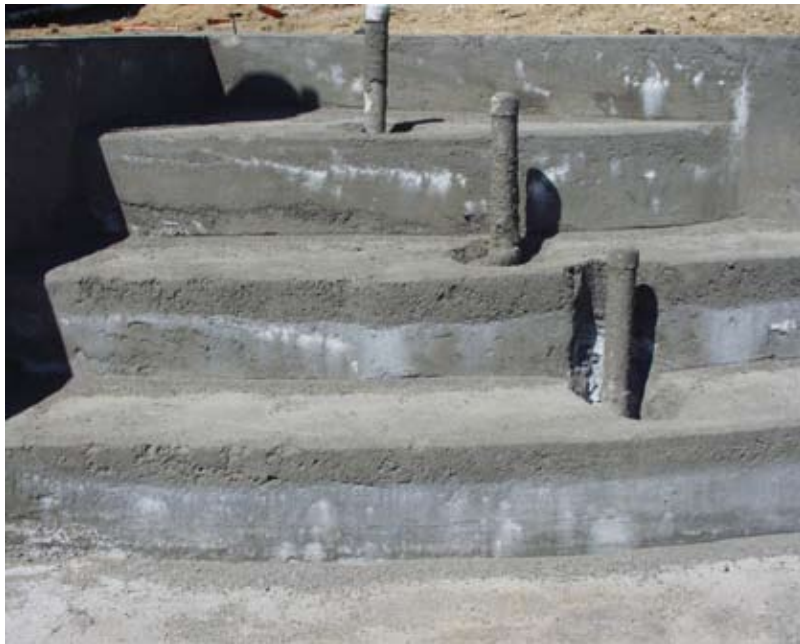
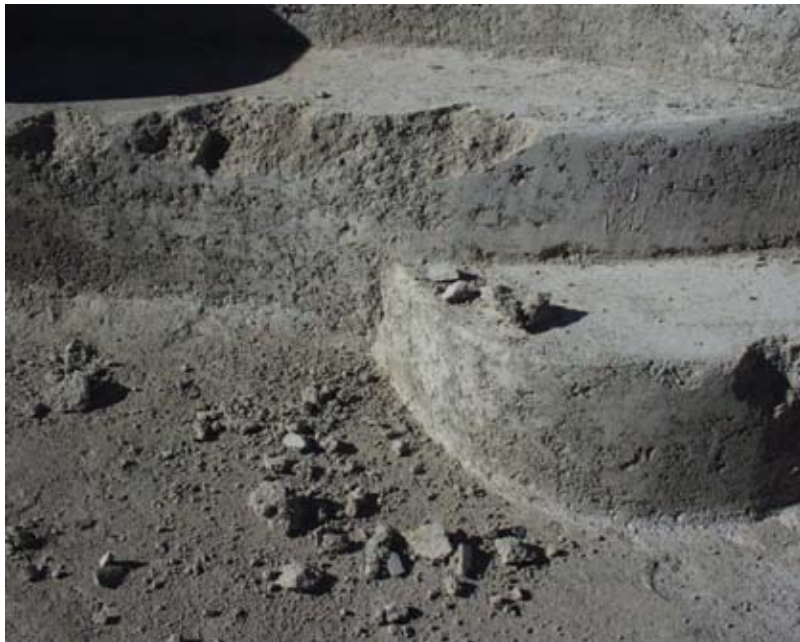
The newly shot shell shows the tell-tale signs of rebound use. The rebound-filled top surface may be capable of holding its shape until it is encapsulated in plaster, but if it is bumped or disturbed; it will crumble and fail away. Again, this isn't a competent substrate for plaster and should never be used

Instead of this shortcut, there are really two proper choices for good gunite installation practice: Either shoot the benches and steps to final elevation when the spa is initially shot, or bring the hose back into the spa after initial cutting to shoot the steps and benches to final elevation. In both cases, the final cutting of the tops of the steps and benches should *always* be within pneumatically applied material—better yet, with pneumatically applied material *not* placed over waste material.

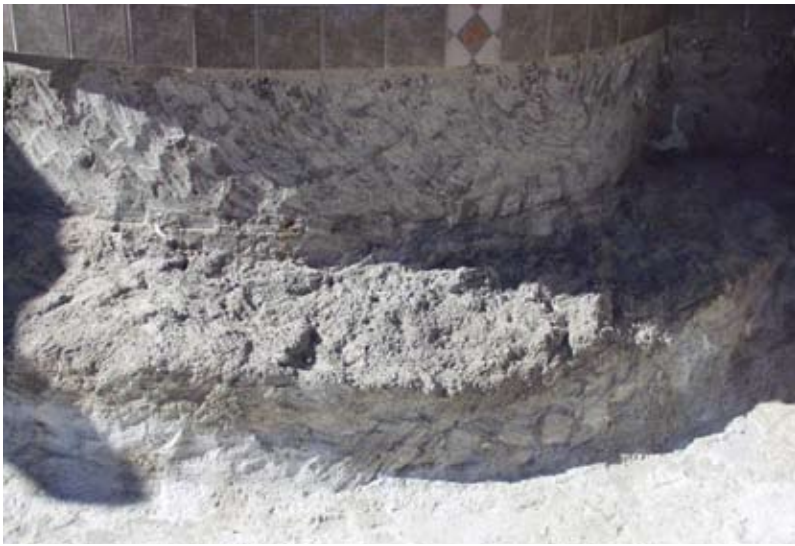
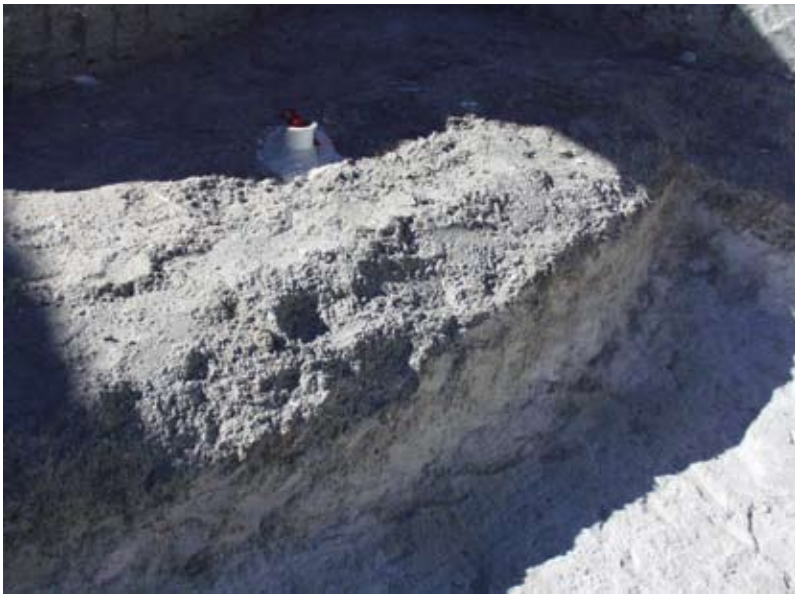
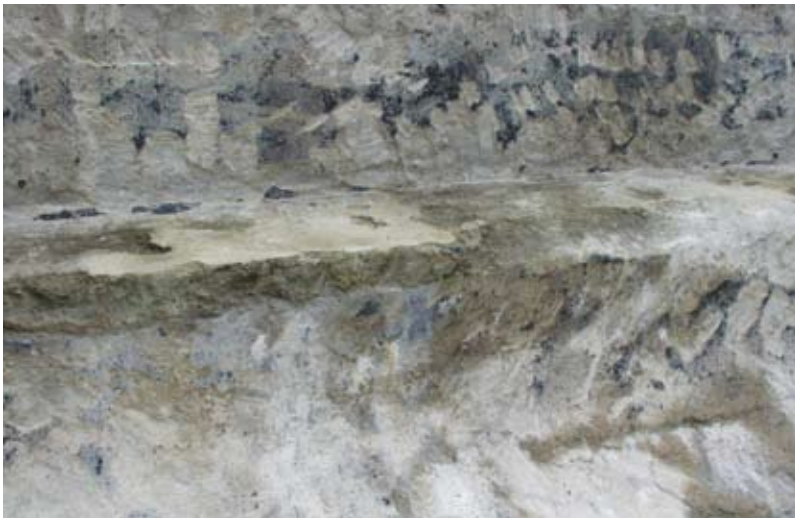
Evidence of the use of rebound often shows up years later, when a pool's interior plaster is stripped for refinishing. In all of these cases, the rebound-bearing steps and benches fell apart once the plaster that held them together was removed, leaving the homeowners and plasterers with messes that won't just take care of themselves, and the pool construction industry with a black eye it really doesn't need
