Fire-Damaged Bridge Repaired with Gunitite

Lake Springfield Structure Spalled by Gasoline Fire Is Completely Restored by Contract in Two Months

Reproduced from Contractors and Engineers Monthly, February 1945

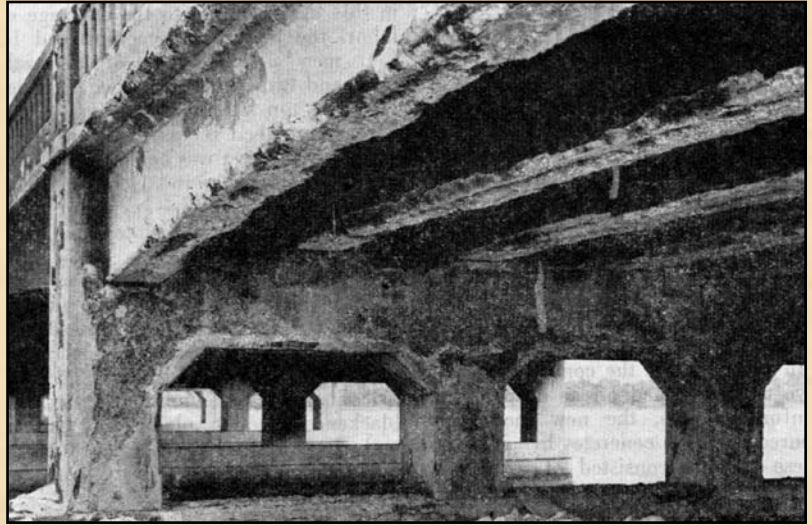
The accident occurred near the southern end of the bridge on span 27 which suffered the greatest damage, although the two adjoining spans were also somewhat spalled by the heat. Strangely enough, the fire did less damage on the deck where the truck cracked up than it did to the beams, columns, and piers below. As the liquid fuel ran down the scuppers, it spread out over the bottom of the bridge superstructure, covering the bents and foundation above the water line. A brisk breeze aided the flames in generating a terrific heat which caused the reinforcing steel in the

structure to expand, cracking and spalling the concrete around it. When the fire ceased and the smoke finally cleared away, an inspection of the concrete, once clean and white but now blackened from the fire, clearly indicated that the bridge would have to be repaired at once before the beams were further weakened by exposure.

Beams, columns, and piers of the reinforced-concrete bridge over Lake Springfield, IL, damaged by fire, were repaired with gunite

protection from flying fragments, removed the crumbly concrete for an average depth of 3 inches. On the two outside curved beams, however, which were gutted more than the others, the concrete was removed for an average of 18 inches upward on the sides from the bottom of the beam and for a depth of 4 inches, exposing the steel reinforcing.

The beams were then faced with a 3-inch mesh of No. 10 wire which came in 30-inch rolls. As the beams are 18 inches wide, a 6-inch strip was turned up on each side of the mesh so that the section could be wired to the reinforcing rods. For ease of handling, the mesh was cut with nippers into 5-foot lengths and when placed along the bottom of the beam had a 6-inch lap at each junction. The wire was light enough so that it could be bent by hand to the shape of the beam.

On the two arched outside beams, wooden "shooting" or guide strips were wired to the reinforcing in order to secure true lines and camber. Sixteen-foot strips of 3 x $\frac{7}{8}$ -inch board were used, along one edge of which a $1\frac{1}{4}$ -inch chamfer strip was nailed. With the strips in place, shooting began, with the nozzle man directing the stream of sand, cement and water against the bottom of the beam first and then moving towards the top. The Gunite was built up in layers until the concrete conformed with the original outline. Encasing the beams with reinforced Gunite restored the design to the structure.
