# Water Pollution Control Plant Structures Successfully Repaired with Shotcrete

by Amer Syed and Tim Gillespie

**T**he Joint Water Pollution Control Plant (JWPCP), owned by the Sanitation District of Los Angeles County is located in the City of Carson, CA. The plant is on roughly 350 acres and treats 350 million gal. (1325 million L) of wastewater per day. The plant is critical to supplying the needs of over 3.5 million people and many industries in southern and eastern Los Angeles County.

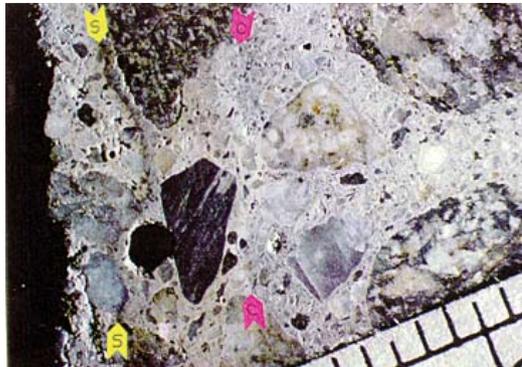
Following the field investigation, cores were extracted from various representative areas of the structure and examined by petrographic examination. The water-cement ratio was estimated to range from 0.40 to 0.50, the paste within the body of the cores was in good condition, and the bond to the aggregate was tight. However, there were several areas of concern. Carbonation had progressed in some areas up to 0.4 in. (10 mm) into the concrete. The concrete paste had softened in some core samples down to 0.25 in. (6 mm).

*Carbonated concrete in a sample core*

this problem was limited to the top 0.25 in. (6 mm) of the surface. The cause of the cement paste softening and consequent surface erosion was the result of continuous exposure to the aggressive nature of the effluent with the pH ranging between 6.1 and 6.9.

- Remove the top 0.5 in. (13 mm) of the surface using high-pressure water blasting. This would ensure that the entire softened matrix would be removed. It would also remove (although not a specific requirement of the engineer) the carbonated concrete as well.

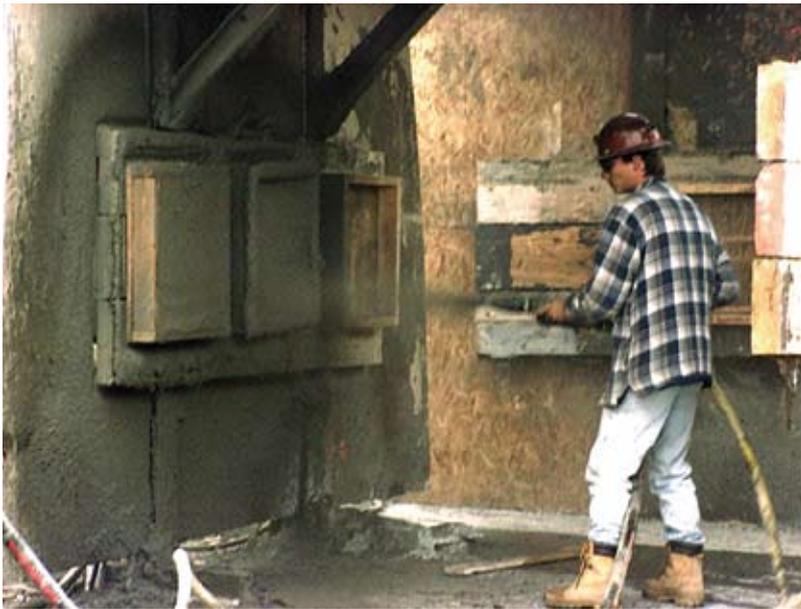
*Test panel being shot on site*

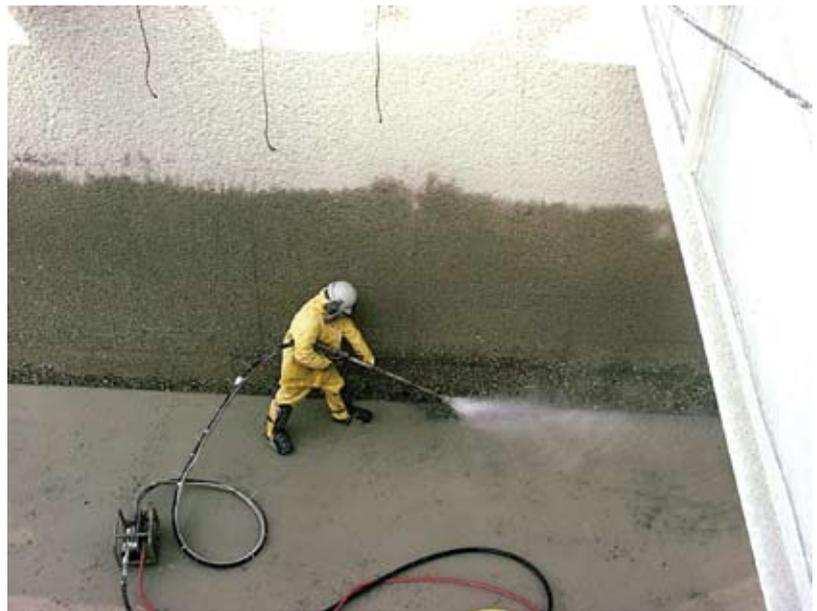
*Surface preparation being done*

The surfaces were prepared using high-pressure water blasting at 30,000 psi. The equipment was operated robotically. The profile resulting from the preparation was very aggressive, approximately ±0.25 in. (6 mm) amplitude, ICRI concrete surface profile (CSP) 9, exposed aggregate, clean, and sound. Because of the aggressive nature of the preparation 1 to 1.25 in. (25 to 32 mm) was removed rather than the 0.5 in. (13 mm) specified. Fortunately, the contractor had ordered double the amount of material originally estimated.

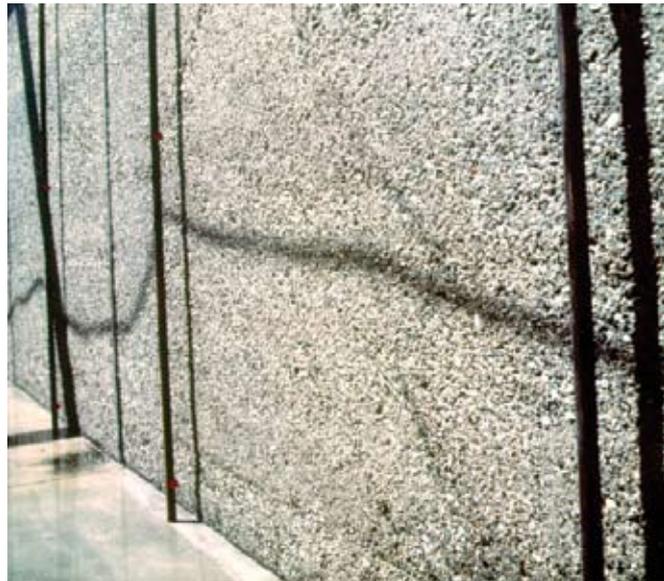
*ICRI concrete surface profile 9*

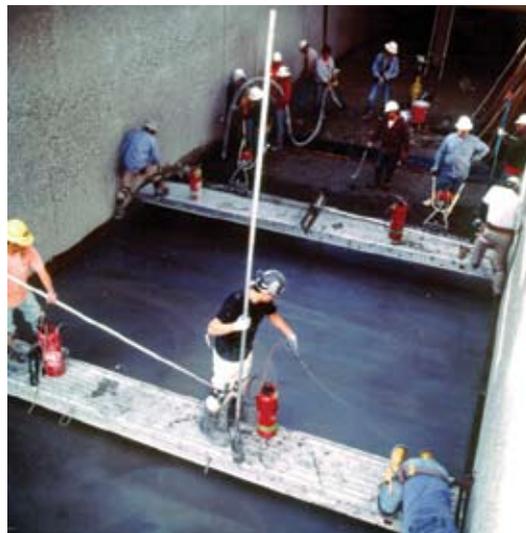
*Curing compound being applied*

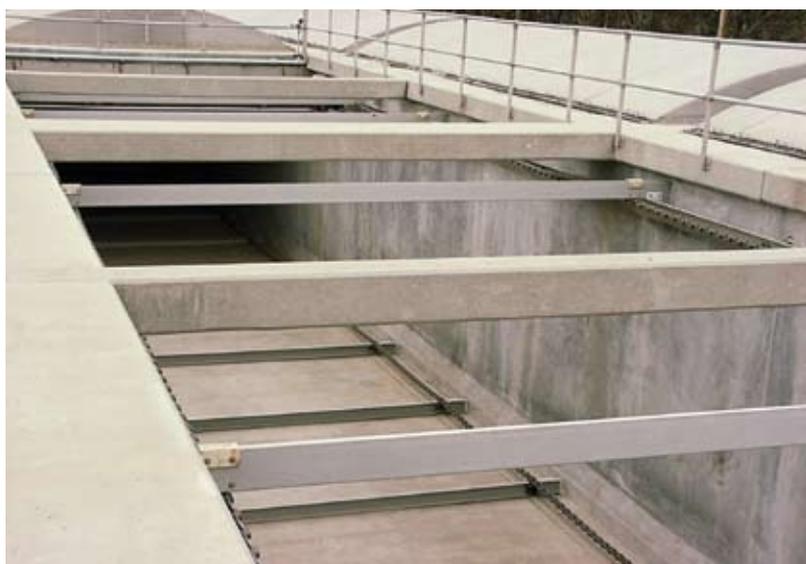
The completed project
