*Gunite Protection for
Steel Structures*

Full Reprint of Bulletin No. 4, 1924
Issued by the University of Toronto

Gunite Protection for Steel Structures

Experiments at Leaside, Ont., with Two 42-ft. Steel Plate Girders Covered with Gunite to Ascertain Cause of Superficial Cracks on Bridges at Hamilton — Conclusions Favor Employment of Guniting Process

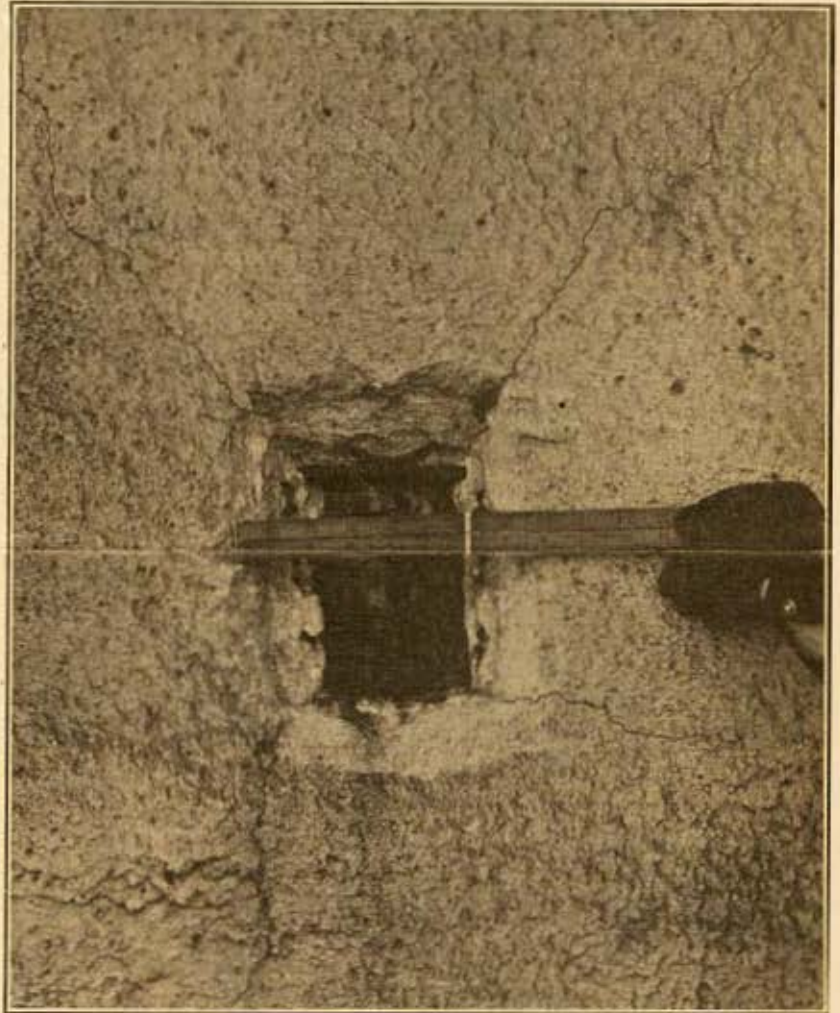
FIG. 3.—CRACKS RADIATING FROM AN OPENING CHIPPED IN GUNITE

Frequently when gunite has been chipped from the centre of a panel, cracks radiating from the opening have been observed to develop in the course of a few weeks following the chipping. This is particularly noticeable where the shell of gunite is very thick. This shows the effect of lack of continuity in the covering envelope.

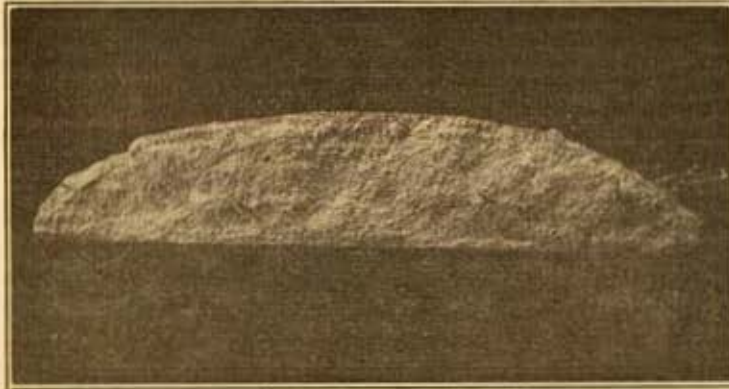
FIG. 4.—SECTION OF GUNITE SLAB

Figs. 4 and 5 are photographs of fractured sections of a slab of gunite and a block of hand-placed concrete respectively, the mixture in each case being 1:3. The gunite is the denser of the two and being denser is more impervious to the entrance of water. An examination with a reading glass shows that the face of the slab, which was in contact with the steel, is a film of practically neat cement, any sand present being of an extremely fine character. The imperviousness of gunite and the layer of almost neat cement in contact with the metal surface are two circumstances which render corrosion difficult. If, however, cracks occur in the gunite, what may be expected?

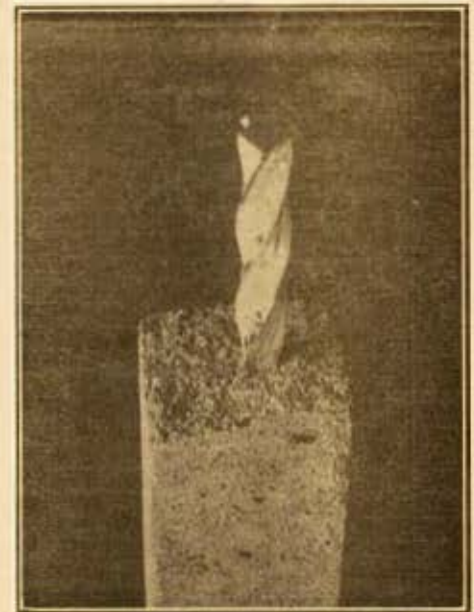
FIG. 5.—SHOWING SPURS OF RUST ON METAL OTHERWISE PROTECTED BY MORTAR
