Shotcrete is a Versatile Structural Concrete Repair Material

By Bruce A. Collins and Adam N. Zius

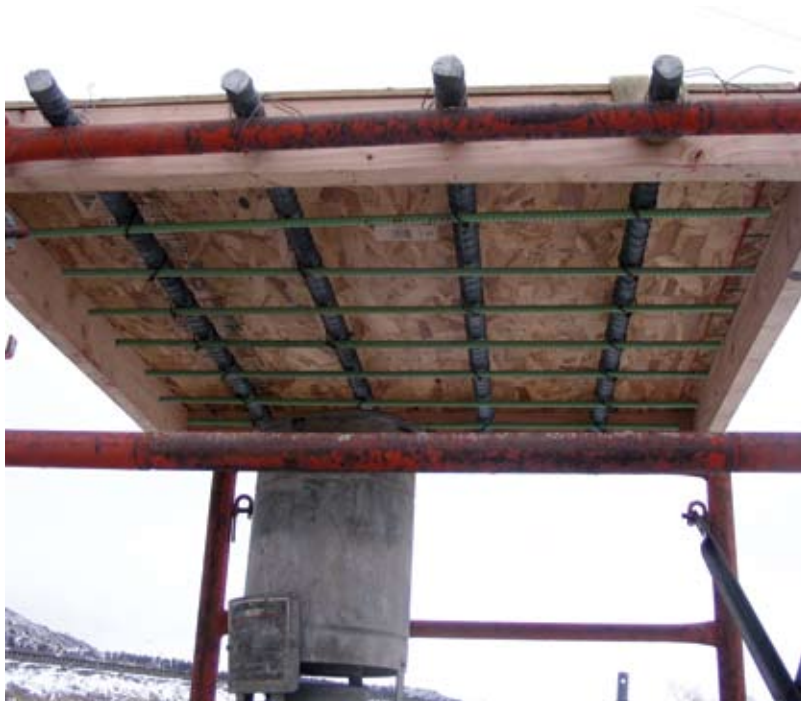
Project No. 1: Core grading test panel from Hoover Dam bypass bridge project

unreinforced lumber construction panel was prepared and shot at the repair contractor's facility. Initial curing was completed using water foggers. Three cores were extracted for compressive strength testing and visual core grading per ACI 506.2. Visual grading showed excellent results with all cores achieving an ACI Grade 2 or better. Compressive strength testing results averaged 8180 psi (56.4 MPa). The second test panel was constructed using No. 11 (35 m) reinforcing bars at 10 in. (250 mm) on center with No. 4 (13 m) bars at 6 in. (152 mm) on center over the larger bars. The test panel size was 4 ft x 4 ft x 5-3/4 in. (1.2 m x 1.2 m x 146 mm). This panel was shot at the repair contractor's facility and three cores were extracted including the reinforcing and visually graded by FHWA officials. All results were ACI Grade 2 or better. The third test panel was built at the joint venture contractors' facility and was constructed using the concrete mixture design used for the original pier cap construction. The concrete panel was constructed with exposed No. 11 (35 m) bars and No. 4 (13 m) stirrup bars similar to the pier cap reinforcing steel placement. The concrete test panel was shipped to the repair contractors' facility. Surface preparation of the 6 x 6 ft (1.8 x 1.8 m) concrete test panel was completed using a 20,000 psi (138 MPa) pump delivering water at approximately 12 gal. (45 L) per minute. The test panel was shot using the designated repair shotcrete. Initial curing was completed using fog sprayers. After 7 days of curing, shotcrete-to-concrete bond tests were completed per the ICRI guideline. An average direct tensile shotcrete-to-concrete bond strength of 259 psi (1.78 MPa) after 14 days was obtained.

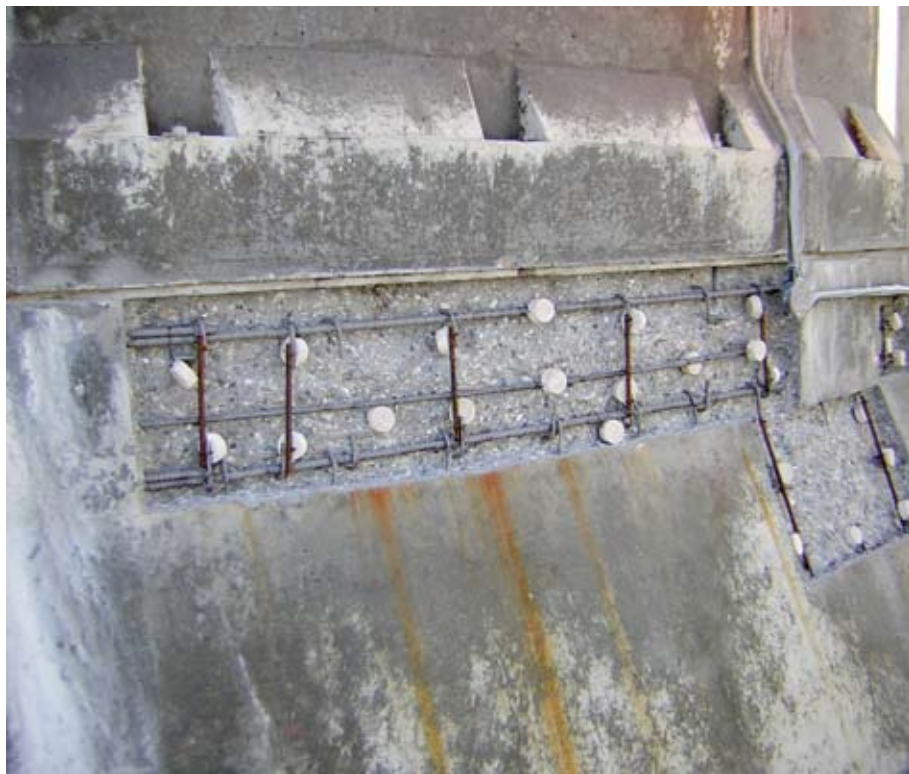
An investigation revealed that the wetting and drying action combined with low (3/4 in. [20 mm]) concrete cover was allowing the corrosion process

Project No. 2: Repair areas ready for shotcrete application

to initiate. Results of the investigation revealed that approximately 15% of the 24,730 ft² (2297 m²) of concrete area was delaminated or spalled and required repair. First, it was important to develop a repair scheme that addressed the source of corrosion.

The repair scheme consisted of installing a thick epoxy coating on the inside face of the concrete assembly to cut off the vapor drive through the concrete. This work was completed during two separate 30-day plant shutdowns for maintenance periods. Once the vapor drive was shut down and the concrete humidity level was reduced, the shotcrete repairs were started. The repair material selected was a prepackaged 5000 psi (34 MPa) 28-day compressive strength product with aggregate gradation No. 1 per ACI 506. Dry-mix installation was selected due to the large number of repair locations coupled with the small average area per location. The repair locations were on a vertical surface, and the use of dry-mix shotcrete eliminated the need for the use of concrete formwork required for casting repairs. The repair material was tested for permeability. The permeability requirement allowed for compatibility with passive cathodic protection anodes installed along the perimeter of each repair location. Delaminated concrete was removed using 15 lb (7 kg) chipping hammers. Surface preparation was completed using dry sandblasting. The shotcrete was installed over a 2-week period during operation of the cooling towers. Shrinkage cracking occurred in greater amounts than normally experienced due to the elevated temperatures of the concrete substrate and the difficult curing conditions. A silane sealer was applied to the shotcrete upon full curing. Corrosion current, half cell potential, and

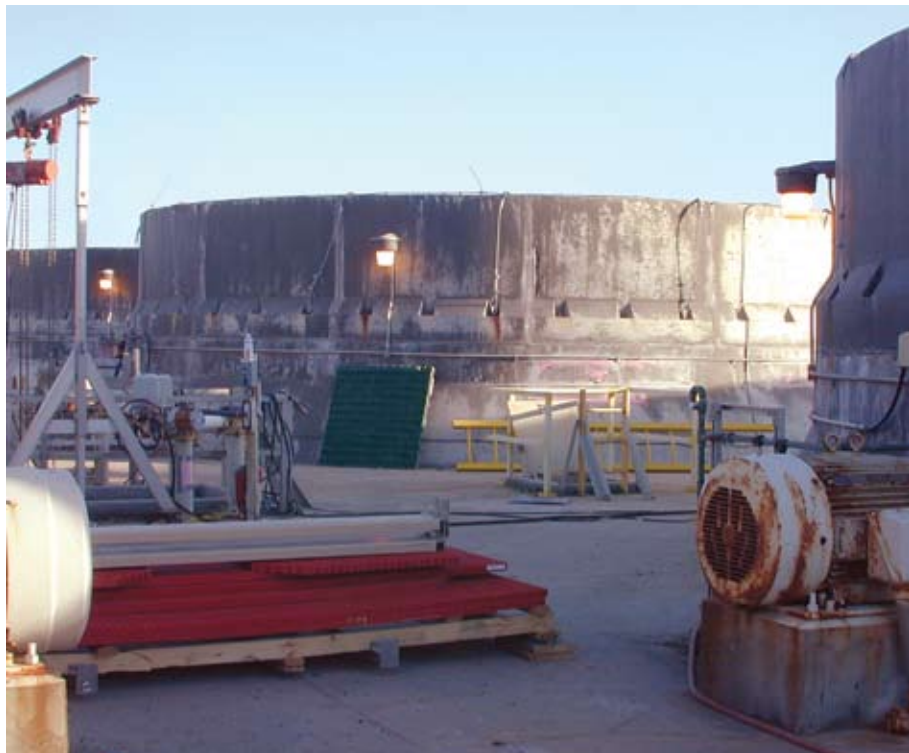
A coal-fired electrical generation station located in the desert southwestern U.S. was experiencing reinforcing steel corrosion in certain components of the concrete draft cooling towers on the property. The conventionally reinforced concrete lower rings of the fan stack assemblies were deteriorating from reinforcing bar corrosion.

Project No. 2: Fanstack assembly sitting on top of concrete draft cooling towers

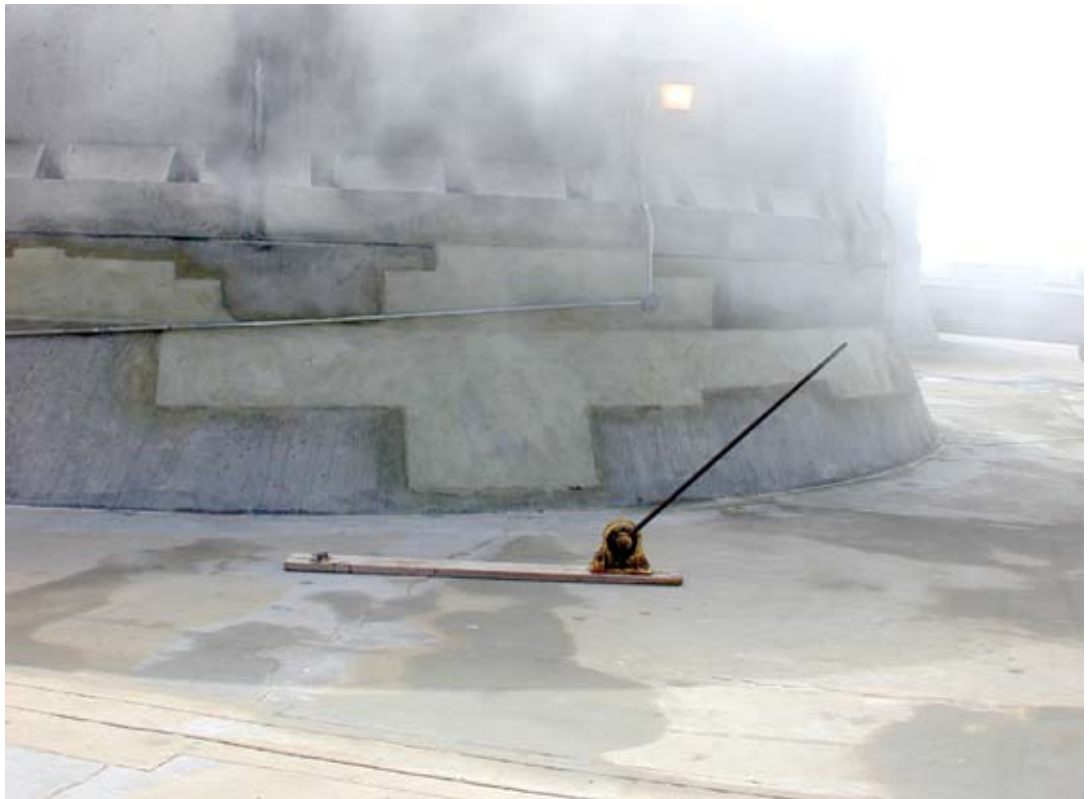
Project No. 3: Repaired fanstack assembly

resistance measurements were taken using a linear polarization tool prior to and after repair completion. Concrete resistance, an indirect measure of concrete humidity levels, improved nearly nine fold from 10 kilo-ohms to 90 kilo-ohms resistance. Reinforcing bar corrosion currents improved from 150 μm per year dissolution to 25 μm per year. Finally, corrosion potential improved dramatically. At the conclusion of the project, it was determined that the reinforcing steel is once again in a passivated state.
