Use of Dry-Mix Shotcrete to Repair a Lighthouse Structure

By Martin Gendreau, Denis Beaupré, Pierre Lacombe, and Jean De Montigny

Originally printed in the Fall 2000 issue of Shotcrete, Volume 2, Number 4.

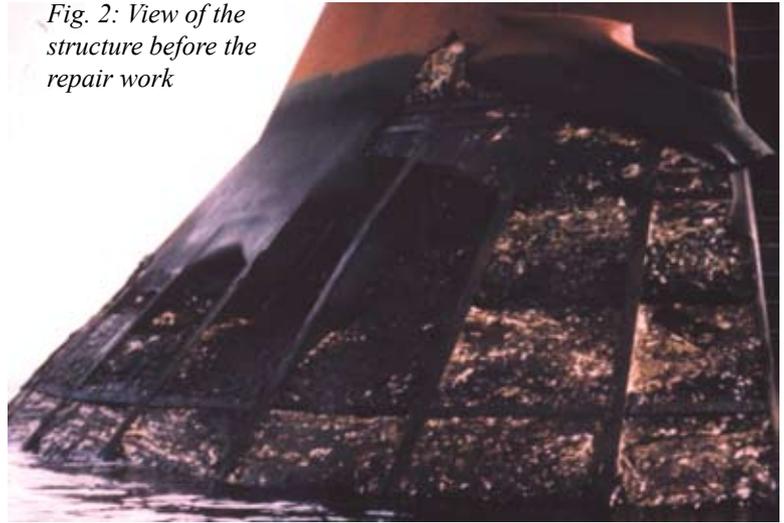
Situated in the tidal zone of the river, the repaired section of the structure showed damage on the steel laps and the concrete forming the pier base. This damage was caused by the high pressure of ice grinding against the surface. The covering made of steel plates 0.5 in. (12 mm) thick was deteriorated and the concrete was damaged by ocean currents, ice movement, and freezing-and-thawing cycles. Some sections of the concrete were deteriorated up to 5 ft (1.5 m) deep. Figure 2 shows a section of the Haut-Fond Prince Lighthouse in its deteriorated state before its rehabilitation.

Fig. 2: View of the structure before the repair work

For both technical and economic reasons, the Canadian Coast Guard, owner of the lighthouse, chose shotcrete to repair the structure. The repair work consisted of removing the damaged steel plates, removing the deteriorated concrete, and applying shotcrete to reinstate the structural integrity of the lighthouse. The repair work was carried out during the fall of 1996.

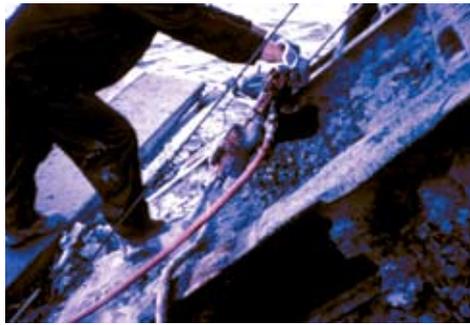
Fig. 3: Removing deteriorated concrete

the application of shotcrete. The steel facing plates were removed and the contractor used pneumatic chipping equipment to remove damaged concrete (Fig. 3). The equipment mass was limited to 59.5 lb (27 kg) to prevent damage to the concrete forming the shotcreting surface. Heavier tools could have induced additional cracks in the concrete base of the structure, which could have adversely affected the quality of bond between the old concrete and the shotcrete.

The specifications required the removal of the deteriorated concrete until sound concrete was exposed. The minimum demolition depth was fixed at 4 in. (100 mm) from the surface of the structure to ensure a sufficient shotcrete thickness to obtain an adequate anchorage of the shotcrete to the structure. At different places, concrete deterioration was observed from as much as 3.3 to 4.9 ft (1 to 1.5 m) deep.

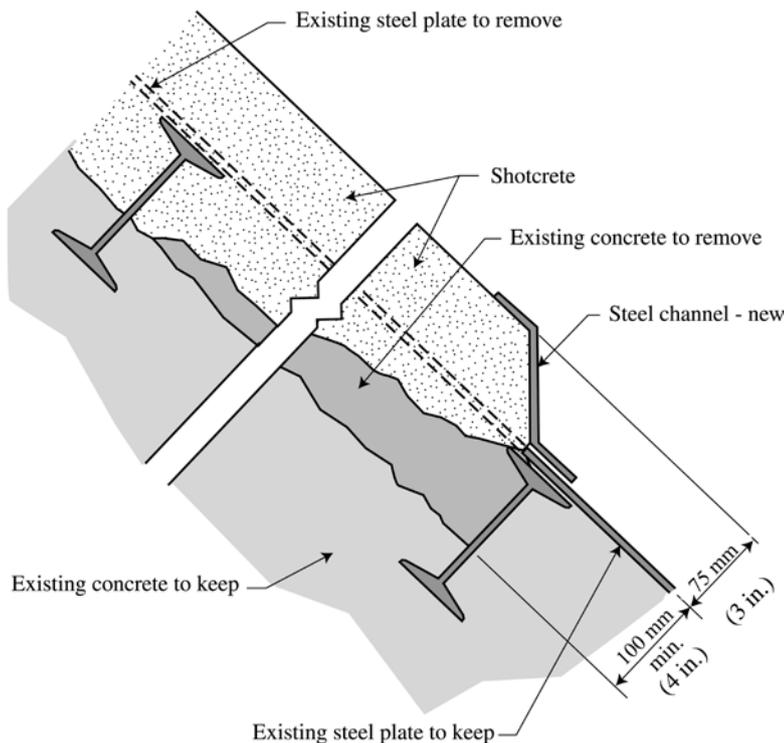
Fig. 4: Details of the repair work

Figure 4 illustrates the detailed surface preparation. A new steel channel was installed on the perimeter of the repair zone. This was first used as a framework for the shotcreting operations, and then later kept as protection against ice pressure due to the angle of the channel.

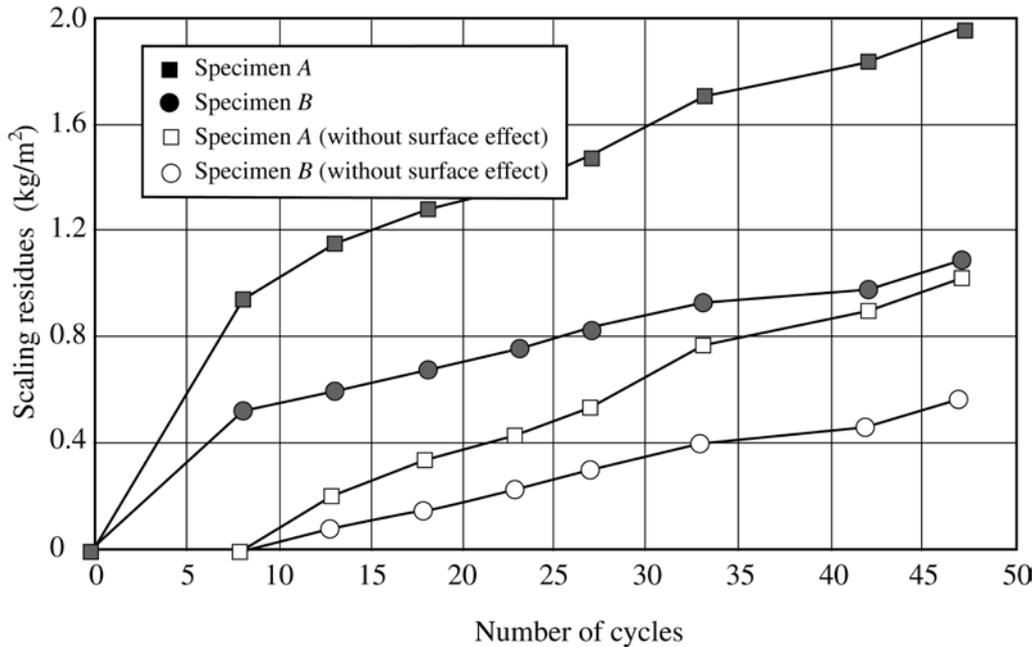
Fig. 5: Scaling losses with and without the first freezing-and-thawing cycles (ASTM C672)

The scaling test results are presented in Table 2 and the scaling loss curves are presented in Fig. 5. The results show a rapid loss in mass during the first freezing-and-thawing cycles. This surface deterioration was probably due to the lack of curing and the gun-finish surface of the shotcrete

specimens. Figure 5 also shows the scaling losses without the effect of the first freezing-and-thawing cycles. It can be seen that the shotcrete produced for the repair project was durable in terms of scaling resistance.⁴

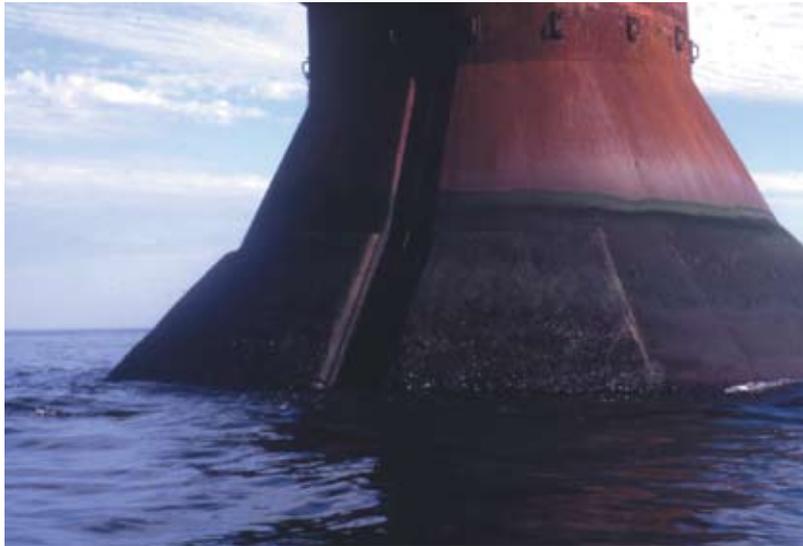
Four years after construction, a visual examination of the structure was performed to evaluate the behavior of the repair. The shotcrete used as a repair material showed excellent resistance to damage from freezing-and-thawing cycles, erosion, and impact from ice (Fig. 6). It is believed that the design and supply of a well-adapted shotcrete mixture, according to this repair project specification, and the quality work performed by the shotcrete crew are responsible for the success of this rehabilitation.

Fig. 6: View of the structure 1 year after the repair work
