## Underground Shotcrete Roof Repair of Hanging Lake Tunnel

By Warren Harrison

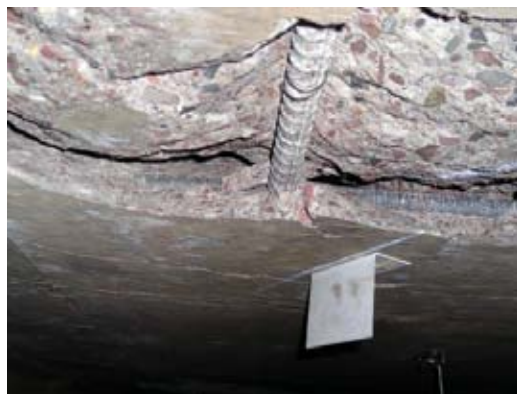
**D**uring a Federal Highway Administration annual safety inspection in March 2007, a crack was found in the flat roof portion of the cut and cover section of the Hanging Lake Tunnels along Interstate 70 in Glenwood Springs, CO. The crack—an end shear failure—was discovered in the roof section of the eastbound tunnel only. The total displacement was 2 in. (50 mm) and moving.

The apparent cause of the failure was a rock fall in January 2002 that overstressed the open cut portion of the tunnel, adding 35 ft (10.6 m)

Crack in roof

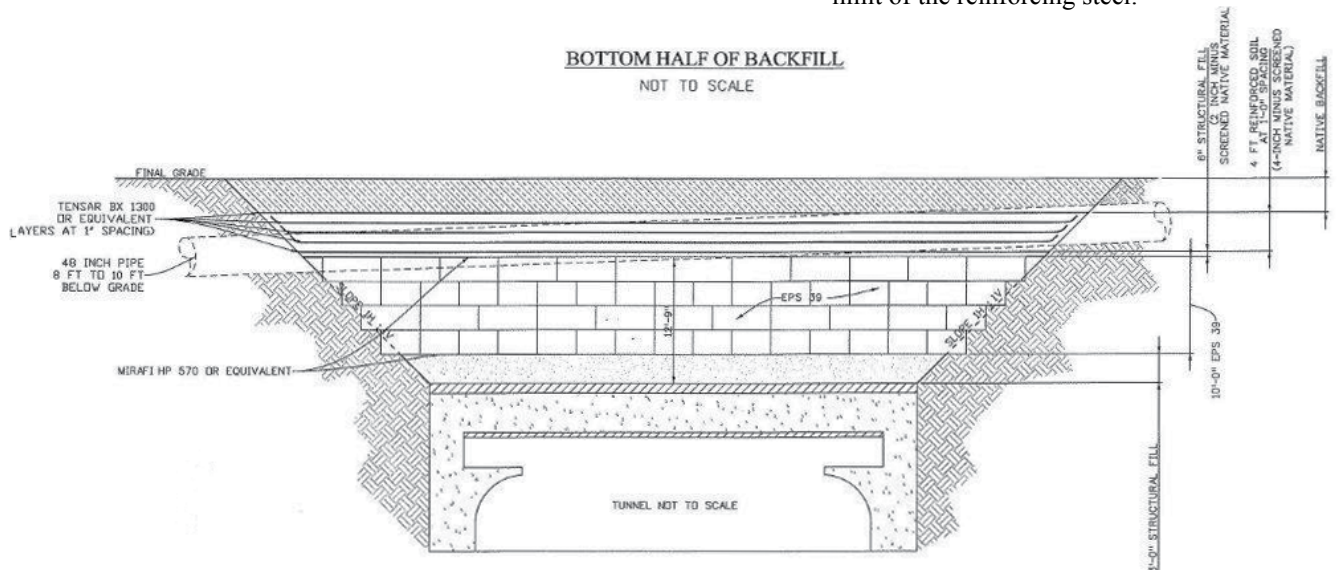
Tunnel section showing final backfill with expanded polystyrene fill to reduce load

The final backfill over the tunnel included a thick layer of expanded geo foam to reduce the dead loading for the beam.
