Ruskin Dam Spillway Shotcrete Assessed

Study shows that the dam's long service life can be extended by almost 50%

By Lihe (John) Zhang, Mazin Ezzet, Natalya Shanahan, Dudley R. (Rusty) Morgan, and A.P. Sukumar

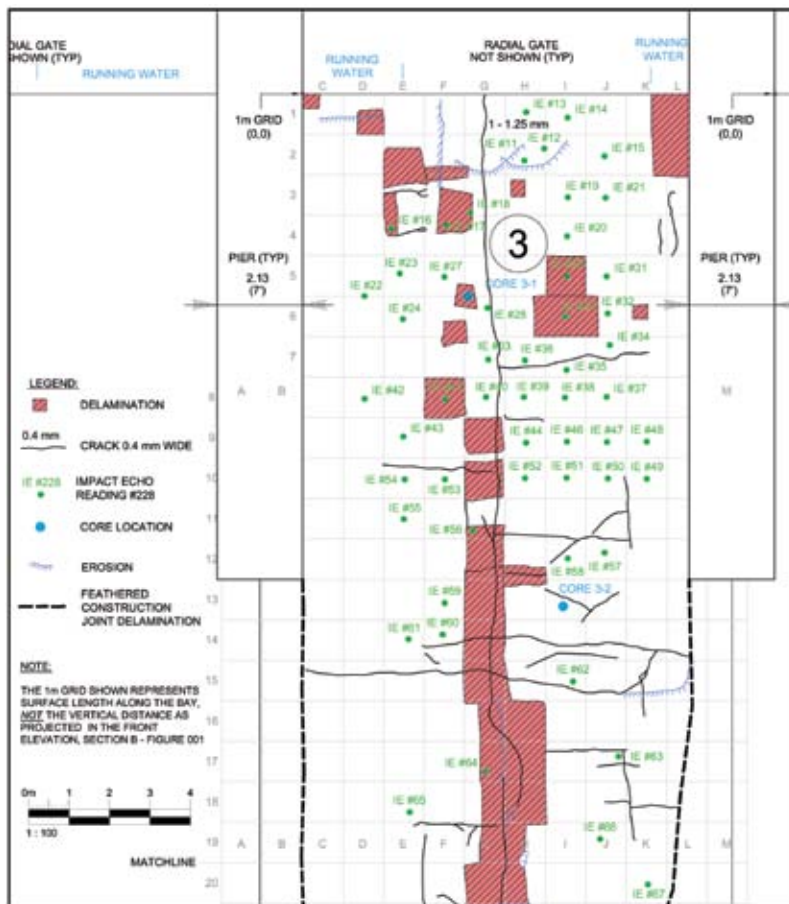
Visual inspection revealed a number of deficiencies, including cracking; erosion; construction joint delamination at what appeared to be feathered

edges; efflorescence and leaching from water seepage; and surface irregularities. Results of visual inspections were recorded in the condition survey maps (Fig. 4).

Fig. 4: Example of condition survey map

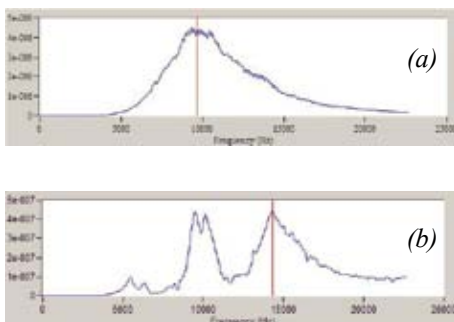
IE and sounding data were used to categorize the concrete as sound, delaminated, or defective. If IE indicated no defects to a depth of about 300 mm (12 in.), the overlay and substrate were deemed sound (Fig. 5(a)). If a defect was detected using IE and confirmed using sounding, the concrete was deemed delaminated (Fig. 5(b)). If IE indicated a defect that was not confirmed by sounding, the concrete was deemed defective—the defects could be deep delaminations or voids. We also found areas where the IE data could not be interpreted because of poor signals. Although we made attempts to grind rough areas smooth in the majority of test locations, the poor signals could perhaps be attributed to a rough surface.

Fig. 5: IE testing results: (a) results indicating sound shotcrete; and (b) results indicating delaminated shotcrete

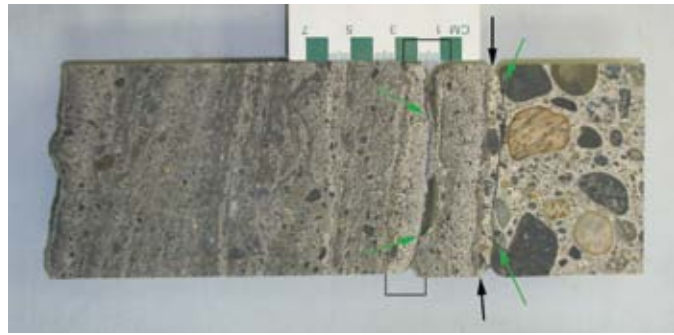
The petrographic examination indicated that the principal form of distress affecting the concrete is freezing-and-thawing damage. There was evidence of through-core fracturing and cracking,

both attributable to freezing and thawing. While some minor signs of alkali-silica reaction were observed, the associated expansion would have been insufficient to have caused the observed cracking (Fig. 6).

Fig. 6: Example of petrographic examination photo. Polished core surface of Core B2-1 prepared along the long axis of the core. The black arrows indicate the tight shotcrete (gray) parent concrete (at right) contact. The green arrows indicate through core cracking both in the parent concrete and in the shotcrete layer. The black brackets outline a zone of very weak, highly porous shotcrete

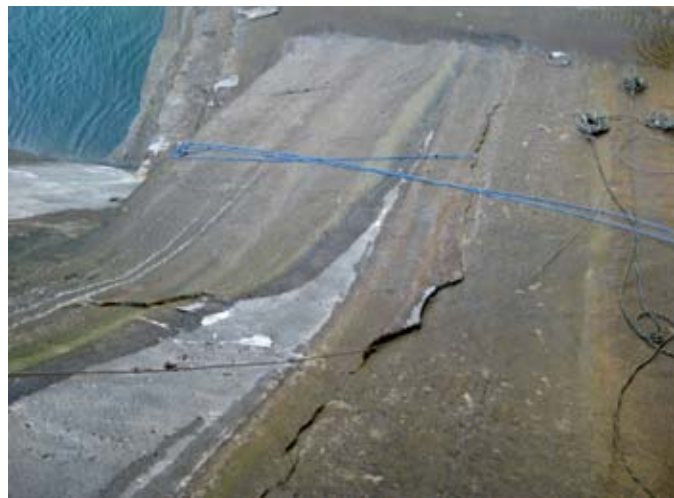
The condition survey established that while the shotcrete-faced spillway appears to be in reasonably good condition overall, there is distress in the forms of cracking, delaminations at construction joints with feathered edges, and more deep-seated delaminations at the shotcrete/concrete interface or in the substrate concrete. There are also localized areas of erosion and seepage through the shotcrete face (Fig. 7).

physical testing of shotcrete and concrete components of extracted cores, it is concluded that the prime mechanisms of continuing deterioration of the spillway face and stepped structures were delamination and cracking attributable to ongoing freezing and thawing. This is compounded by the effects of localized seepage and erosion in the shotcrete face and at feathered-edge construction joints.

Fig. 7: Feathered edge construction joint delamination

Therefore, we recommended that the defective and deteriorated areas of the spillway shotcrete be removed and replaced. An overall schematic showing the general areas that have to be removed and replaced is in Fig. 8.

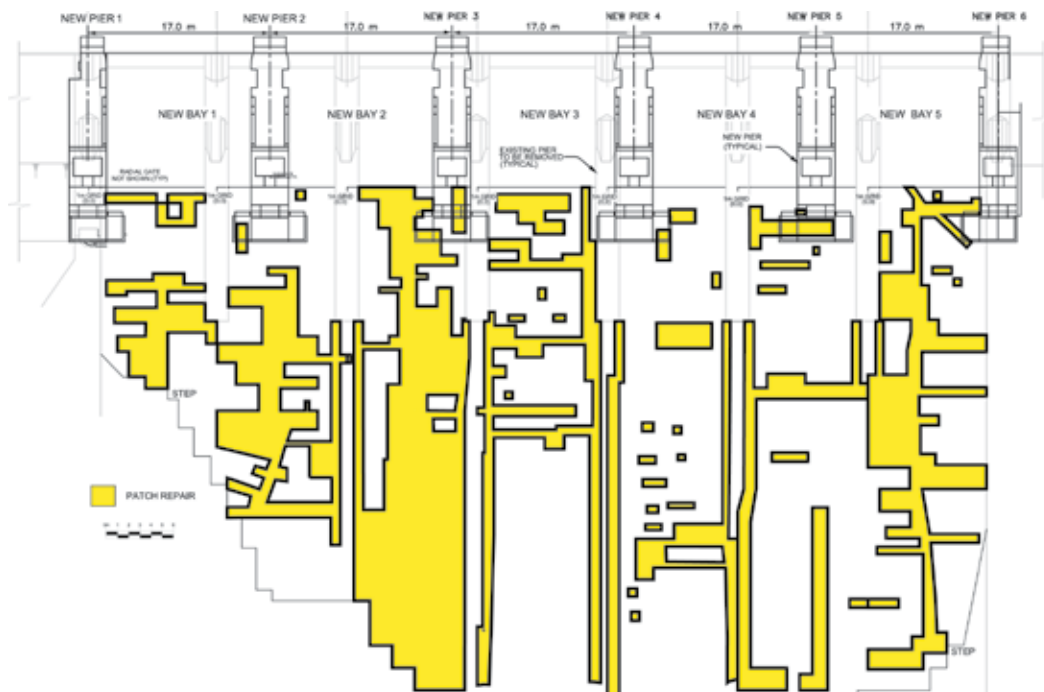
Fig. 8: Sketch of spillway repair maps (yellow represents area to be removed)

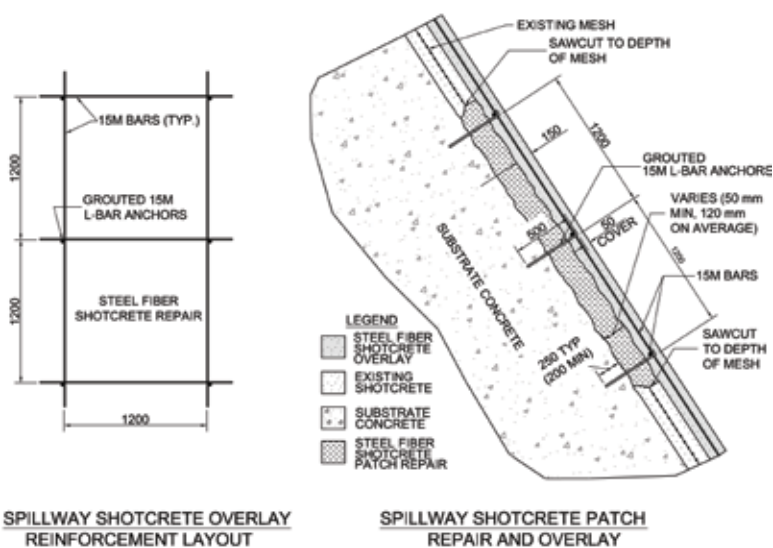
Fig. 9: Steel fiber-reinforced shotcrete repair of spillway surface. All dimensions in mm (1 mm = 0.03937 in.)

performance and will work well to produce the sloped, irregularly shaped patches needed on the spillway. Cast-in-place concrete would be difficult to form, deliver, and consolidate; and it would be difficult to obtain a quality surface finish (air bubbles tend to get trapped under sloped formwork, resulting in numerous voids on the concrete face). With modern wet-mix, steel fiber-reinforced, silica fume modified shotcrete, it's possible to achieve high quality, dense concrete with smooth surface finishes. It is also possible to achieve high compressive strength, excellent resistance to freezing and thawing, and resistance to erosion and abrasion. We recommend removing delaminated zones and placing a full thickness replacement overlay, using mild steel reinforcement to tie the overlay back to the original concrete dam material (Fig. 9).

A complete shotcrete overlay was also proposed as an option. This overlay involves resurfacing approximately 3000 m² (32,280 ft²) of the spillway with a reinforced shotcrete overlay. Although you can use either WWR or steel fibers, we recommend resurfacing the spillway with a steel fiber-reinforced shotcrete overlay to a nominal 150 mm (6 in.) thickness (Fig. 9). This is similar to the approach used in the Littlelock Dam shotcrete overlay seismic retrofit.⁴ As in the Littlelock Dam project, it was recommended that a system of shotcrete anchors connected by reinforcing bars be installed to provide mechanical anchorage so that the long-term performance of the bonded overlay is not entirely dependent on bond. Using steel fibers eliminates the complications of installing and achieving good shotcrete
