Structural Repair of Galveston Island Historic Pleasure Pier Cycle of Life

Project Name Galveston Island Historic Pleasure Pier— Structural Concrete Repair

Project Location
Galveston, TX

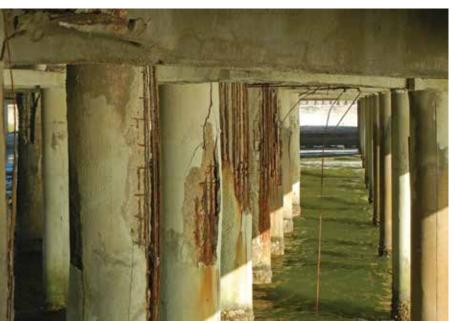
Little or no maintenance over the 70-year life of the pier has resulted in exposed reinforcing steel with accelerated corrosion and concrete spalling at piles, beams, joists, and reflective overhead flat plates. The new design plan increased live- and dead-load factors on the pier, harmonic motion of ride equipment, anticipated high lateral wind load

Fig. 1: Deteriorated columns between water line and deck

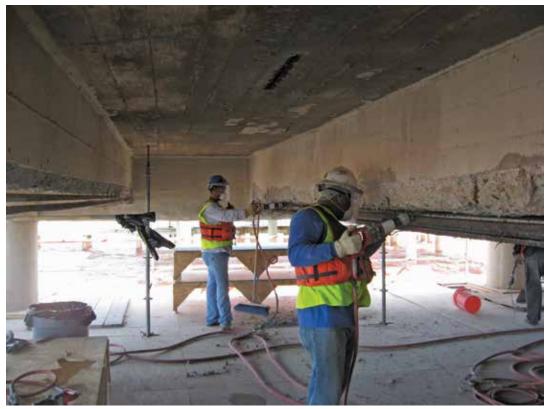
Fig. 2: Surface preparation of deck support beams

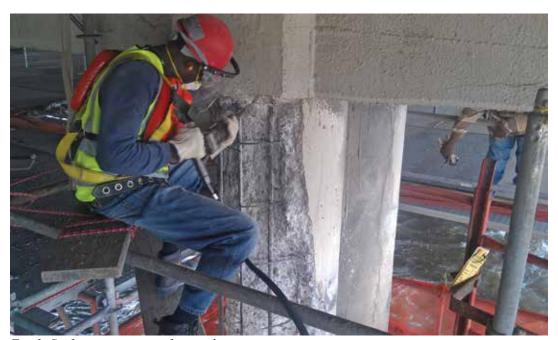
Fig. 3: Surface preparation of pier columns

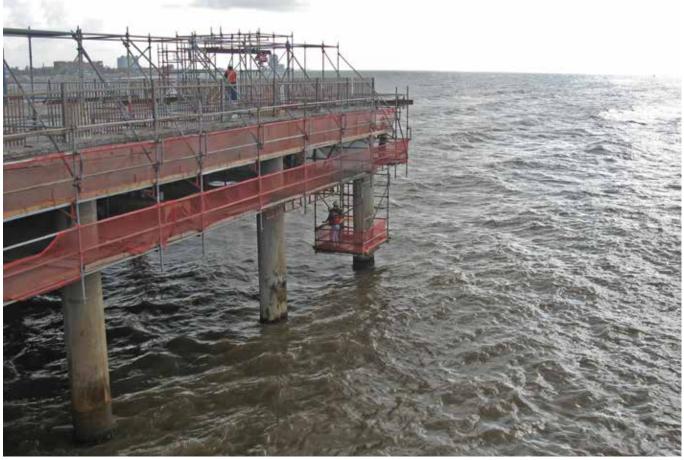
Fig. 4: Scaffolding setup for open access to underside of deck

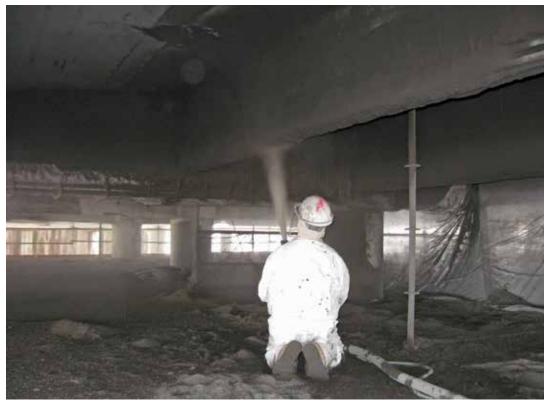
Fig. 5: Shotcreting deck beam overhead with very limited access height

corrosion material in advance of any shotcrete material. Access to the pier underside and safe support of all workers was a major problem for the duration of the project over salt water with wave action around pilings, tidal fluctuation, afternoon storms, and constant prevailing winds. Once the 10-story hotel was demolished one floor at a time by a specialty demolition contractor, working platforms 120 x 200 ft (37 x 61 m) were suspended and anchored 7 ft (2.1 m) below the pier deck and at existing concrete columns. Betco Scaffold of Houston designed, engineered, erected, and sequentially moved multiple sections to designated work zones, beginning at the farthest point over water allowing safe access for EDS to structurally restore each pier element (refer to Fig. 4). Environmental restrictions were in place throughout the project by the city of Galveston, the U.S. Coast Guard, and the Environmental Protection Agency (EPA) for concrete demolition dust control, debris removal, and cementitious overspray during shotcrete placement. Large tarps, screens, netting, tethers, and tie-offs were present each day as workers restored each platform section in a predetermined repair sequence to completion (refer to Fig 5).
