Bridge Preservation over the Oregon Inlet

A History of Concrete Rehabilitation on North Carolina's Outer Banks

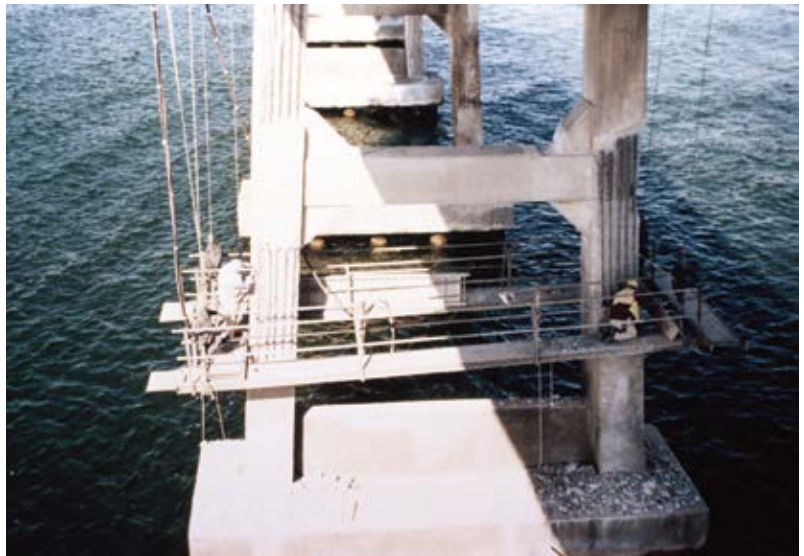
The first rehabilitation project began in 1987, nearly 25 years after the bridge first opened. Coastal Gunite repaired spalled concrete and damaged reinforcing steel on the bridge bents—everything from the support bearings to the waterline, including bent caps, columns, and footers (Fig. 2).

Fig. 2: Chipping of unsound concrete

The project took 2 years, and all distressed concrete was identified, removed, and replaced. The shotcrete mixture used for the repair was a simple 3:1 sand-cement mixture that was batched on-site by the contractor.

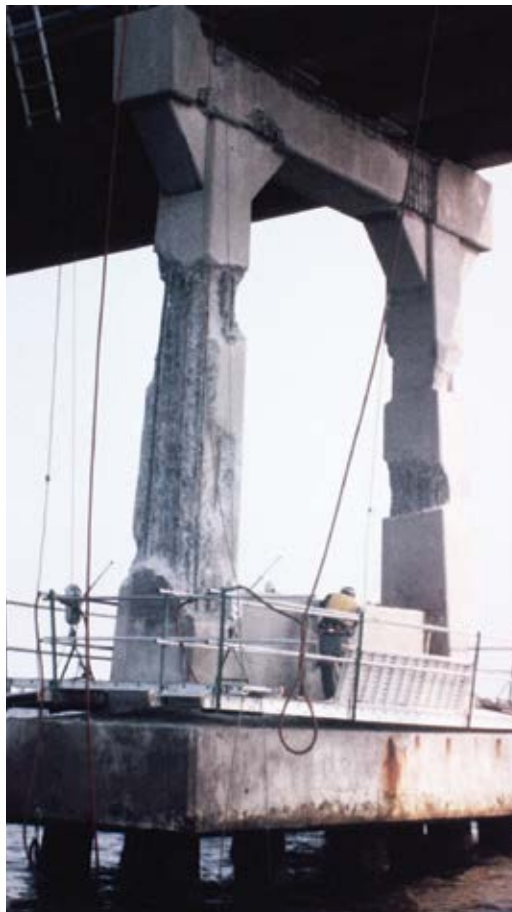
In 2008 and 2009, Coastal Gunite repaired spalled concrete and damaged reinforcing steel on the bridge bents. In addition, the underside of the superstructure was repaired, including the concrete beams and the underdeck. Interestingly, all the repair work done in this phase was on concrete NOT repaired 20 years earlier. All of the earlier concrete repairs were still in sound condition (Fig. 3).

Fig. 3: Unsound concrete removed

Then, in 2013 and 2014, Coastal Gunite performed a third round of repairs on the bent caps and underdeck. This repair addressed new areas that were not previously identified for repairs. Both the second and third repair iterations were performed with a prepackaged shotcrete mixture enhanced with silica fume and polypropylene fibers.

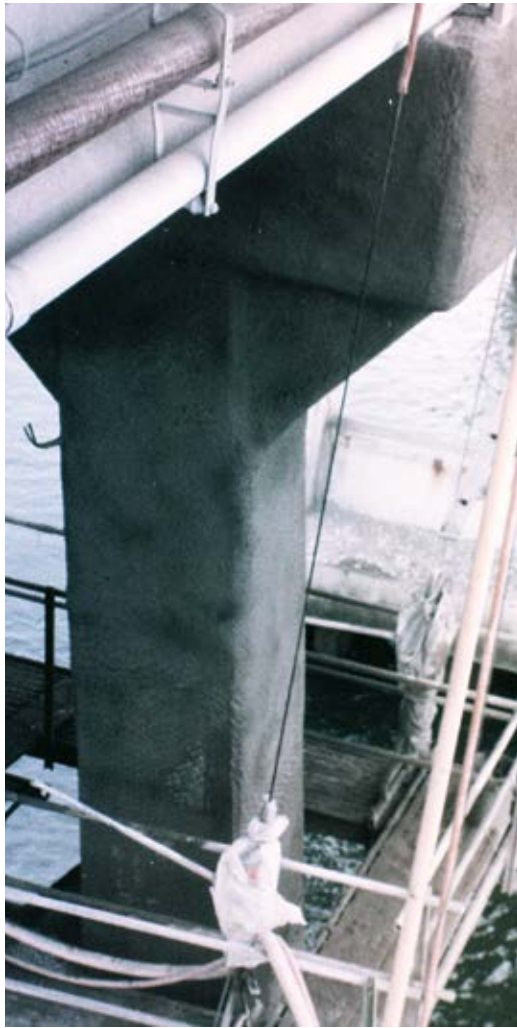
Fig. 4: Freshly shot pier column

Those spots are still solid. They look like they were just shot last week” (Fig. 4).

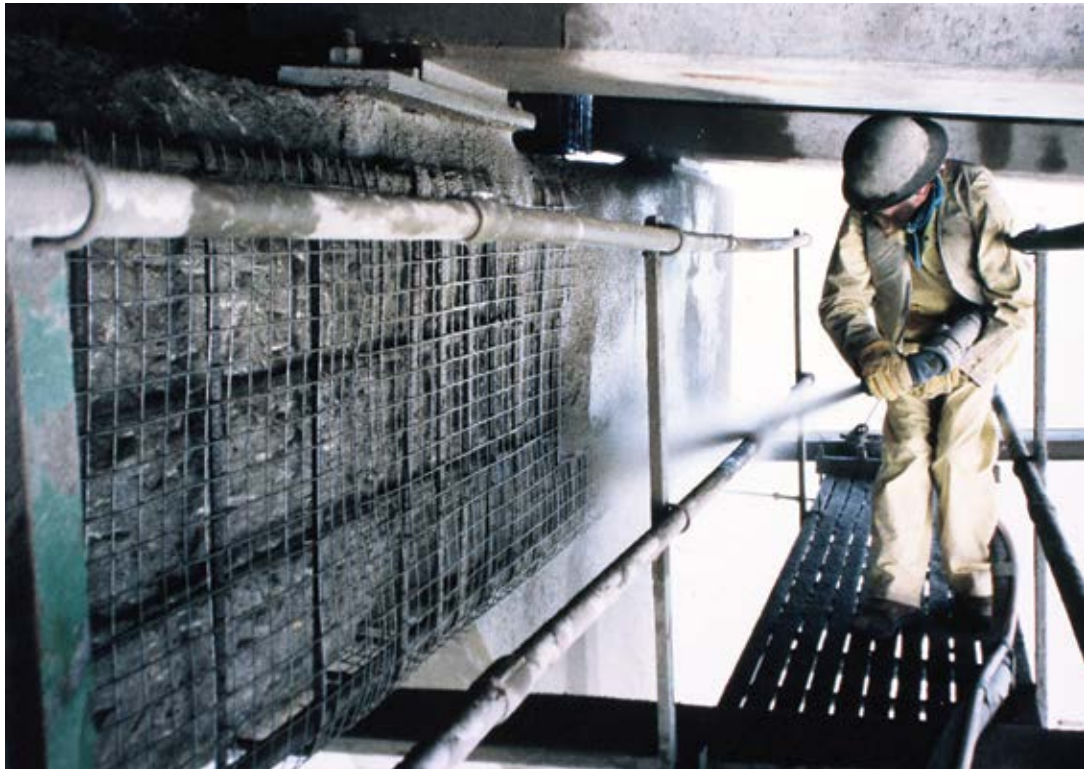
Coastal Gunitite employed a truck-mounted aerial platform to access a majority of the under-deck work and swing-stage scaffolding to access the columns and footers (Fig. 5). Where feasible, barges were also used to access bent footers.

Fig. 5: Shotcreting pier cap
