Hose and Fitting Wear

Critical Safety Issues in Shotcreting

By Sean Madole

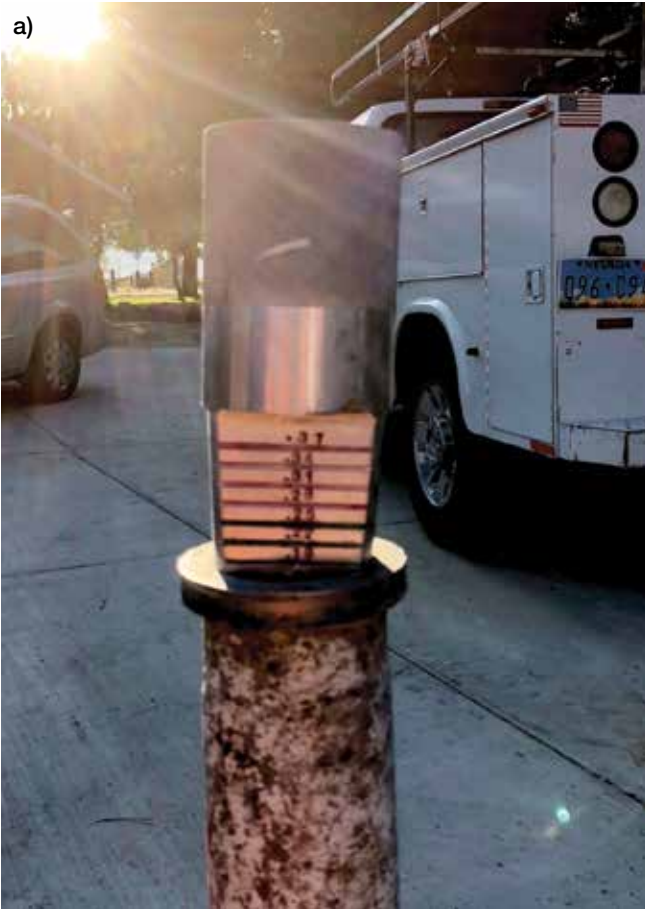
a)

Fig. 1(a) and (b): Gauge to measure wear levels

unsafe part in the system. So, to try and make evaluating wear as foolproof as possible, we developed a hose wear indicator from a piece of aluminum round stock. The concept for the indicator was simply building it as the reverse of a case gauge used in handloading ammunition. A round aluminum stock piece was machined in a lathe with a taper to just have the end fit inside a new 2 in. fitting. As the part wears, the gauge will slide deeper to accurately measure the wear. One side of the taper rabbeted to provide marks showed how much wear was present. We added green lines to show acceptable wear levels and a red line for excessive wear. The tapered gauge is a more reliable indicator of wear, easier to use, and can quickly measure the pipe in more than one direction.
