Hudson River Park Repairs

PIER 40 PHASE 2

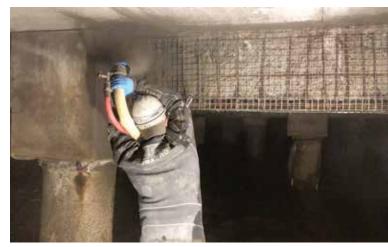
Fig. 2: A Type 3 repair with preparation completed. The repair is awaiting the application of shotcrete

The Type 3 repairs, or beam repairs, called for the bottom and bottom corners of each beam to be repaired. The deteriorated beams were chipped back to sound concrete with a requirement to remove 1 in. (25 mm) around the reinforcement. The reinforcement was cleaned by abrasive blasting. All reinforcing stirrups that were deteriorated 25% or more were replaced using EZ-lock epoxy-coated couplers. A total of

approximately 200 couplers were installed on the job. A natural gun finish was applied to the final surface. Any overspray was cut back to the saw-cut line around the repaired area.

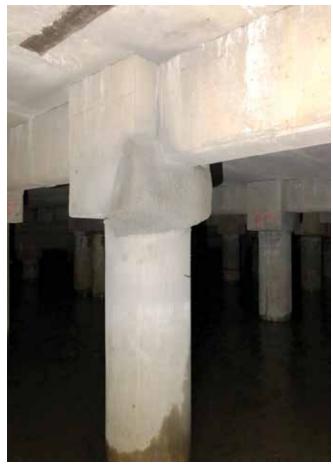
Fig. 4: A completed Type 4 repair

The Type 4 repair, or pile cap repairs, also required deteriorated concrete to be removed back to sound concrete. New reinforcement was required to be installed to form a new reinforcement cage. Epoxy-coated No. 5 bar was epoxy embedded 6 in. (150 mm) on center into the existing concrete. A bottom "U-bar" was installed with a 1 in. overlap of the vertical bars. Welded-wire reinforcement was installed and shotcrete was applied using a natural gun finish.
