Norick State Fair Arena Structural Repairs

Oklahoma State Fair, Inc., Oklahoma City, OK

By Dean Brunken

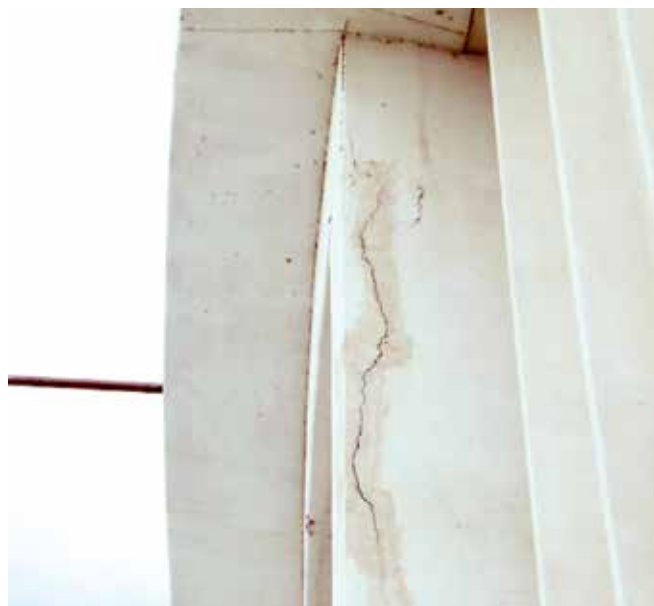
Fig. 1: Cracking in monumental concrete column

After selective demolition and evaluation, the primary source of the concrete cracking was identified as corrosion of the embedded steel reinforcement in the concrete columns. The cause of the corrosion was determined to be due to a construction detail that allowed water to enter the concrete columns at upper levels and over time percolate through the steel reinforcement network, resulting in corrosion of the steel reinforcement and subsequent cracking and delamination of the concrete.

The repair procedure selected by the design team required sounding the concrete columns prior to selective concrete removal to determine the extent of demolition required, followed by removal of all delaminated concrete. All aspects of the concrete repair work were specified to conform to ICRI 310.1R-2008, "Guide for Surface Preparation for the Repair of Deteriorated Concrete Resulting from Reinforcing Steel Corrosion."

Surface cracks were selected for epoxy injection if subsurface concrete delamination was not evident after sounding. Following removal of delaminated concrete, steel reinforcement was sandblasted and examined for adequate critical section. If an inadequate section was identified, additional steel reinforcement was added. The steel reinforcement was coated with an anticorrosion primer. A penetrating corrosion inhibitor was applied to the concrete surface, followed by the application of dry-mix, fiber-reinforced shotcrete.

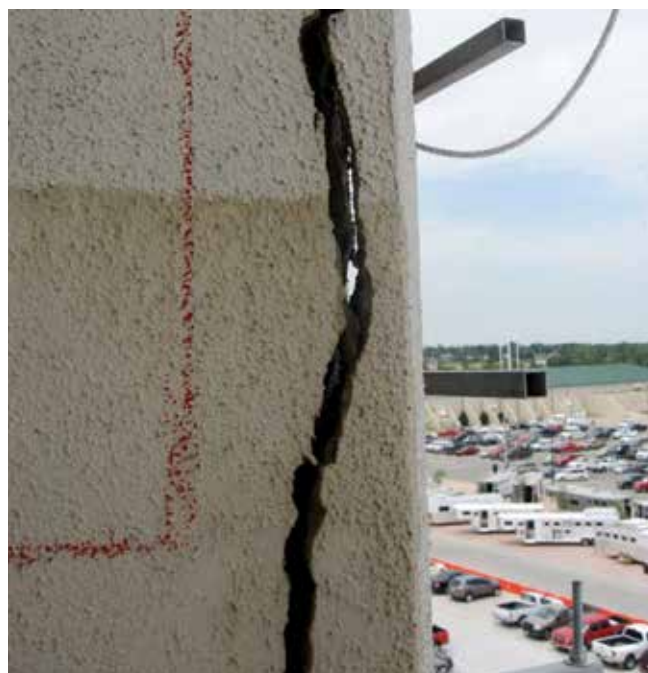
Fig. 2: Crack in monumental concrete column

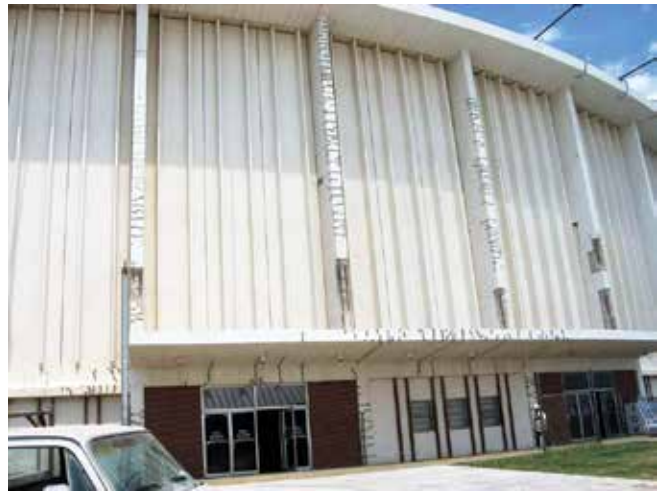
Fig. 3: Epoxy injection and removal of delaminated concrete of concrete columns

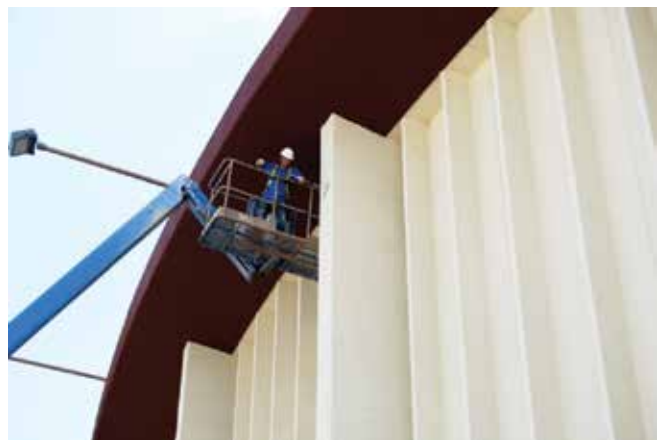
Fig. 4: Applying elastomeric coating to concrete ring beam

All sealants in the structure were removed and replaced during construction. Following all structural repairs and sealant removal and replacement, a volatile organic compound (VOC)-compliant, 100% acrylic emulsion elastomeric coating was applied to all exterior surfaces of the arena and supported concrete ring beam to improve the aesthetic appearance of the arena and to mitigate water intrusion into the concrete structure.

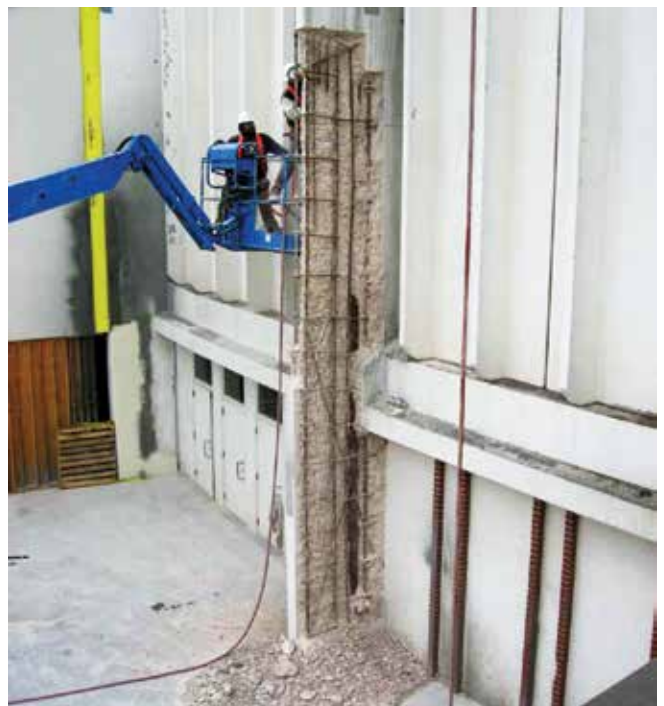
Fig. 5: Demolition of delaminated concrete

Small electric and pneumatic hammers were used for concrete demolition to mitigate damage to surrounding sound concrete. After selective demolition to expose at least 1 in. (25 mm) around steel reinforcement, the limits of the

repair were saw-cut to a depth of 0.75 in. (19 mm) to provide a defined area for repairs.

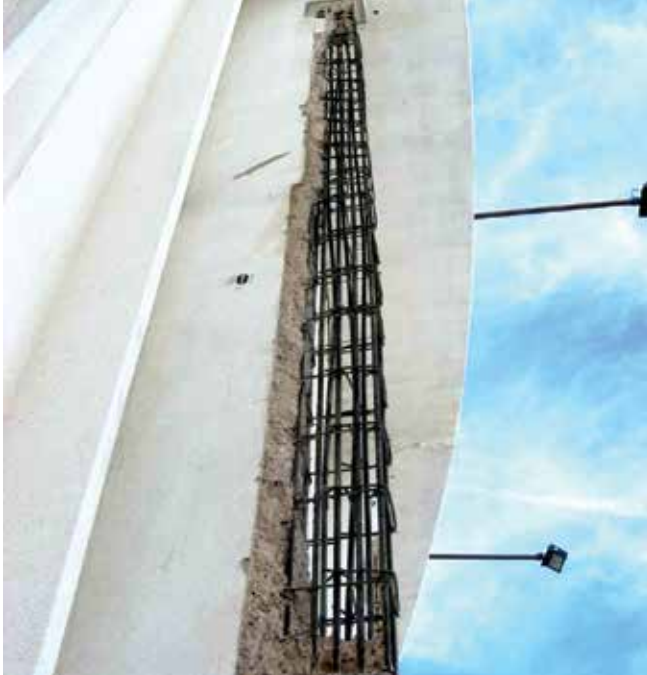
Fig. 6: Column section following demolition

Structural steel was sandblasted to remove all rust and scale. All concrete surfaces were mechanically cleaned to obtain an exposed aggregate surface profile of ± 0.0625 in. (2 mm). Concrete surfaces were cleaned and saturated to saturated surface-dry (SSD) conditions using high-pressure power washing immediately before shotcrete placement.

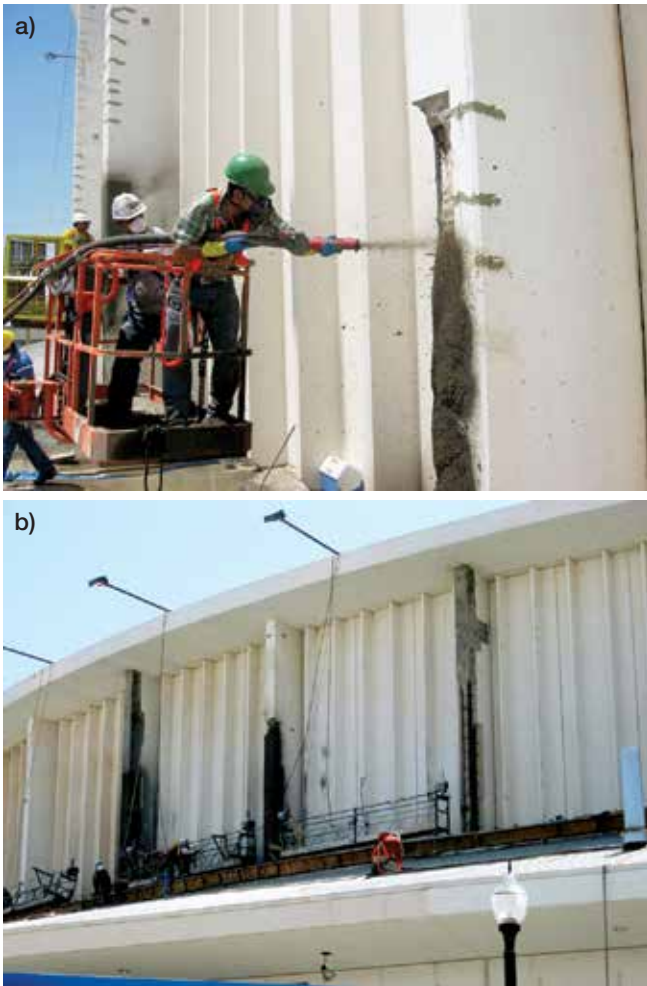
Fig. 7(a) and (b): Dry-mix shotcrete installation

Dry-mix shotcrete was selected as the concrete repair method due to the depth, size, and location of the anticipated repairs. Dry-mix had significant advantage over form-and-pour in reducing time and formwork materials required for the project. Dry-mix shotcrete also provided increased consolidation of the concrete repair. Material test panels were produced daily to test for compressive strengths. Mockup panels were constructed to simulate the reinforcement within the columns and shot to qualify the materials, equipment, and nozzleman on the project. The design team

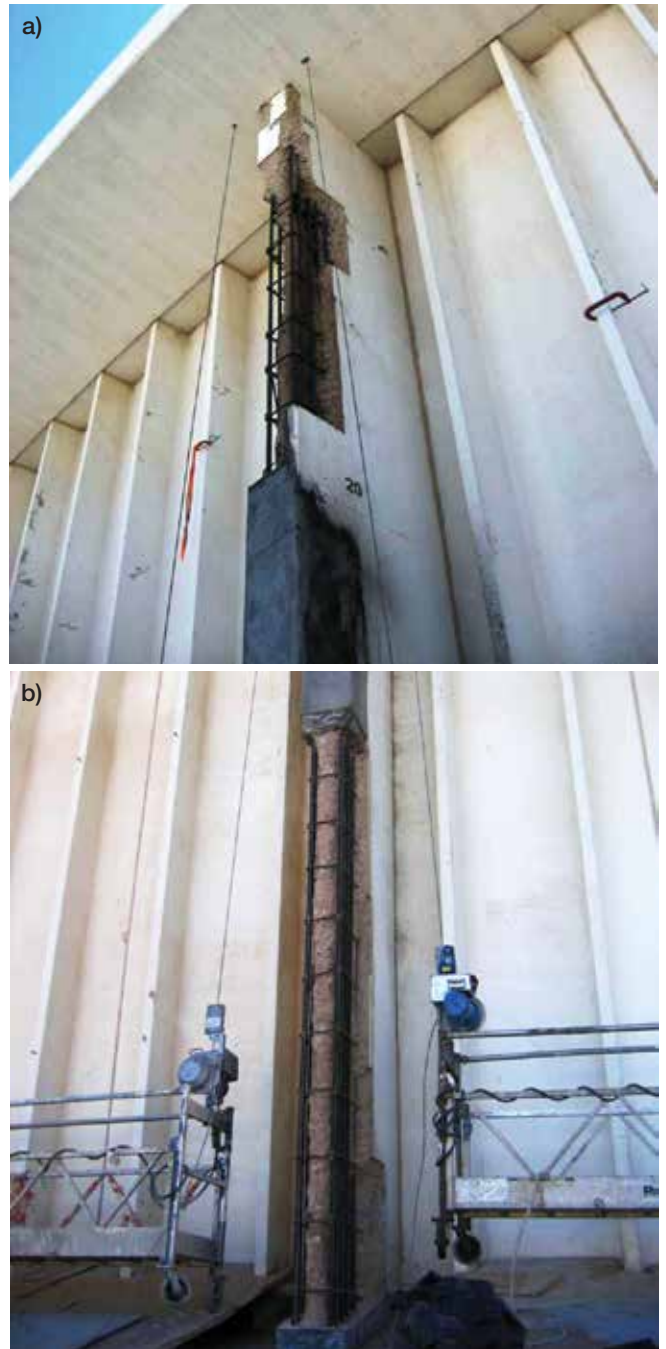
Early in the construction process it was determined that the extent of corrosion was greater than originally anticipated. Due to the large areas affected, the depth of concrete delamination, and the absence of critical steel section in the reinforcement, a new construction sequence was developed that limited the size of an area that could be repaired on an individual column and created an overall schedule that designated column location, area size, and sequencing of repairs. These changes dramatically affected the construction productivity, requiring many more mobilizations to complete repairs than originally anticipated and close coordination with the design team to monitor construction progress.

Fig. 8(a) and (b): Phasing structural column repairs. Note cored holes in upper ring beam to support our swing stages

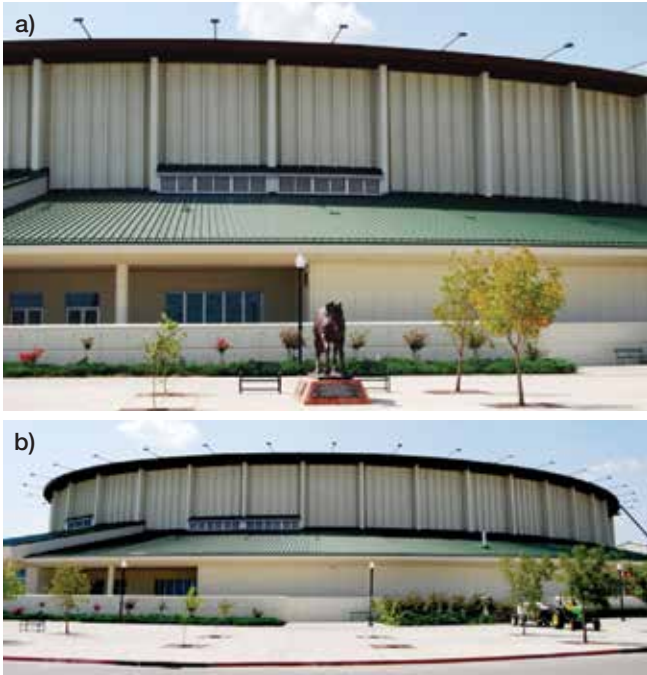
Fig. 9(a) and (b): Norick State Fair Arena repairs complete

Although the construction sequence was altered dramatically, all repairs were completed satisfactorily with minimum impact to the owner’s operations and met the repair designer’s objective of repairing the arena’s structural problems.
