Shotcrete Solution To Tricky Underpinning Problem

by Roger W. Abbott

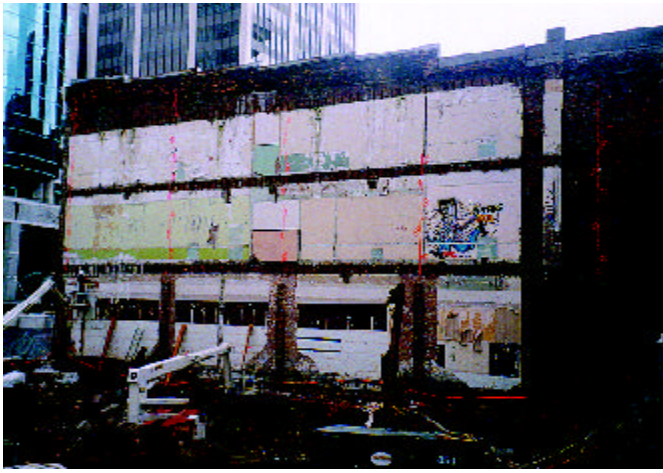
Figure 3: Affixing angles and placing rebar for footing and first lift.

The general contractor was able to perform the task of installing the joist tie-ins by accessing the ends of the joist through the T-bar ceiling after store hours. The 4 x 4 x 1/4 in. (100 x 100 x 6 mm) angles were attached to the existing joists, as illustrated in Figure 2, with redi-rod being drilled through the brick wall for fastening in the proposed shotcrete beam. This was done at 4 levels. Dowels were epoxied into the brick at 30 in. (760 mm) on center to hang the reinforcing.

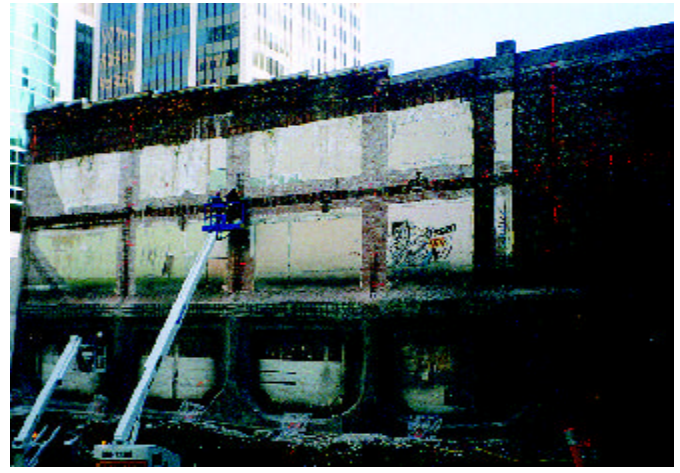
Figure 4: First lift in place and prepping for second lift.

The beams and pilasters were shot first to the underside of the first floor level to systematically build support from

the bottom up. The silica fume wet-mix shotcrete was cured utilizing a curing compound. The high early strengths attained enabled the next lift of rebar to be shot in 2 day cycles. This system progressively reinforced the structure as lifts were added. Typical 24-hour strength of the shotcrete was about 3050 psi (21 MPa), giving immediate rigidity to the structure. In this case, forming and pouring would have been a longer process. Superior adhesion of the pneumatically applied shotcrete over concrete was desirable.

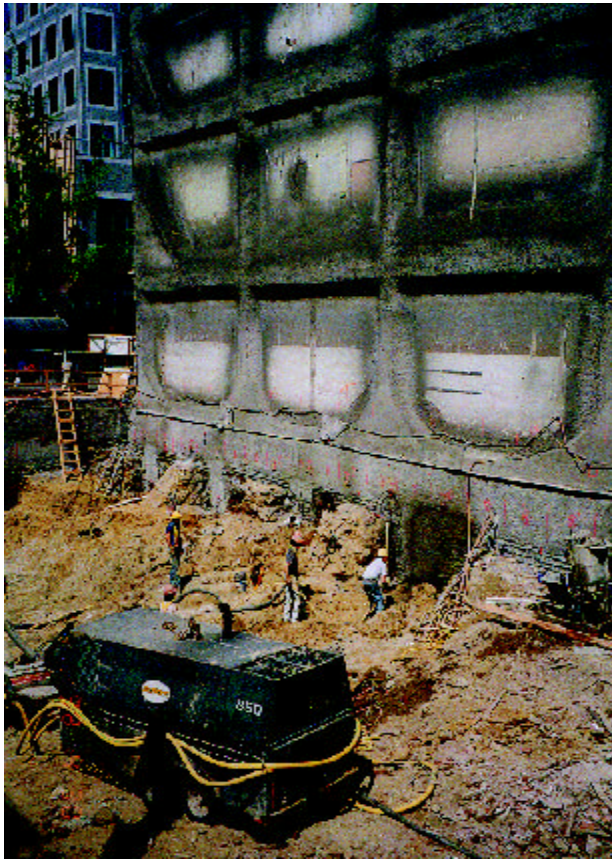
Figure 6: Panel sequence of underpinning.

A typical section of the underpinning detail is shown in Figure 5. The anchors were installed through stable beams, and the underpinning shotcrete was applied in a panel sequence by shooting a 5 ft by 5 ft (1.5 x 1.5 m) reinforced panel every fourth panel until the whole row was complete.

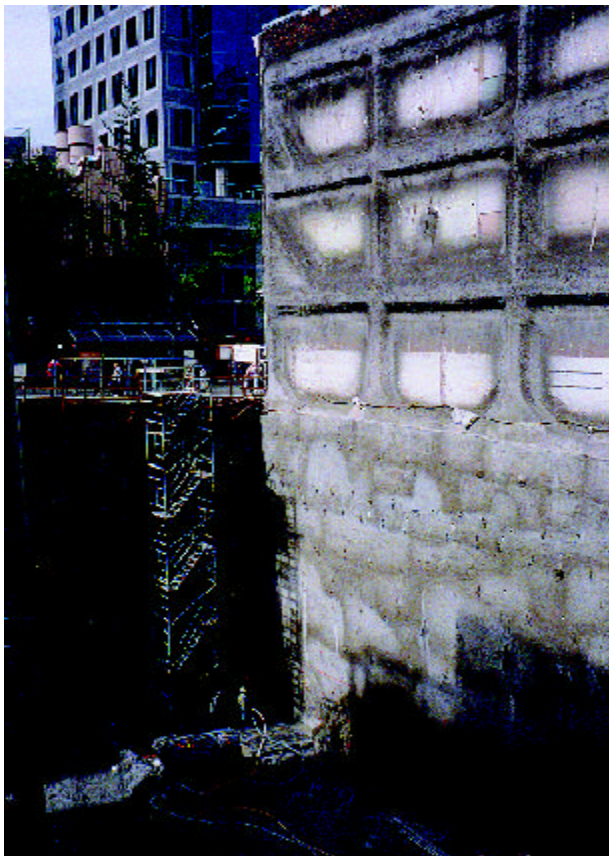
Figure 7: Completed underpinned and shored shotcrete.

The final structure is shown in Figure 7, 45 ft (14 m) below street grade. The shotcrete solution was a very quick and innovative approach to solving the problem, and it illustrates the adaptability the shotcrete method can provide.
