## Deterioration and Rehabilitation of Berth Faces in Tidal Zones at the Port of Saint John

by Paul Gilbride,  
Dudley R. Morgan,  
and Theodore W.  
Bremner

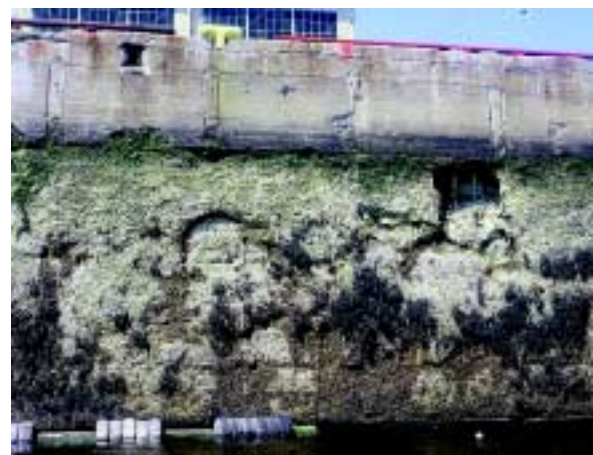
freezing and thawing damage suffered by the concrete, particularly in a zone about 2 to 3 m in height occurring around midtide. This type of deterioration is well illustrated in Fig. 2. The overall height of the wharf face at low water is approximately 10 m and the tidal range is about 8.5 m.

The zone that suffers the most damage is around the midtide, which is exposed to repeated cycles of wetting and drying and freezing and thawing in a saturated condition. It is estimated that concrete in this zone is subjected to 200 to 300 freezing and thawing cycles per year.

Figure 2: Deterioration in intertidal zone of berth face.

The wharf face is prepared for shotcreting by removal of the existing deteriorated concrete face to a depth of 100 to 150 mm. It has been found that generally at this depth, sound concrete is encountered. The chipping is done using chipping hammers in the 14 to 18 kg size range. The work is done from a mobile hanging staging as well as from a floating barge alongside the berth face.

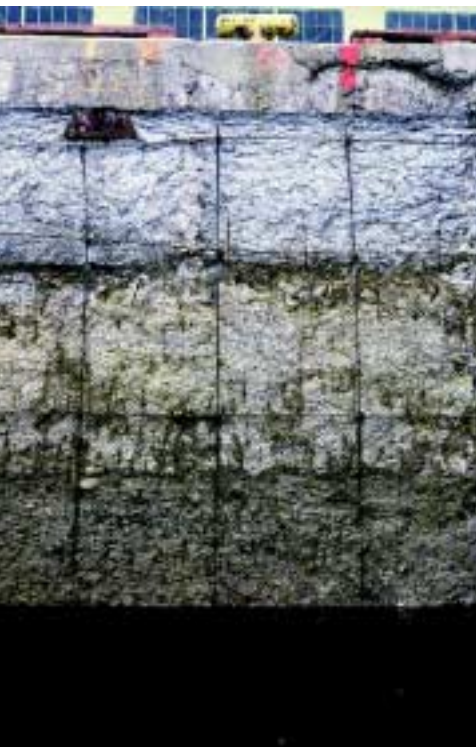
Upon completion of the chipping, an anchorage system is installed using 20 mm Grade 60 threadbar grouted into drilled 50 mm-diameter holes. The holes are drilled on a 15-degree incline from the horizontal to allow installation of a 1.12 m-long anchor with a 100 mm projection. The grout is a one part sand to one part Type 10 portland cement mixture. After the anchors are installed, a grid of 15 mm rebar is run horizontally and vertically between anchors. The bars are positioned on the anchors to allow for 50 mm of cover on the outer bar. During the shotcreting operation, a 100 x 100 x 9 mm steel plate is fitted on each anchor and secured with a 15 mm-deep hexagonal nut. Anchors are spaced in a grid to allow for a design loading of 78 kN in tension. This would be sufficient to hold the new facing in the event it completely debonded from the existing concrete surface and was subject to full hydrostatic pressure. Anchors are randomly tested in tension up to approximately the yield strength of 115 kN of the bar. A general view of a typical anchor layout is shown in Fig. 3 and 4. Details of the anchor system are given in Fig. 5.

Figure 4: Prepared berth face, with anchor system installed, ready for shotcreting.

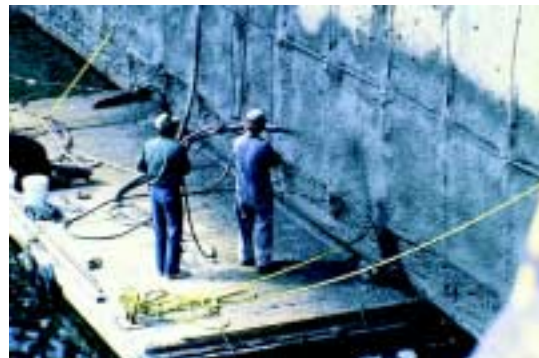
Shotcreting is usually scheduled for the dropping tide to avoid damage by the barge of the freshly placed shotcrete. The outline of the area covered by a load of shotcrete is basically dictated by the tide level and the life of the load of shotcrete. Normally, one load of shotcrete covers a height of about 1.2 m over a length of 27 m. The shotcrete is applied to this area in two lifts over approximately a barge length 9 m at a time. The first lift of 50 mm generally encapsulates the rebar and facilitates setting of the anchor plate in the fresh shotcrete. The second lift of 50 mm covers the steel with approximately an additional 25 mm applied at the anchors to ensure adequate cover on the steel. Figure 6 shows application of the second lift of shotcrete to the berth face.

Figure 6: View of shotcrete being applied to berth face from floating barge.

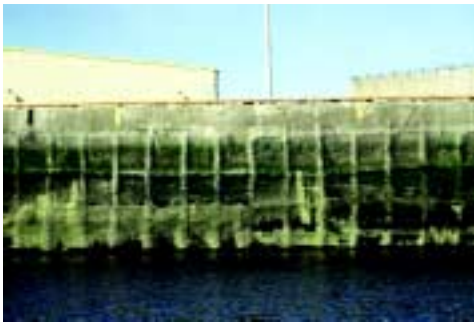
Figure 7: View of shotcreting in 1995, after 10 years of service with buildup of shotcrete at reinforcing steel to help alleviate restrained drying shrinkage cracks.

and while some deficiencies were noted, these were estimated to constitute less than 1% of the total area of berth faces repaired. Most of these deficiencies were related to construction practice and included items such as less than adequate encapsulation of reinforcing bars (leading to localized rebar corrosion) and featheredging of construction joints (leading to localized peeling-type delaminations). Some restrained drying shrinkage cracking was encountered, but much of it had undergone autogenous healing and the conclusion was drawn that “the minor cracking in the shotcrete is not likely to affect the long term performance of the facility.”
