Shotcrete Repair in Paper Mill

by Marc Ferland, Jean-François Robert, and Alain Chassé

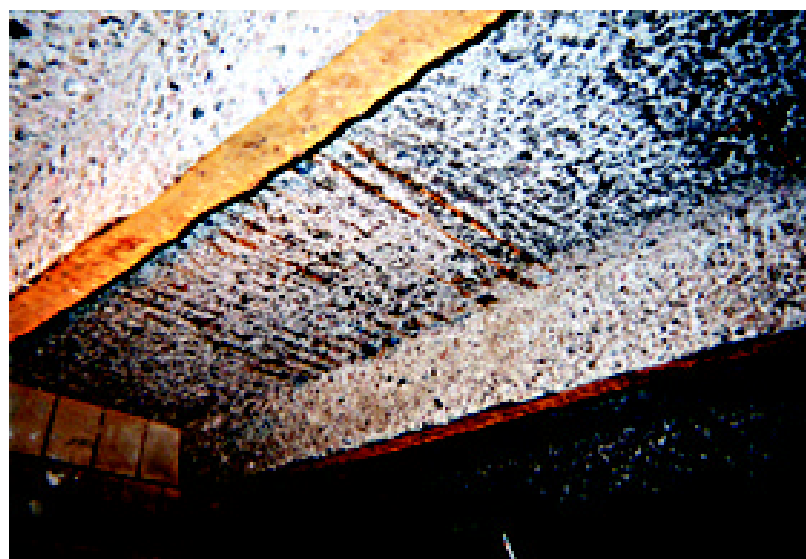
Figure 1: Unidirectional beam and slab roof system before maintenance.

Concrete ceilings inside paper mill process vessels are often subjected to high temperatures and a highly corrosive environment. Typical repairs of this type of ceiling require 5 to 6 days of production downtime. For Abitibi-Consolidated (La Baie, Quebec, Canada), this period was too long, given that the overall plant shutdown was only 4 days. The conventional repair sequence consisted of cleaning the concrete surface with high-pressure water-blasting, followed by troweling of a cementitious repair mortar onto the surface 13 mm (0.5 in.) thick. Depending on the repair dimensions involved, this single operation normally required a 72-hour window during a mill shutdown. In comparison, the cleaning of the surface, mesh placement, shotcreting, finishing operations, and application of a protective coating required only about half of this time. The area in need of repair for each vessel was approximately 93 m² (1000 ft²). All surfaces to be repaired were overhead and located at 6 m (20 ft) above the ground. Figure 1 shows one of the damaged ceilings before repairs were performed.

When the Béton Projeté M.A.H. and Canadian Stebbins Engineering Ltd. team first inspected the vessel in June 2001, the concrete ceiling was in major need of repair. Chemical attack of the cement binder and corrosion of the reinforcing steel had reached critical levels. The lower flange of the steel I-beam was also seriously corroded. The contractor proposed to proceed by first removing the damaged concrete, cleaning or replacing rebars, and placing a hot, galvanized 50 mm (2 in.) square wire mesh with L-shaped anchors positioned 400 mm (16 in.) apart. Finally, a 50 mm (2 in.) layer of dry-mix silica-fume shotcrete was applied. Figure 2 shows the prepared concrete surface prior to shooting, and Figure 3 shows the final appearance of the repaired surface. A smooth finish was required so that a special epoxy coating could be applied to the shotcrete surface to provide long-term protection against corrosion in this hot, steamy, and acidic environment.

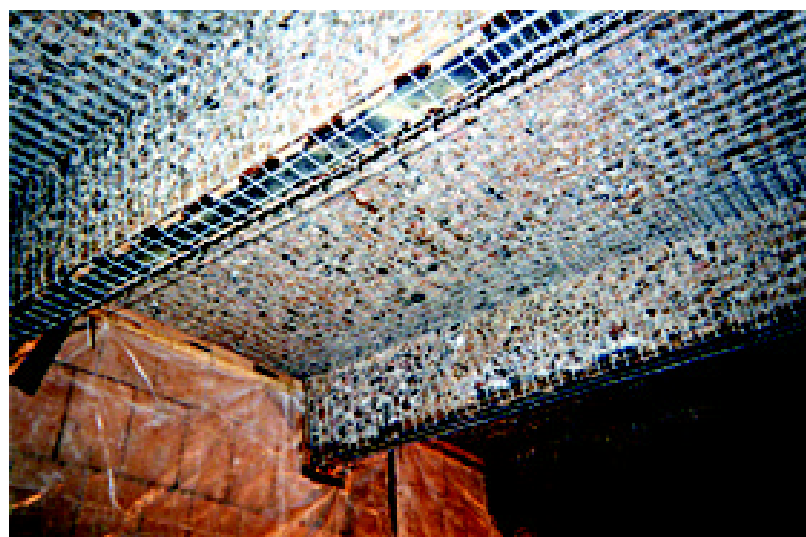
Figure 2: Prepared surface prior to shooting.

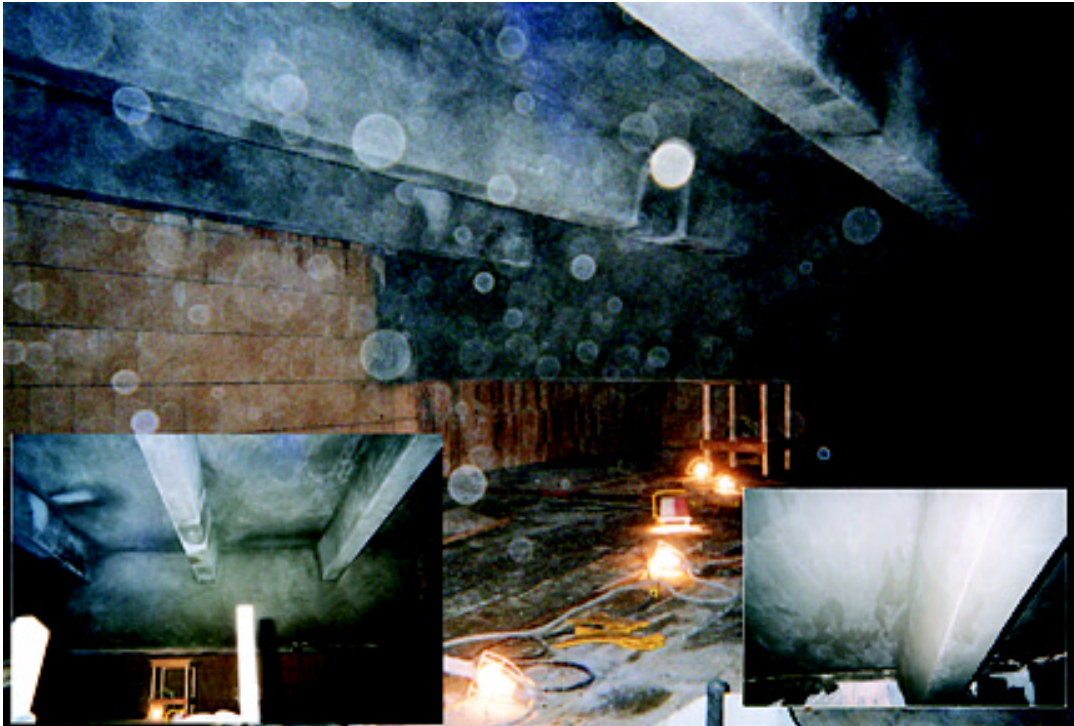
Figure 3: View of the finished surface.
