## Shotcrete Repair Saves Baltimore Bridges

by I. Leon Glassgold

# Shotcrete Classics

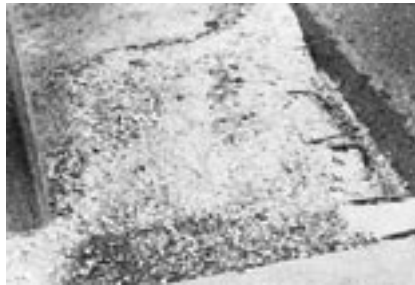
Figure 1: Deterioration of a bridge sidewalk due to freeze-thaw action coupled with liberal use of deicing salts.

While the causes of concrete deterioration are many and varied, it is not our purpose to define or analyze them in depth (Fig. 1, 2, and 3). Suffice to say that concrete not properly designed, prepared, installed, finished, or cured is more susceptible to those deleterious influences which cause the concrete to decay and spall and the reinforcing to rust and lose section (Fig. 4 and 5). This in turn reduces structural sufficiency, usually limits utility, and results in eventual failure (Fig. 6).

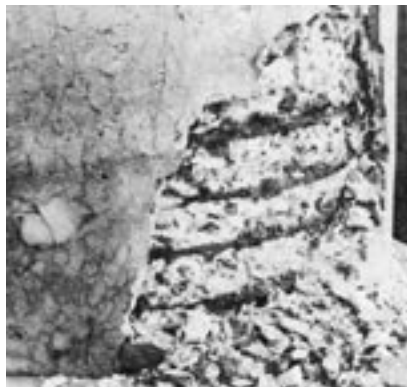
Figure 2: Crack development of column base followed by rusting of the reinforcing steel causing aggravated decay of the concrete. Water and salt leaking from bridge deck plus freezing splash water from the roadway have combined to cause this distress.

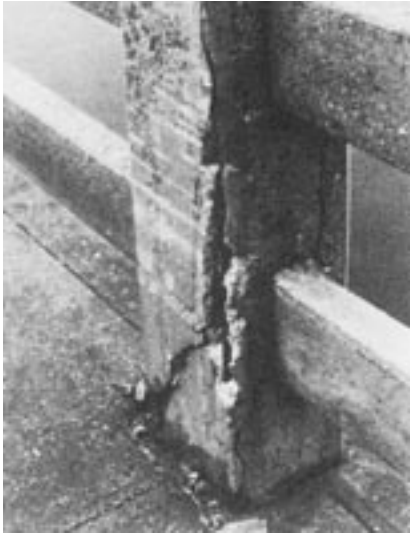
Figure 3: Crack development in handrail post-penetration of moisture to the reinforcing with the subsequent rusting, cause the concrete to spall and break away.

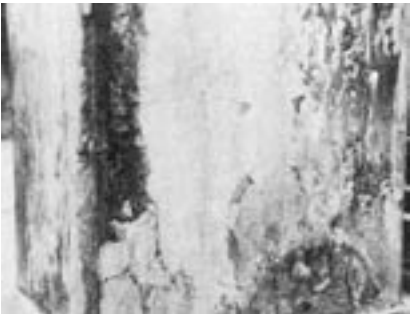
Figure 4: Questionable quality of concrete with scaly finish and reinforcing bars too close to the surface. Reinforcing has developed heavy scale and lost considerable section.

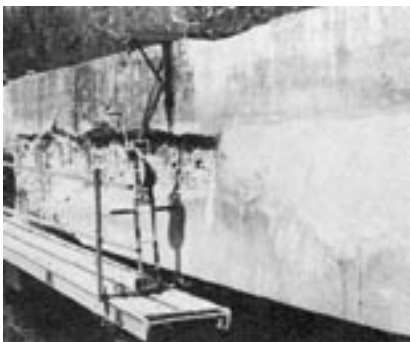
Figure 5: Fascia beam with advanced concrete decay at bridge deck level and below. Area to right of decay is hand patched or plastered and hollow sounding when struck with a hammer. Reinforcing is scaly.

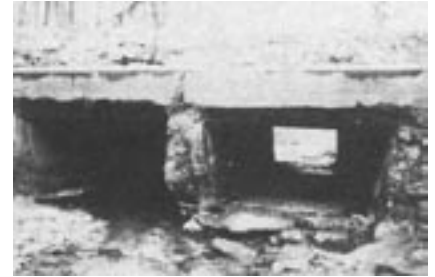
Figure 6: Culvert showing heavy disintegration and structural distress almost to the point of failure.

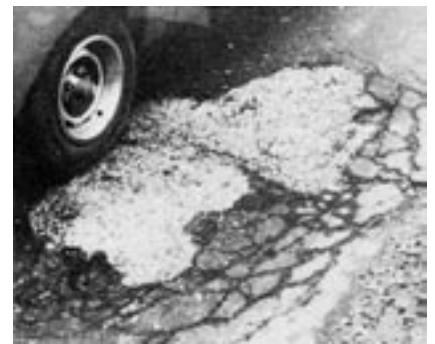
Figure 7: Bituminous surface breaking up exposing deck to corrosive influences. Even though surfacing has been patched, concrete underneath is severely deteriorated and ready to break through. Area in lower right hand corner is rubble from sidewalk deterioration.

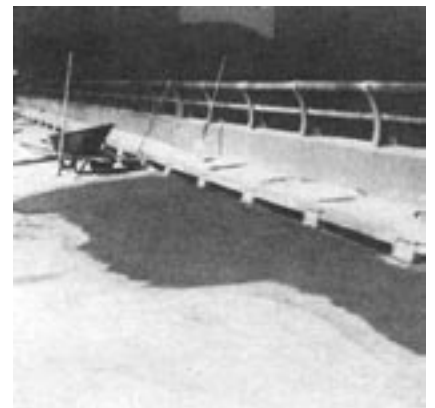
Figure 8: Shallow shotcrete repair of concrete deck to curb line. It is characteristic of bridge deck repair that the deepest areas of decay are usually found at the curb line.

While shotcrete repair can be used for deck rehabilitation, it has been found to be economically unfeasible for major full thickness repairs (Fig. 8). It is, however, extremely effective for variable depth repairs of beams, caps, columns, abutments, wingwalls, and underdeck from the standpoint of technique, cost, and other practical considerations. In many areas where a bridge has all the

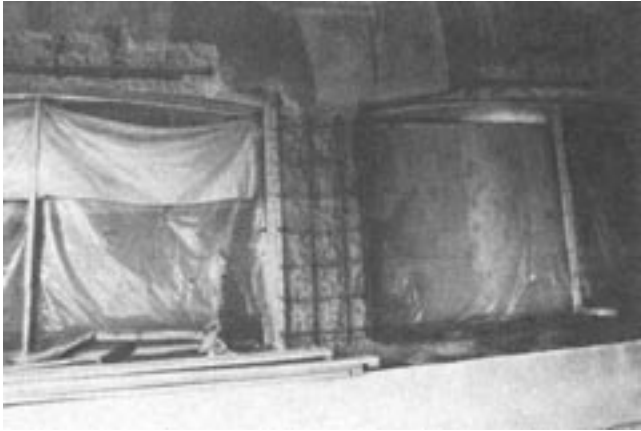
Figure 9: Column and cap repair showing chipped areas. The column steel has been sandblasted and welded wire fabric attached.

A case in point is the City of Baltimore which has many types of bridges built between the two World Wars which have undergone severe deterioration. For the past 20 years the City has been salvaging many of these bridges by replacing the superstructure and salvaging the substructure. In addition, a yearly preventive maintenance shotcrete program has been established to provide emergency repairs when needed and to upgrade the condition of as many bridges as the budget will allow. Several photographs in this article represent shotcrete work on the bridge system of Baltimore City. Figures 9, 10, 11, and 12 show some typical before-and-after repair photographs.

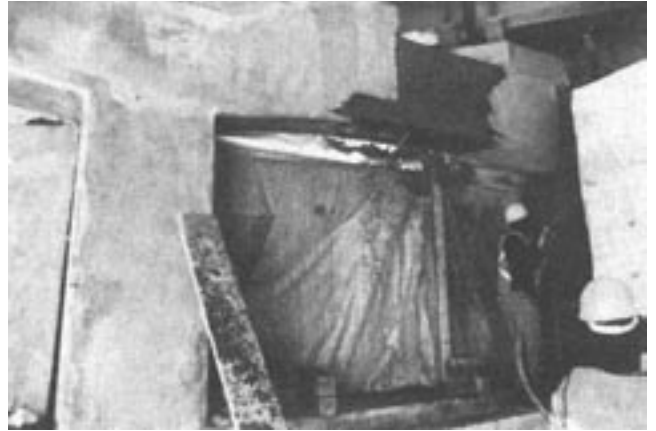
Figure 10: Same general view as Fig. 9. Areas have been shotcreted, finished, and a membrane curing compound applied.

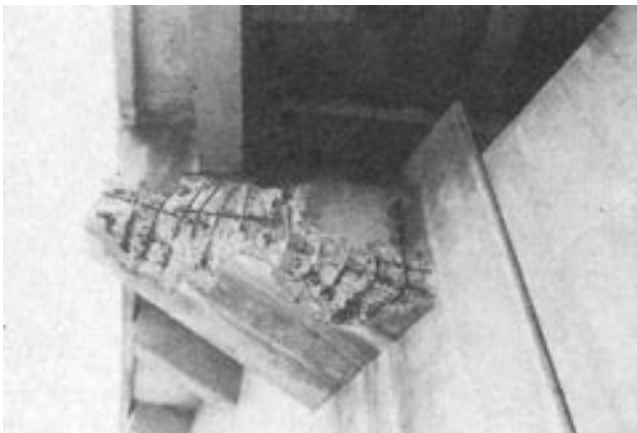
Figure 11: Cantilever reinforced concrete beam support prior to repair. Note penetration of rust to areas adjacent to reinforcing.

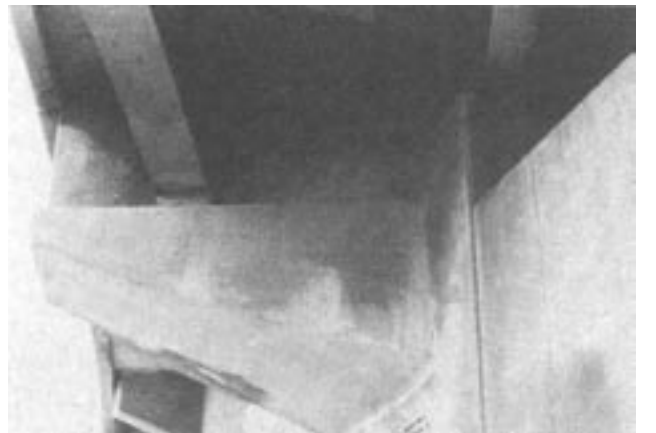
Figure 12: Same cantilevered beam as shown in Fig. 11. The repair has been completed using the shotcrete process.

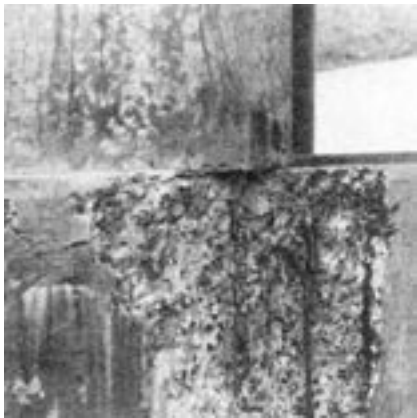
Figure 13: The deterioration of the concrete in this crash barrier and column base is primarily due to roadway splash adhering to the surface and going through many freeze-thaw cycles. Deicers accelerated the process.

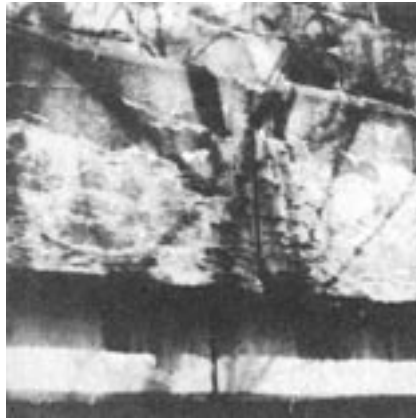
Figure 14: Fascia projection showing leaching of lime substances from the concrete due to wetting and drying. Once deterioration has started, freezing and thawing action during cold weather aggravates the problem.

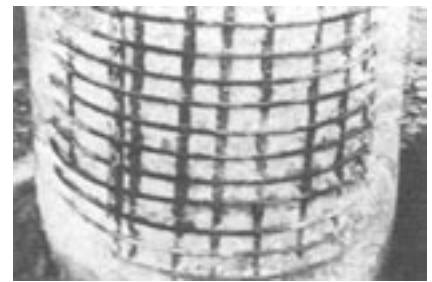
Figure 15: Circular column steel showing the effect of moisture and water infiltration on concrete of poor quality. Close spacing of reinforcing and overly dry concrete mixes can set the stage for this type of problem.

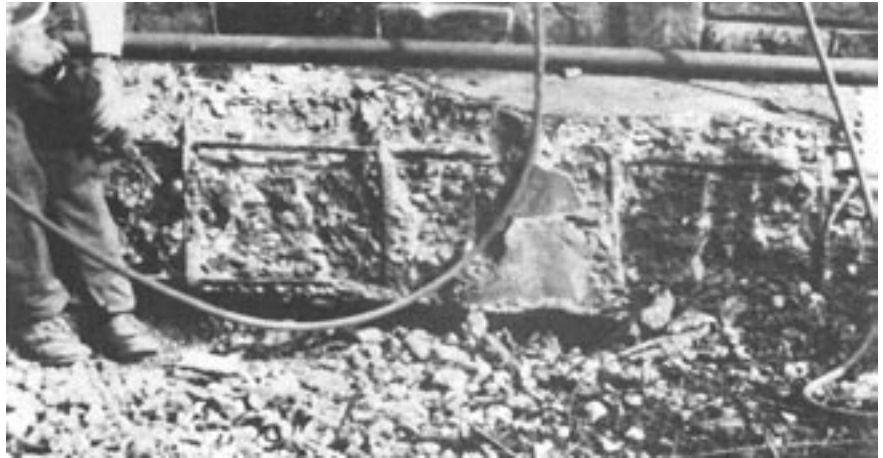
Figure 16: Same fascia beam as shown in Fig. 14. Chipping concrete with a pneumatic chipping hammer. The concrete is soft, spongy, weak, and relatively easy to remove. Chipping must continue until a hard surface is exposed.

**Preparation**— The most important phase of shotcrete repair of concrete structures is the preparation of the disintegrated areas. It is absolutely essential that all disintegrated, soft, spongy concrete be removed to a hard, sound base (Fig. 16). If any weak, unsound concrete is left, the shotcrete will not properly bond to the original material and a plane of weakness will remain which can result in future failure.

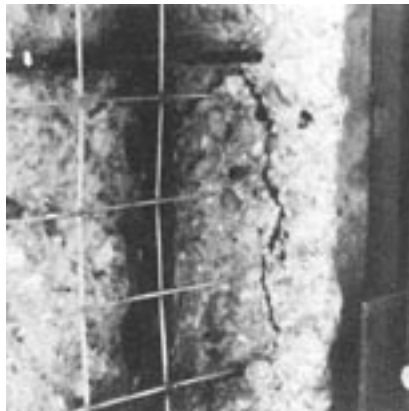
Figure 17: The dark crack in center of figure starts just behind the rusted reinforcing bar and represents dissolved rust. The crack is filled with rust which ends at the bottom of the figure.

It is also imperative to remove any questionable material behind exposed reinforcing steel. Weak, fractured, or cracked concrete surrounding a reinforcing bar can provide internal access to seepage water recreating the conditions that are being corrected (Fig. 17).

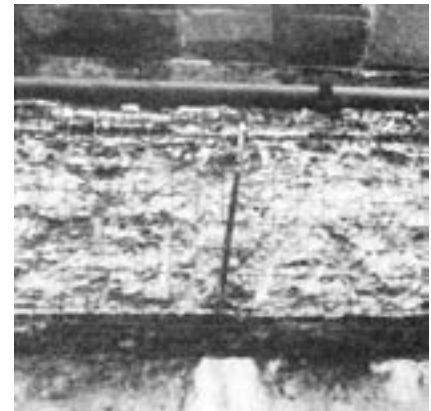
Figure 18: Fascia beam as shown in Fig. 14 and 16. Concrete chipped with welded wire fabric attached.

**Reinforcing** — After preparation is completed, rusted reinforcing steel should be sand-blasted and steel of inadequate section replaced. Welded wire fabric usually galvanized, is then attached to the exposed reinforcing bars (Fig. 18). Plated anchor bolts at appropriate spacing are used where the bars are not sufficiently exposed. The mesh should be spaced in the repair so that  $\frac{3}{4}$ -1 in. (19-25 mm) of shotcrete coverage is provided.

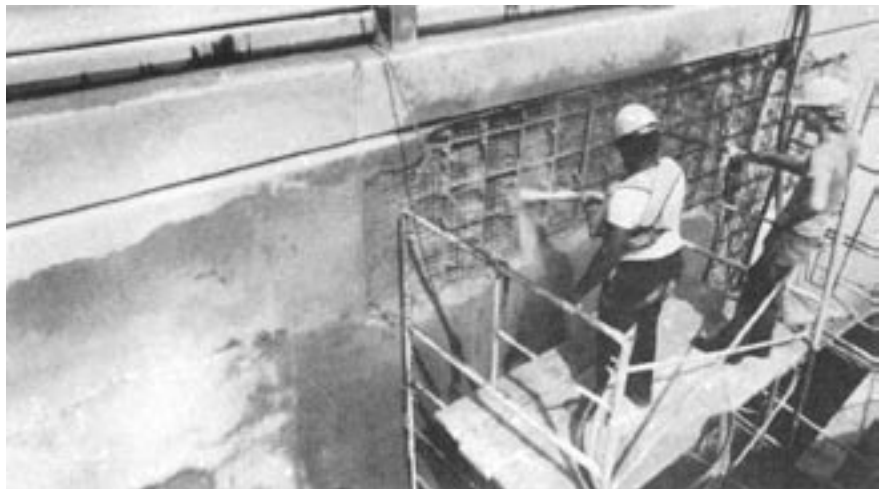
Figure 19: Wetting down an area prior to shotcreting with air-water blast. This procedure cuts down the absorption of mix and water and cleans the area prior to shotcreting.

Shotcrete of good quality requires well maintained equipment, a more than sufficient volume of air and water at required pressure, and an experienced nozzleman and crew. Careful attention to nozzle techniques is required for good bond, reduced rebound, elimination of sand pockets and voids, complete encasement of all reinforcing steel, and minimal

overshooting (Fig. 19, 20, and 21). Finishing should be kept to a minimum to avoid breaking bond, hair crack development, and other surface distress (Fig. 22 and 23).

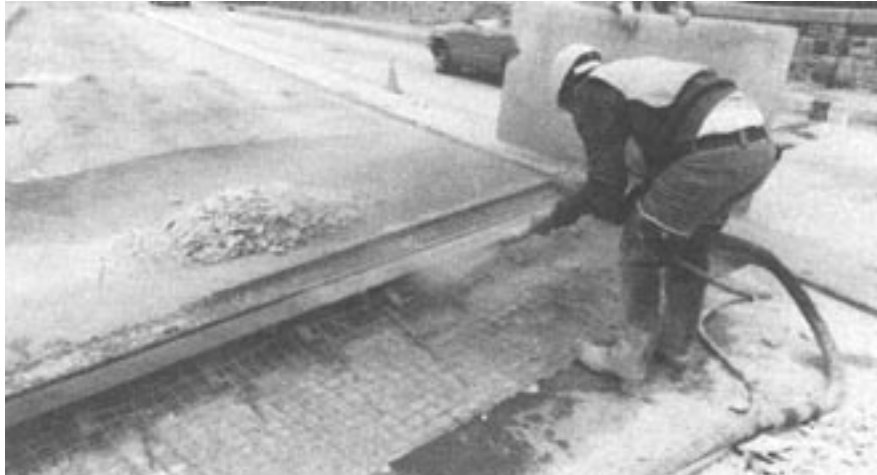
Figure 20: Shotcreting expansion dam that had become loose and had to be rewelded. Care must be taken by nozzleman to see that rebound does not build up in the inaccessible areas.

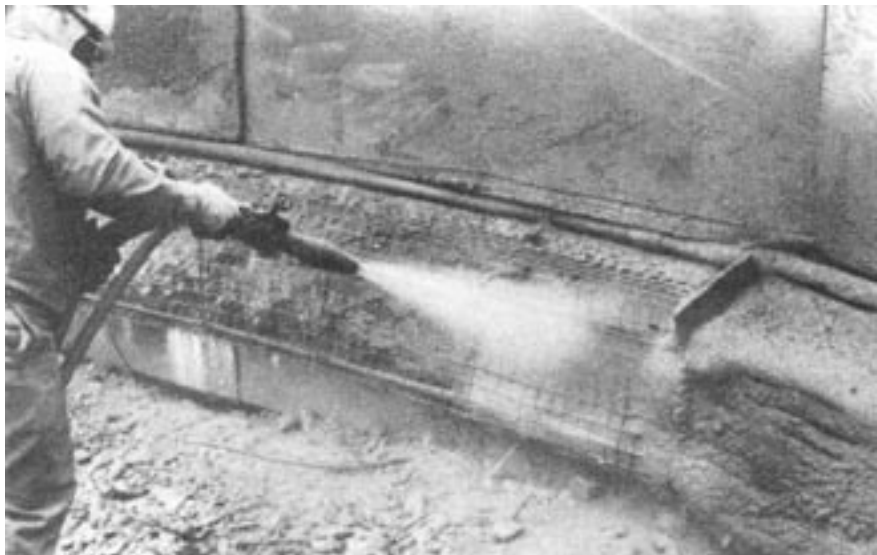
Figure 21: Shotcreting fascia beam. Area to right is over shot. Material will be wasted when surface is trimmed to wire fabric.

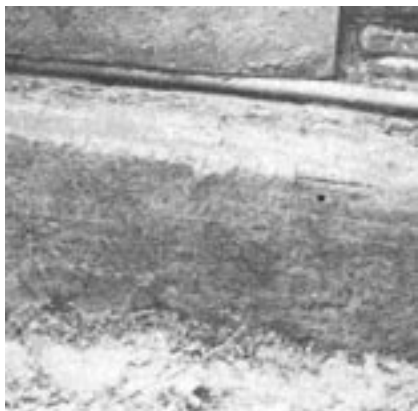
Figure 22: Fascia beam trimmed to welded wire fabric. A final coat of about 1 in. (25 mm) will be applied, finished to required texture, and cured.

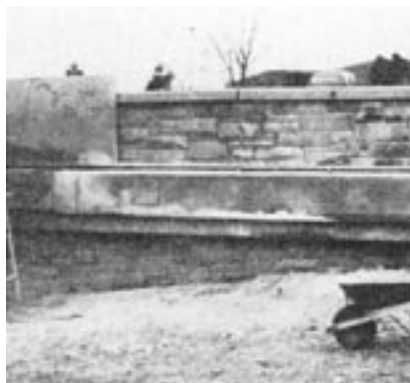
Figure 23: Fascia beam completed. Note that calcium deposits show on bottom of beam. Seepage water from roadway has made its way past the repair to the underside of the beam.

In those cases where seepage is deep-seated and beyond the depth of repair, the infiltrating water must be stopped at its source. This can be a difficult chore and if not effected, a new repair can exhibit cracks and staining at an early age.

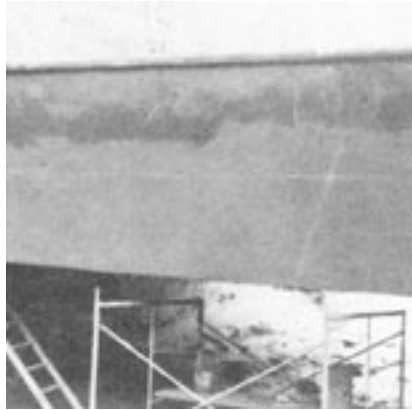
Figure 24: Outside beam and parapet of single span bridge showing completed shotcrete repair with fairly smooth brush finish.

It should be noted that shotcrete practice varies from locale to locale. Climate, materials, and economics dictate procedures. A good understanding of the effect of these variables is required to insure a successful shotcrete installation. If proper attention has been paid to all details the end result should be a dense, high strength, impermeable, durable, and quality shotcrete repair (Fig. 24 and 25).
