# Waterproofing and Concrete Restoration at Blackwater Dam

by David Jamieson

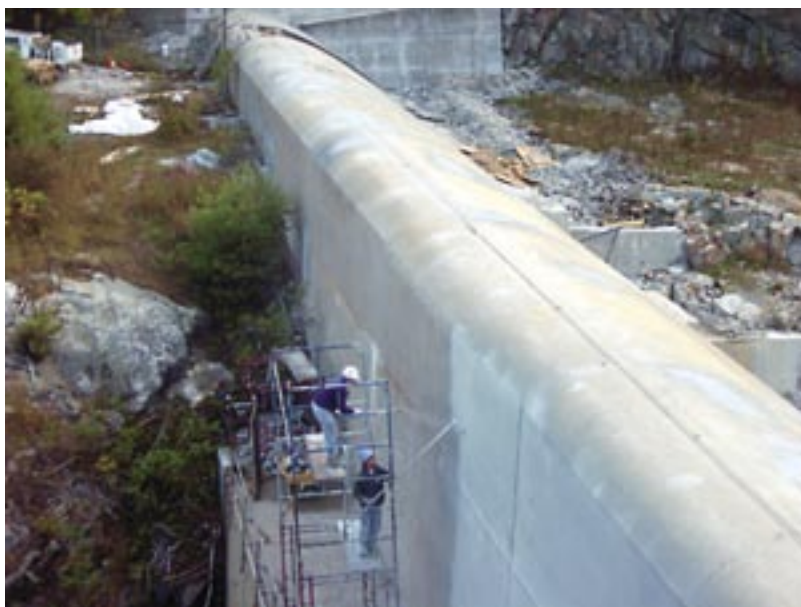
Fig. 1: On the upstream side of Blackwater Dam, cementitious waterproof coating is spray-applied and backrolled with two-coat application by Aulson crewmen
