History of Shotcrete in Seismic Retrofit in California

by James Warner

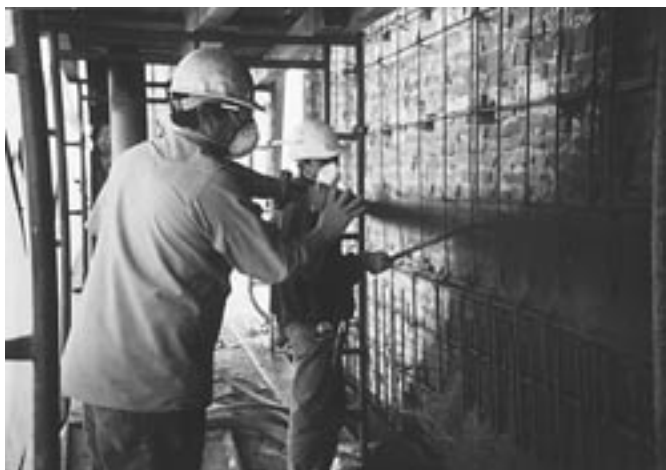
Fig. 1: Minimal reinforcing and fairly thin shotcrete augmentations were common in early seismic retrofit

Initially, the work involved the application of a thin membrane of reinforced shotcrete over the existing masonry surfaces. A wythe of brick was usually removed around the boundary area of openings, the surface abrasive blasted, and a network of relatively light reinforcing consisting of No. 3 and 4 bars on approximately 18 in. (0.45 m) centers, placed, as shown in Fig. 1. One or more larger bars were placed around the boundaries and 3 in. (76 mm) of new shotcrete was applied.

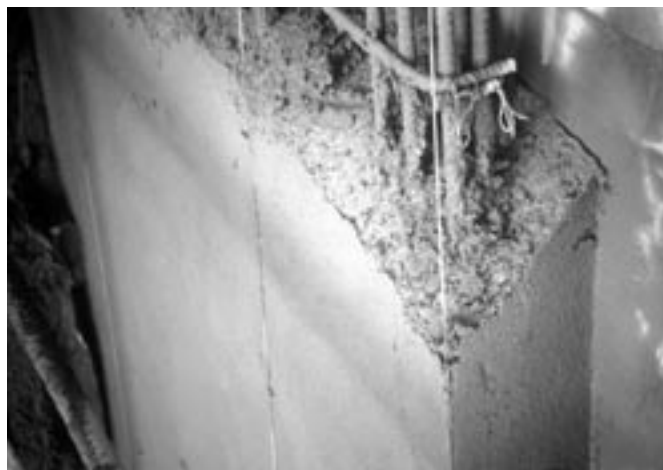
Fig. 2: Ground wires rather than forms were and continue to be used for maximum nozzle access

Rebound tended to gather in the boundary recesses, so a blow man was used to direct a blast of compressed air to clear rebound from the work. Because forms at corners and around the openings added to rebound entrapment, they were eliminated and ground wires were used to provide alignment control for the finishers, as shown in Fig. 2. The work was performed in this manner until 1952.

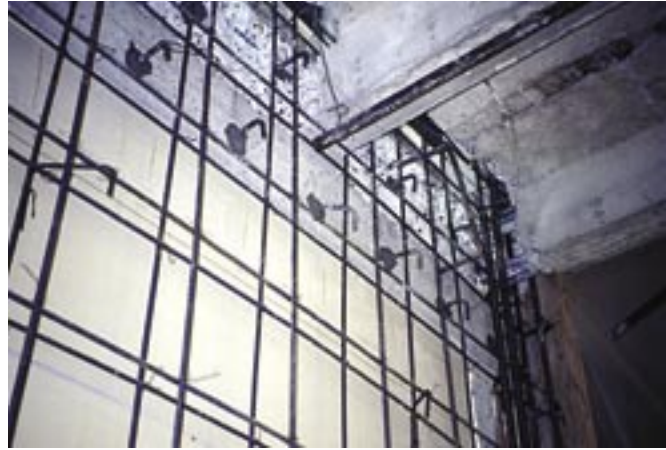
Fig. 3: Multiple reinforcing curtains and continuity between floors became common following the 1952 Tehachapi earthquake

The 1952 Tehachapi earthquake occurred in the early morning, so again there were few casualties. However, schools not yet strengthened suffered significant damage, and even some that had been strengthened were damaged. This resulted in upgrading the design standards, primarily by increasing the size and amount of reinforcing, often using two layers, and also increasing the thickness of the new shotcrete. Boundary recesses were enlarged, similar thickened ribs throughout a wall area were sometimes used, and floor areas penetrated as shown in Fig. 3, to provide continuity for the augmentation. More and larger bars were added to the boundary and rib recesses as well.

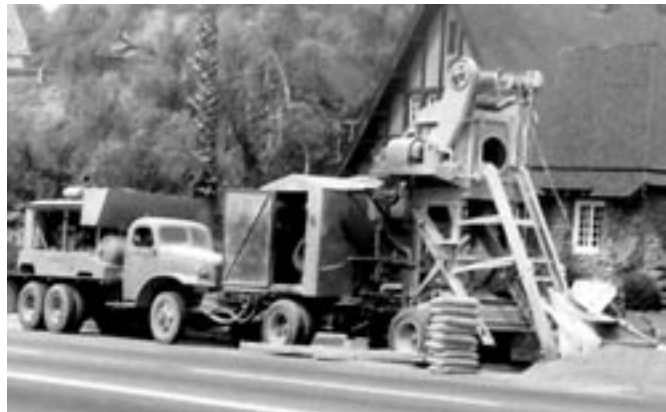
Fig. 4: Typical shotcrete rig used for structural work prior to the mid-1970s

They continued with the double-chamber gun, usually mounted on four-wheel trailers that also contained a mixer and storage for the hoses and other tools, as shown in Fig. 4. Mixing was done with a standard skip-type, drum concrete mixer. It was typically mounted on inclined tracks so once it was on the job, it could be raised sufficiently to discharge directly into the gun. For the skip to be low enough to be filled by hand laborers on the ground, it was supported on tracks and raised with a piston air motor-powered winch. It was filled with concrete sand to guide bars denoting the correct quantity that was always based on the inclusion of even bags of cement.

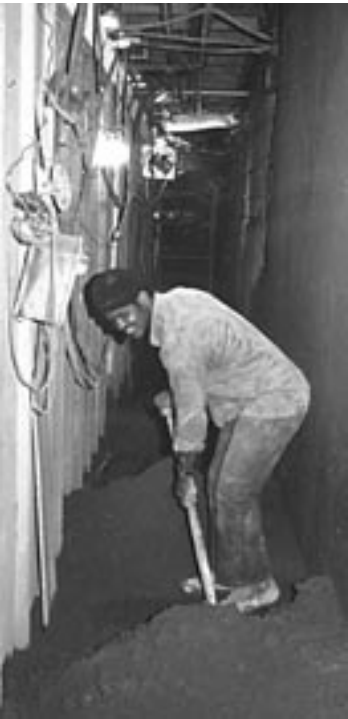
Fig. 5: Large amounts of rebound were produced, especially in cramped conditions with heavy reinforcing

To thoroughly encase the now large and congested reinforcing, the nozzleman was required to shoot at a multitude of different angles; in the process, the amount of rebound increased significantly. Nevertheless, the work continued, as did the high-quality performance. To maintain the quality, however, the rate of placement suffered and large amounts of rebound occurred. A good day might find 30 yd³ (23 m³) of material going through the gun, but as much as 40% was wasted as rebound.

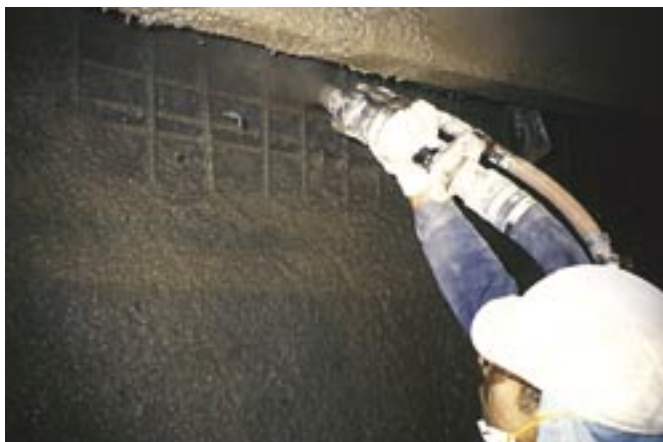
Fig. 6: Final closure of massive placements stopped short of overhead with beveled face, to allow shrinkage prior to final closure

immediately adjacent to the upper boundary, as illustrated in Fig. 6. The final closure would then be shot after the major shrinkage had taken place. In this regard, note the beveled surface of the original placement. Rebound has always tended to gather in isolated areas at the beginning of shooting, and this became an increasing peril as sections became thicker and more heavily reinforced. For this reason, beveled joints have been used from the very beginning to assure quality joints. Notwithstanding the American Concrete Institute's guideline that construction joints subjected to compressive stress should be square, the beveled joints have worked well for more than 50 years and are certainly superior, if not requisite, to obtaining quality in structural applications.

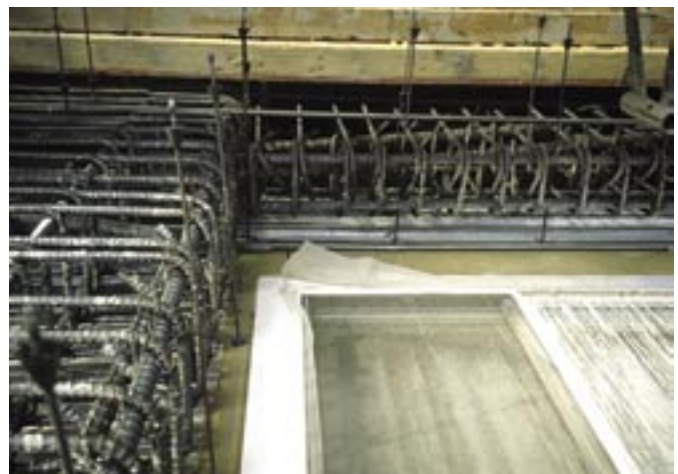
Fig. 7: The reinforcing for seismic retrofit continues to get larger and more congested

The next major events were the Loma Prieta earthquake in 1989 and the Northridge event in 1994. Massive structural damage occurred followed by evermore stringent design standards and subsequent legislation requiring virtually all major structures to be strengthened. This, of course, meant more reinforcing to the point that proper placement and compaction of even regular concrete would be difficult (for example, Fig. 7). Again, shotcrete contractors rose to the challenge, as did their highly competent nozzlemen who now often positioned the nozzle within the reinforcing network itself to properly encapsulate the reinforcing steel, as illustrated in Fig. 8.

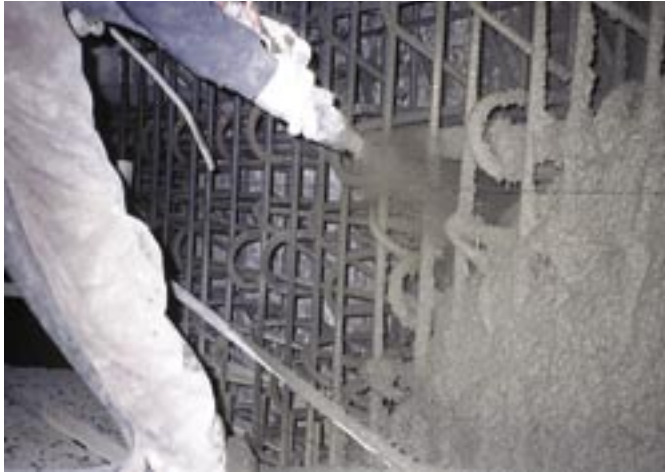
Fig. 8: Wet-mix process allows the nozzle to be held very close and even within the outer reinforcing to achieve complete encapsulation

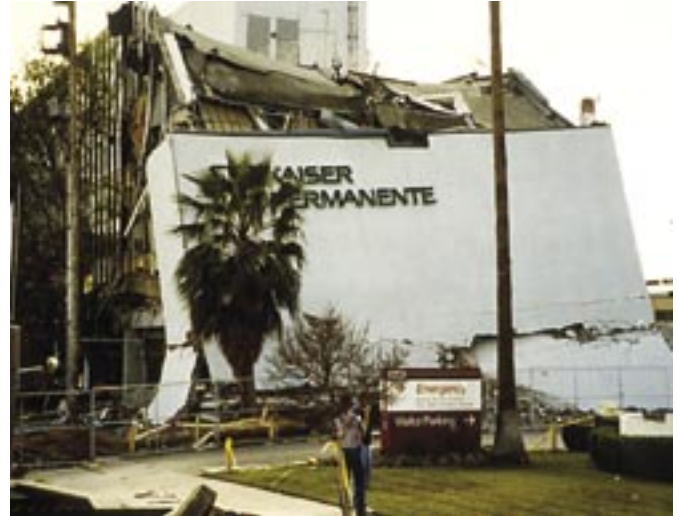
Fig. 9: Shotcrete overlay literally slid down like a curtain as building collapsed

one end of the five-story Kaiser medical clinic collapsed, the upper portion of the shotcrete overlay merely came down as a sheet, as shown in Fig. 9. The original retrofit had been applied to the ends of existing brick infilled concrete frames, according to the standards of pre-1971, using the dry-mix process. Because the length of the structure was much greater than the width, it was strengthened in the transverse direction only. The failure was in the longitudinal direction, the strengthened ends being more resistant. Of great interest was the observation of the excellent quality of shotcrete bond to the original brick. The masonry wall disintegrated but the outer wythe remained strongly bonded to the shotcrete as illustrated in Fig. 10.

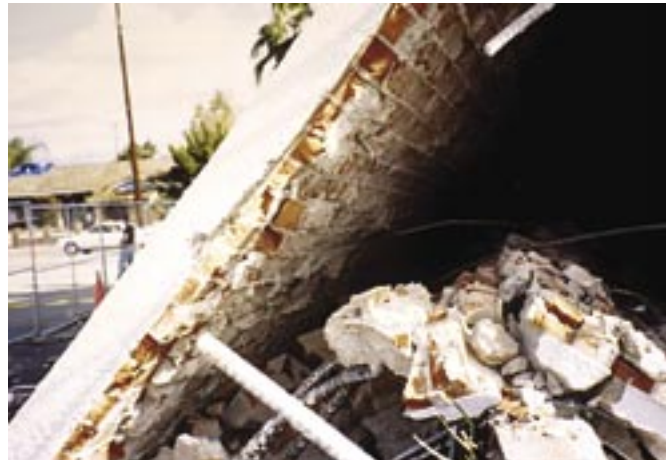
Fig. 10: The brick wall shattered but outer layer remained bonded to the shotcrete
