# Soudan Mine Shaft Rehabilitation

By Shane McFadden

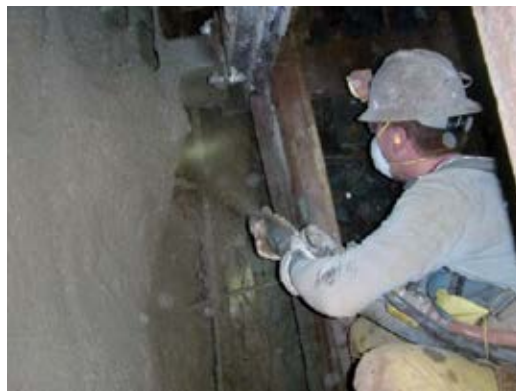
Fig. 3: Application of shotcrete on shaft wall

placement areas. To pump the required distance, a high-slump, self-consolidating mixture was designed with accelerator introduced at the nozzle. The product was to be pumped through a 2 in. (51 mm) line. A surface and procedure test was conducted, including full-mixture testing and the production of test panels. Once the shotcrete mixture and placement techniques were worked out, 2 in. (51 mm) slickline was installed in the shaft to the work area.

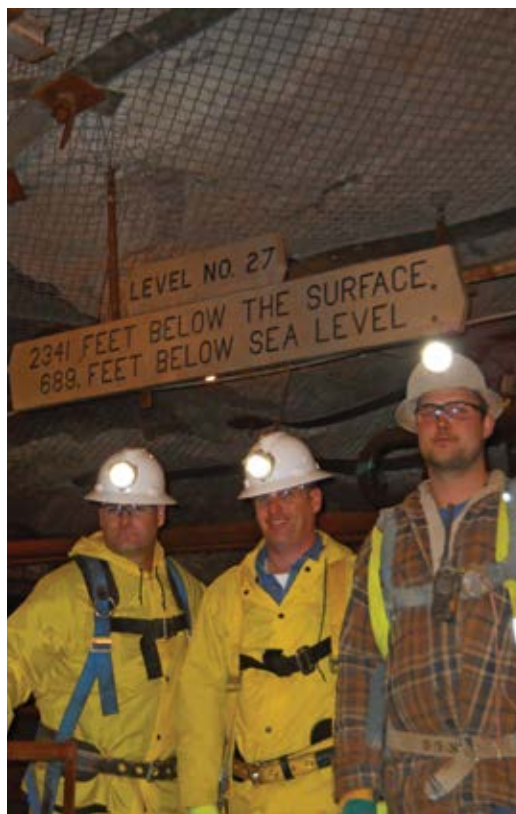
Fig. 4: Bottom of shaft
