## **Shotcrete Corner**

## Meadow Brook Hall Historic Bridge Restoration

By Jessica S. Farley

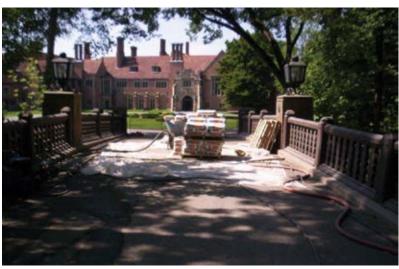
Fig. 1: Bridge approach to Meadow Brook Hall

RAM Construction Services was awarded the contract to restore the bridge adjacent to Meadow Brook Hall (refer to Fig. 1). The work consisted of wood, brick, and concrete repairs. The decorative wood railing was completely replaced with a new custom white oak railing. The deteriorated brick veneer on the piers was removed and replaced with a blend of three brands of brick for a perfect match to the existing masonry.

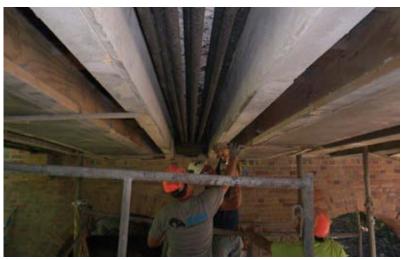
Fig. 5: Finishing the beams

All materials and equipment were at the top of the bridge and just the hoses were mobilized to the work area. The ACI certified nozzlemen at RAM Construction repaired a total of 1200 ft² (110 m²) of concrete on the structural beams. All of the exposed reinforcing steel was cleaned and coated or replaced if deterioration was significant. All seven support beams were finished to the original historic "chamfered" profile (refer to Fig. 5).

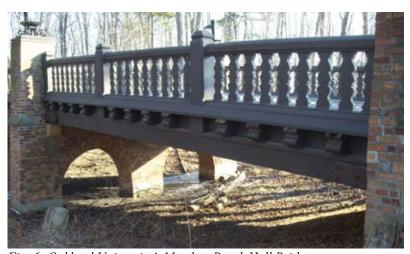
Fig. 6: Oakland University's Meadow Brook Hall Bridge

This project is reminiscent of the "glory days" of the automobile industry in Metropolitan Detroit. The triumph of the Meadow Brook Hall bridge renovation and revitalization symbolizes the historic turnaround of the auto industry and Detroit (refer to Fig. 6).
