# Coastal Maine Negative-Edge Pool

## 2012 Outstanding Pool & Recreational Project

Coastal Maine Negative-Edge Pool

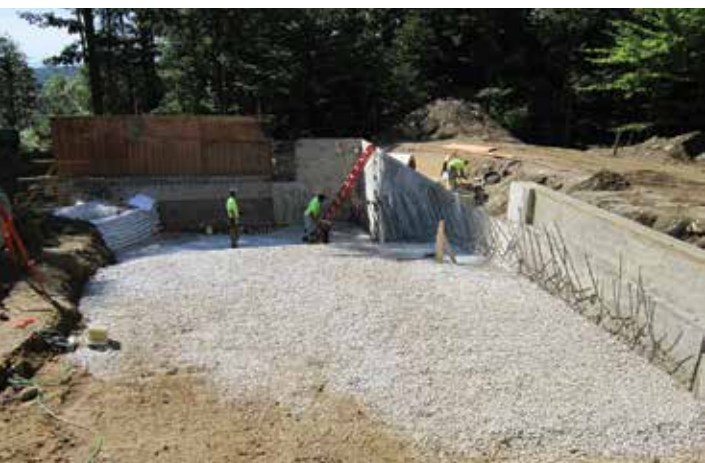
*Fig. 1: Stone underlayment along with the reinforcing bars penetrating out of the first phase of construction so the second-phase pool section could be tied in correctly*

remainder of the pool (Fig. 1 to 3). The negative-edge feature, including the spillway wall and trough, needed to be constructed first to create a deep footing that would reach below the frost line. In the first mobilization, the trough area was excavated to the required depth and then over-excavated on the pool side to allow us room to construct forms. For the future, well-draining fill material was required under the pool. After excavation, extensive plumbing was installed, followed by form erection and placing of the pool shell reinforcing steel, and then shotcreted with dry-mix shotcrete. Some of the reinforcing steel in the trough wall extended out from the wall to allow for subsequent tie-in with the pool floor.

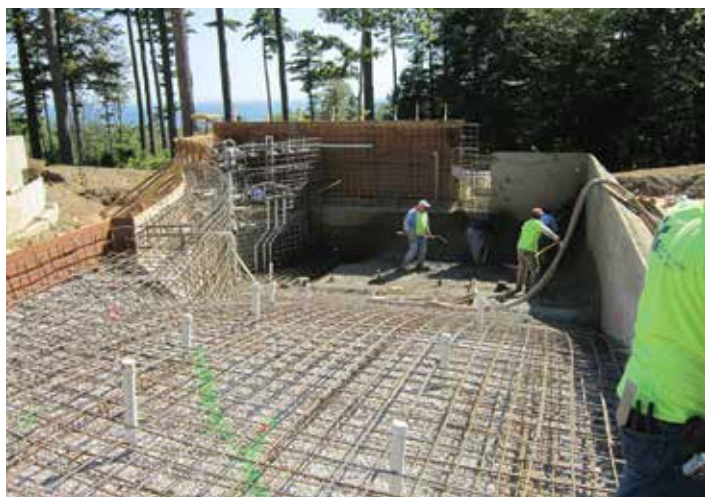
*Fig. 2: Elaborate reinforcing required by the pool design as we start the second phase of shotcrete*

The complexity of the pool structure created sections located from well below the frost line to right at and above the frost line. This required extensive structural design, resulting in a lot of reinforcement. The reinforcing steel consisted of two layers of No. 4 (No. 13M) reinforcing bar in the entire pool. The horizontal reinforcement spacing was 8 in. (203 mm) on center and vertical spacing was 6 in. (152 mm) on center. During shooting, a blowpipe was used extensively to keep the outer layer of reinforcing bar clean and prevent any rebound from building up on the bar surface, where it would reduce the quality of the in-place concrete. Overall, with the multiple phases, the shotcrete portion of the job was completed in 5 days.

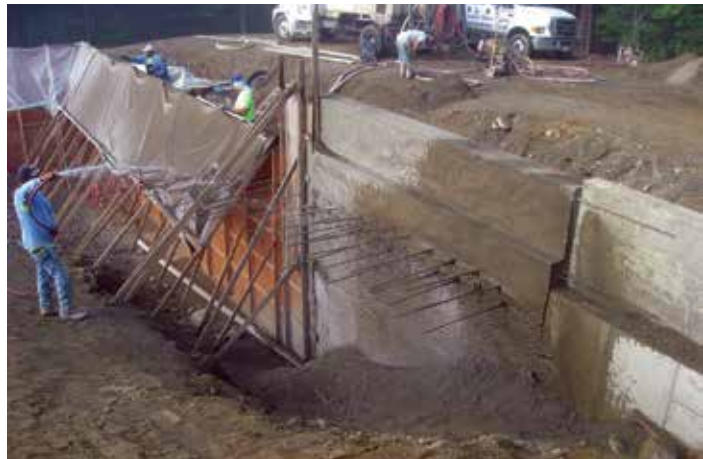
*Fig. 3: Deep excavation required for forming and, subsequently, filling with free-draining stone to prevent frost heave. Also seen is the dowel reinforcing bar that was tied into the pool floor in the second phase*

Next came the pool itself. After the trough and spillway wall were completed, the pool floor area was backfilled with free-draining crushed stone that would prevent any water buildup and potential heaving due to the freezing winter temperatures. Everything within 4 ft (1.2 m) of potential exposure to freezing air temperatures was filled with crushed stone or dry-mix shotcrete, as frost heave does not just affect horizontal sections of the pool but could also impact vertical sections that line the spillway. The pool had a shotcrete perimeter gutter that would later provide the overflow and

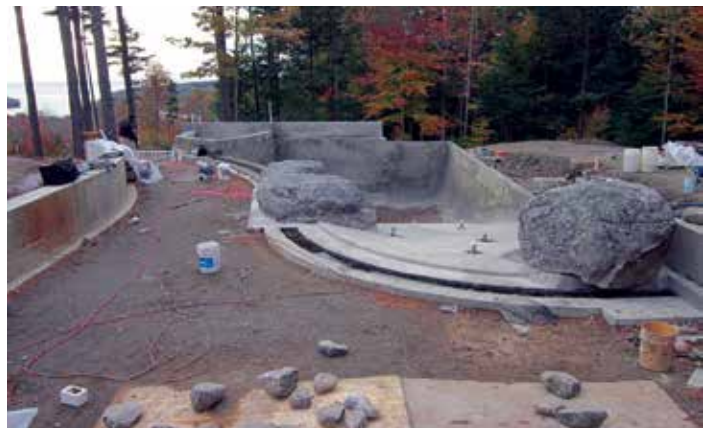
*Fig. 4: Completed shotcrete with large rocks placed*

deck-level water capability. Two pockets on either side of the beach-entry area were constructed to hold natural rocks from the surrounding property to help the pool blend into the landscape. After initial curing and once the pool shotcrete reached the required strength, the boulders were installed. Shotcrete was placed around the boulders to secure them in place (Fig. 4).

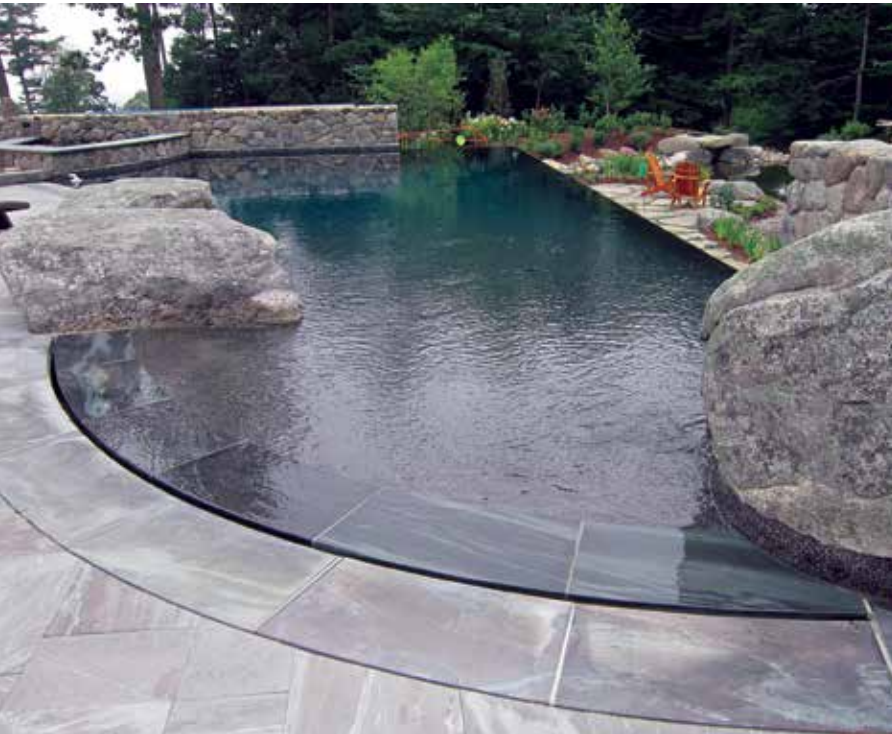
Fig. 5: Completed pool from the beach-entry end

The overall job took about 9 months to complete (Fig. 5 and 6). A lot of the construction was done in the winter under a tent that the general contractor

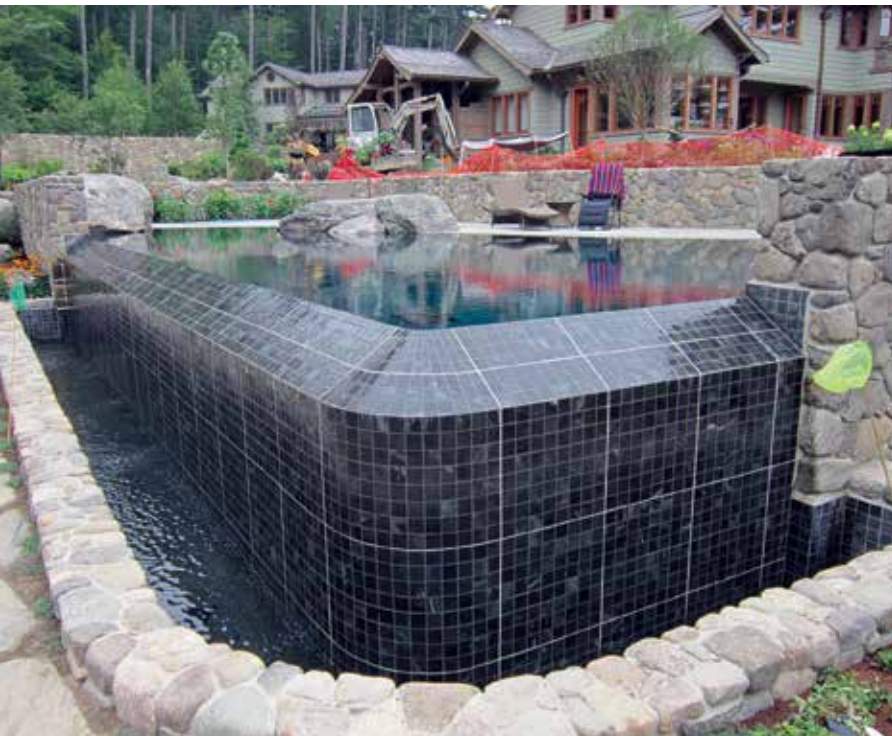
Fig. 6: Completed pool from the negative-edge side
