Long Prairie Digester Rehabilitation Project

By David Graham

Project Name
Long Prairie Packing-Digester Rehabilitation

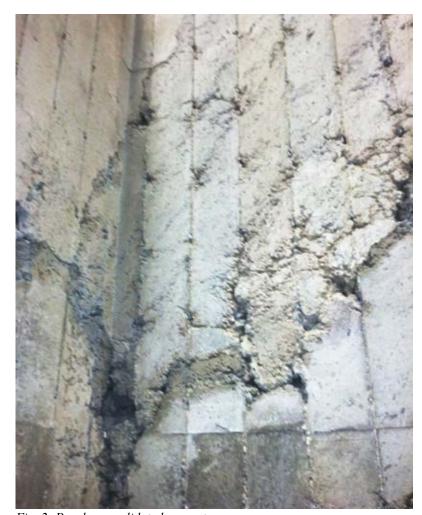
After original construction, the tanks were tested for watertightness. During the testing phase, the tank walls exhibited extensive leaking (Fig. 2 and 3).

After removal of interior insulation, the exposed walls revealed extreme honeycombed areas resulting from poor consolidation during original construction. Also, the ICF wall ties used consisted of a hollow tie without a waterstop feature; thus, water could be leaking from anywhere in the walls through existing voids or through any of the thousands of hollow ties.

Fig. 2: Poorly consolidated concrete

Due to the high volume and severity of poorly consolidated areas, it was determined that the tank walls required repair prior to final lining application. Honeycomb areas were chipped back to sound concrete and brought back with shotcrete to original wall plane using King Packaged Materials MS-W1 with poly fibers. These areas were not troweled and were left with a natural gun finish.

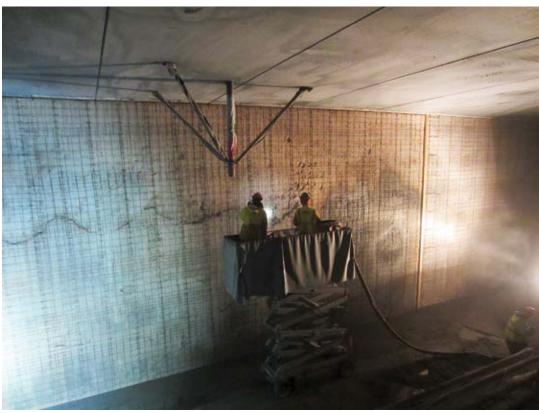
Fig. 3: Honeycomb at cold joint

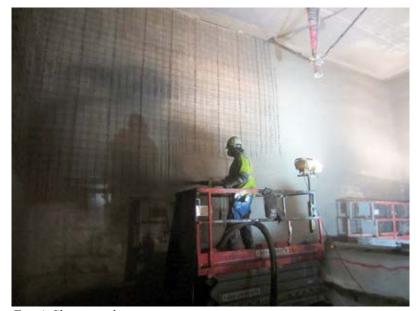
Fig. 4: Shotcrete placement

To complete this project, 640 bulk bags of King Packaged Materials MS-W1 with synthetic fiber were used. The prepackaged dry material was placed into a Cemen-Tech MCD 10-150 mobile concrete dispenser, where it was mixed to the proper slump and conveyed into an Allentown Powercreter 20S shotcrete pump. Pumping distances varied from 200 to 300 ft (61 to 91 m) in length. Shooting wires were installed and shotcrete was placed by ACI-certified nozzlemen. The final finish was with steel trowel to provide a uniform surface to receive the final protective lining system (Fig. 4 through 6).

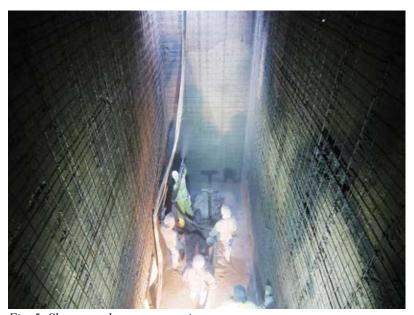
Fig. 5: Shotcrete placement at weir

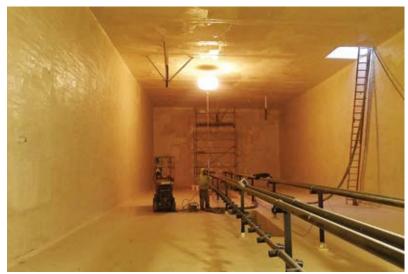
Fig. 6: Completed repair

clean water and allowed to reach saturated surfacedry condition. A minimum of 1-1/2 in. (38 mm) of King Packaged Materials MS-W1 with poly fibers was applied to the wall surfaces and finished with steel trowel to provide a tight, level surface. All newly placed concrete was water cured for 7 days.
