# Pier 57 Repair and Improvements

By Tait Pirkle and Marcus Jeffreys

## 2017 OUTSTANDING REPAIR & REHABILITATION PROJECT

**Pier 57—Pier Repair and Improvements**

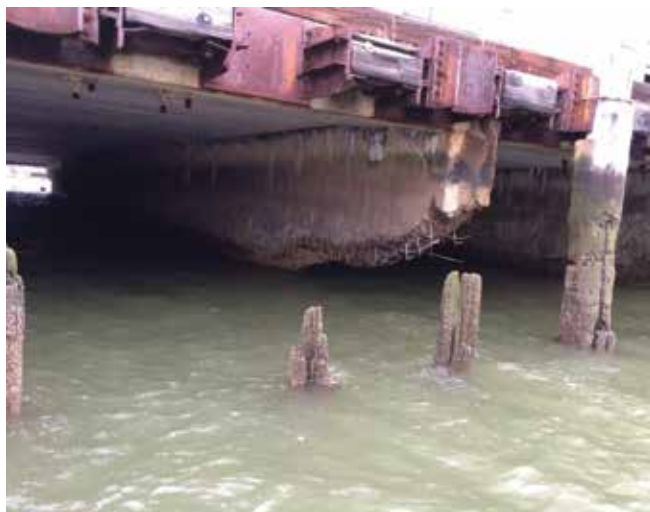
Fig. 1: An example of a moderate girder repair

The shotcrete portion of the project called for the removal of deteriorated concrete, replacement of steel reinforcement using No. 4 and 8 (No. 13M and 25M) epoxy-coated reinforcing bar and reinforcing bar couplers, installation of welded wire reinforcement, and the shotcrete placement. The work was divided into three repair types: vertical girder (shallow repairs with depths of up to 6 in. [150 mm]), moderate girder (deterioration not completely through the girder with depths up to 1 ft [0.3 m]) (Fig. 1), and severe girder (complete deterioration through the entire girder with depths of 2 ft [0.6 m]) (Fig. 2). The project totaled 2600 ft<sup>2</sup> (240 m<sup>2</sup>) of vertical repairs, 60 ft<sup>2</sup> (6 m<sup>2</sup>) of moderate girder repairs, and 1200 ft<sup>2</sup> (1100 m<sup>2</sup>) of severe girder repairs. The repairs that are visible to the public were trimmed back and received a flash finish coat. The remaining repairs (out of sight) were gun finished and cured with a spray-applied compound.

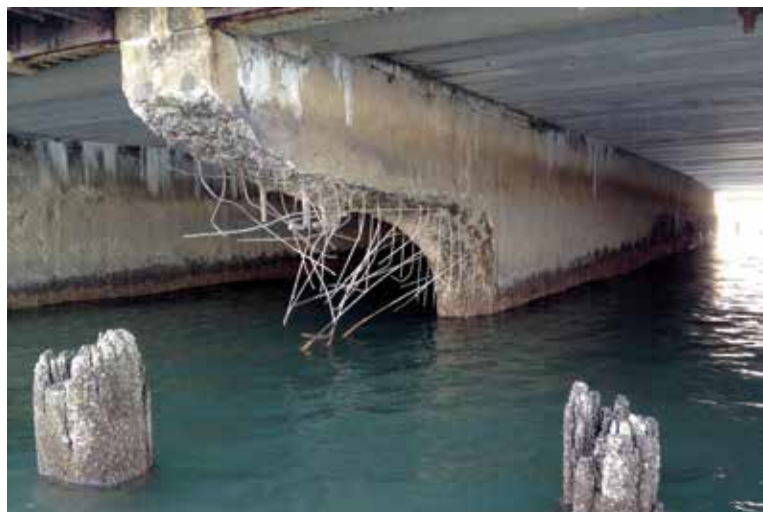
Fig. 2: An example of a severe girder repair

The severe girder repairs varied significantly in length and posed the biggest challenge because the sharp taper had

to be recreated and were 2 ft (0.6 m) thick. After removal of the unsound or deteriorated concrete, individual custom reinforcing bar cages were installed. The cages had to follow the original taper and allow for the specified concrete cover over the reinforcement (Fig. 3). The tapered bottoms of the severe girder repairs were formed using 8 ft (2.4 m) long, 8 in. (200 mm) high wood forms. To mitigate the weight, the prefabricated forms were floated in place, pieced together, and then accurately positioned between the girder's double-sided reinforcement cage (Fig. 4). Eastco's ACI Certified Nozzleman then filled in the bottom form and applied a 3 in. (75 mm) base coat to a simple plywood form connecting the bottom form to the existing top side face of the girder. Typically, during the same tidal shift, the forms were removed and accelerated-set shotcrete was applied in layers to complete the girder repair.

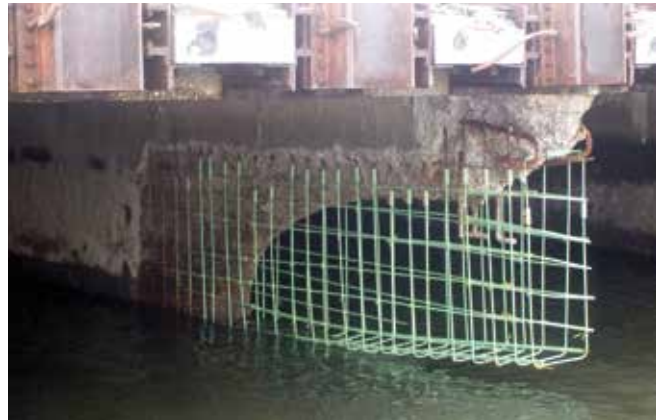
Fig. 3: A reinforcing bar cage using reinforcing bar couplers

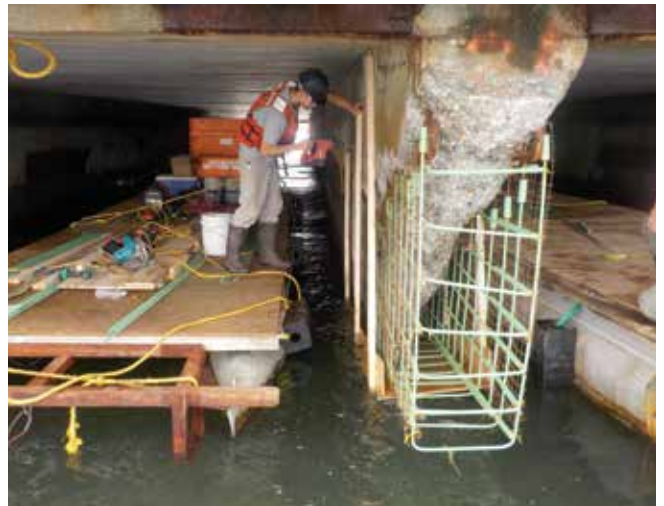
Fig. 4: The installation of a wooden form to help create the right taper of the girder bottom

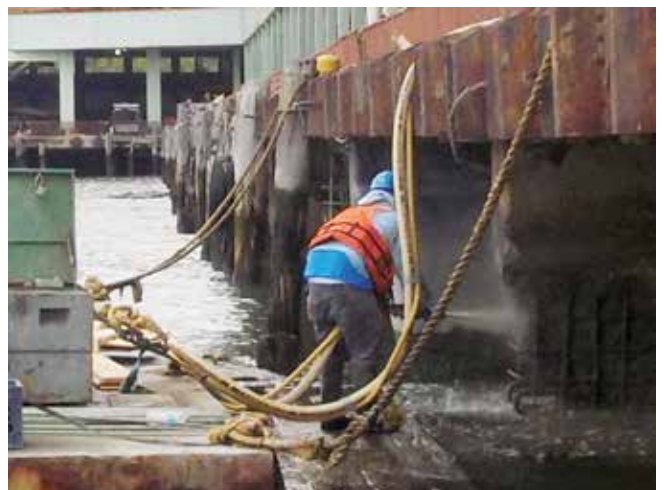
Fig. 5: Eastco's ACI Certified Nozzleman applying shotcrete

As with all jobs, personnel safety on Pier 57 was a concern and a priority. A Health & Safety Plan (HSPA) and a Job Hazard Analysis (JHA) were implemented before mobilization and issued to all employees. The JHA included the hazards associated with working on a work barge and float stages, with special considerations to access and egress (Fig. 5). All employees were suited with proper

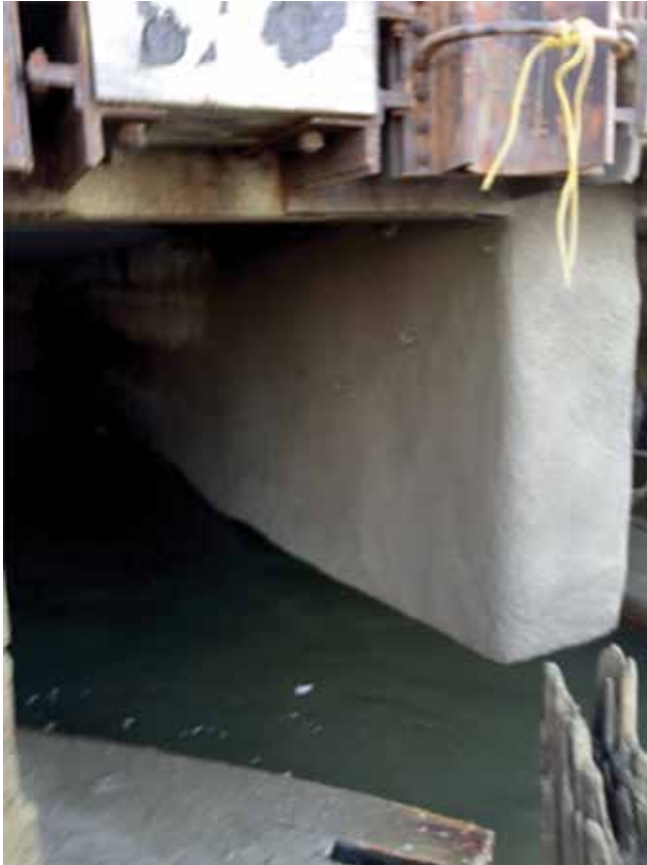
Fig. 6: A completed severe girder repair shot with a gun finish

understanding of the Hudson River. It challenged the crew to be efficient and flexible, and highlighted the quality of Eastco's personnel, especially the ACI Certified Nozzlemen. The project was a huge success that demonstrated the effectiveness and efficiency of accelerated-set dry-mix shotcrete (Fig. 6). Simple, relatively light forms took the place of a heavy-duty form system that would have been required with a form-and-pour repair. The shotcrete forms were routinely erected and removed during the same or
