2019 Honorable Mention

Duck Island Wastewater Treatment Plant: Screw Pump Rehabilitation

Project Name
Duck Island Screw Pump Rehabilitation

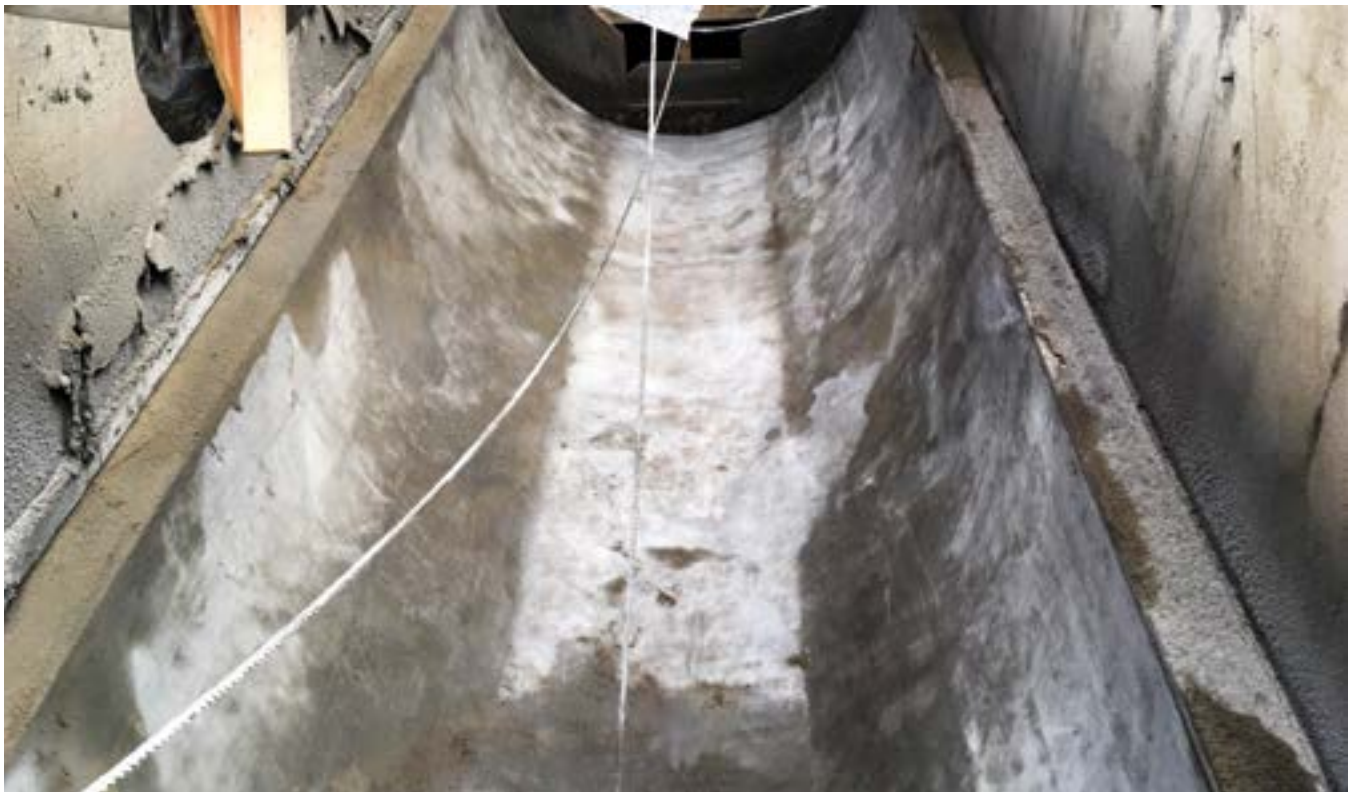
Fig. 1: Finished screw pump basin with tight radius

structure that is approximately 7/16 in. (11 mm) larger than screw flights. The tolerance between the screw and its supporting structure is very tight to ensure efficiency of the pump. The conventional way of repairing this structure is to remove the screw, demolish and remove the old grout lining down to the structural support, reinstall the screw with a 7/16 in. screed rod welded to the screw flights, and use the screw itself to screed the new concrete into place. The screw pumps at Duck Island are some of the largest, longest, and steepest in the country, making them some of the hardest to work on (Fig. 1).

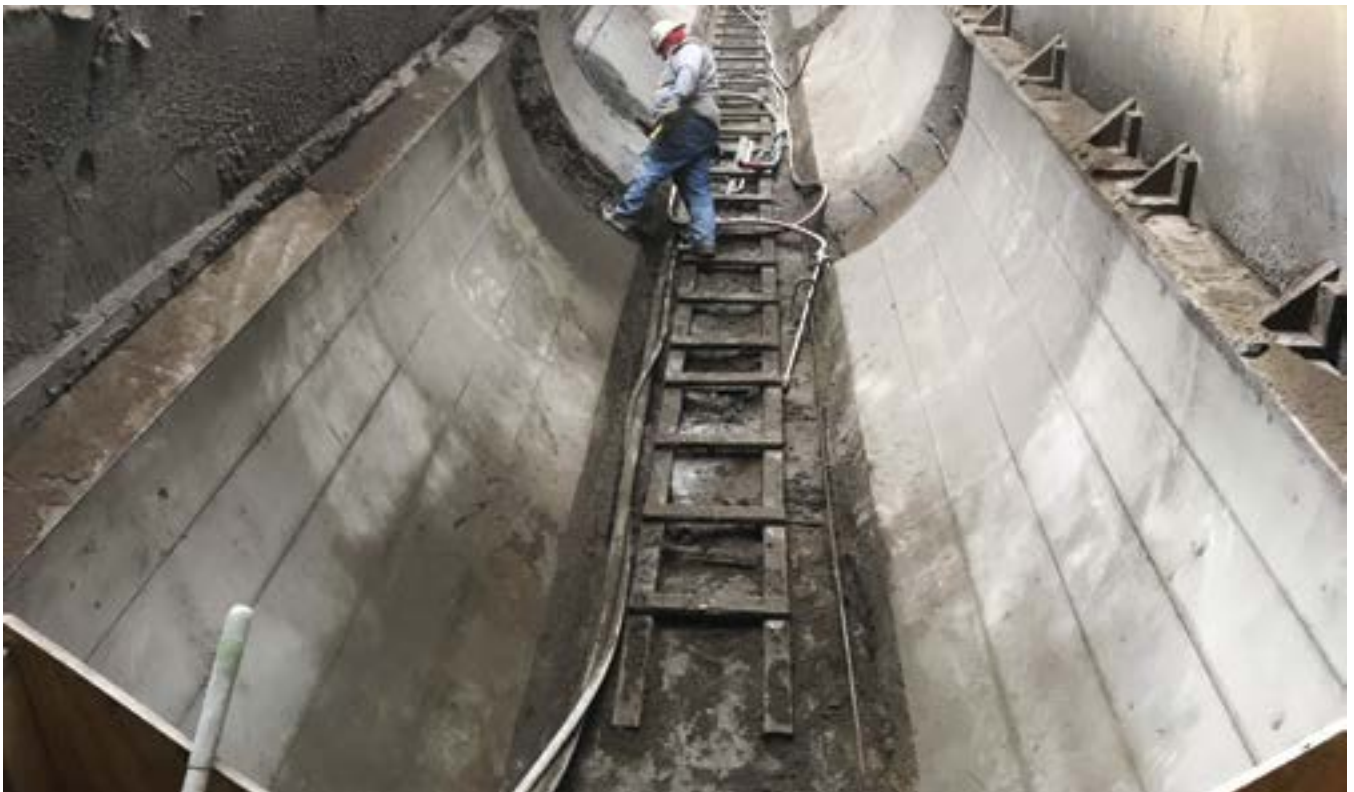
Fig. 2: Basin walls shot with guidewires in place

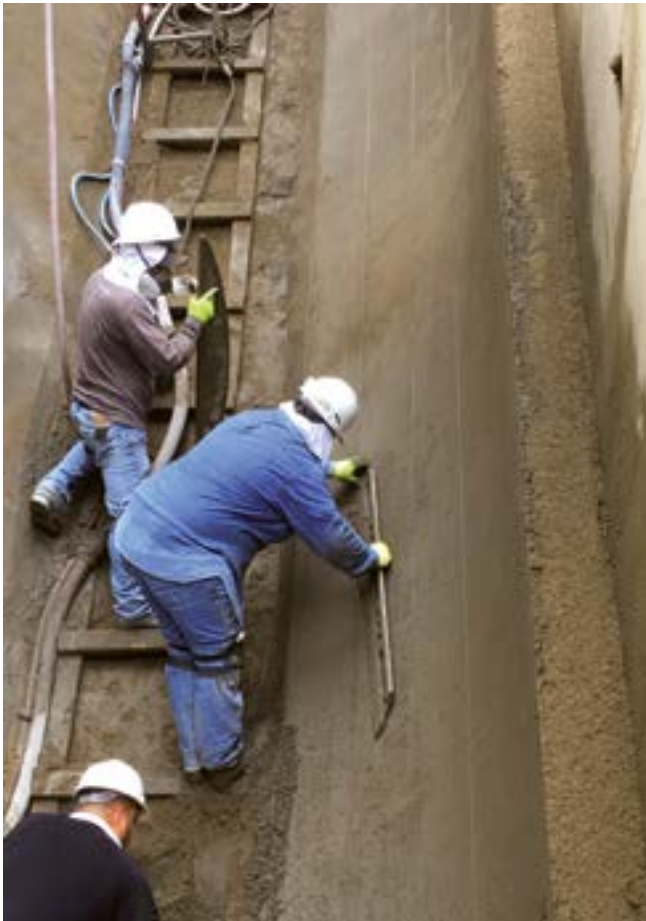
Fig. 3: Careful trimming of the sides

WI and SSG proceeded to work on repair of the next screw pump following the same procedure as the first one, building the shotcrete to the final finish elevation this time. SSG chose a specific pattern for the shotcrete placement that would ensure accuracy while maintaining production (Fig. 3). It would be easier to manage rebound and work from the top to the bottom of the screw, but the bottom is where all the rebound and water could accumulate, making it difficult to clean with the uneven surfaces from the demolition. The bottom sides were shot first (Fig. 4), along with the bottom middle on the setup day, but only up about 4 ft (1.2 m) to make rebound cleanup easier. Then SSG moved back to the top right, shooting about 10 ft of one side leaving a 3 ft

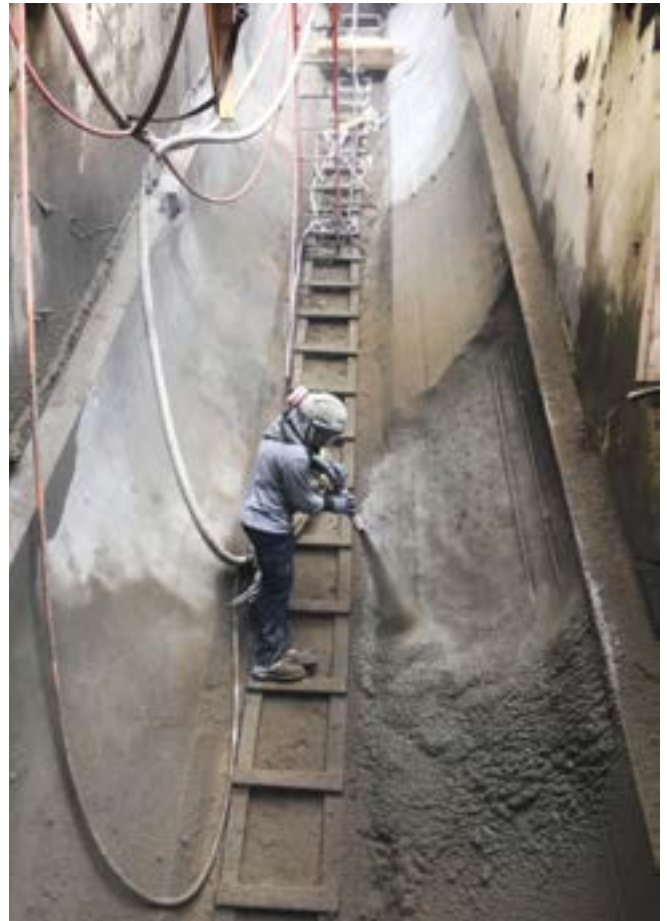
Fig. 4: Shooting side of basin off middle strip

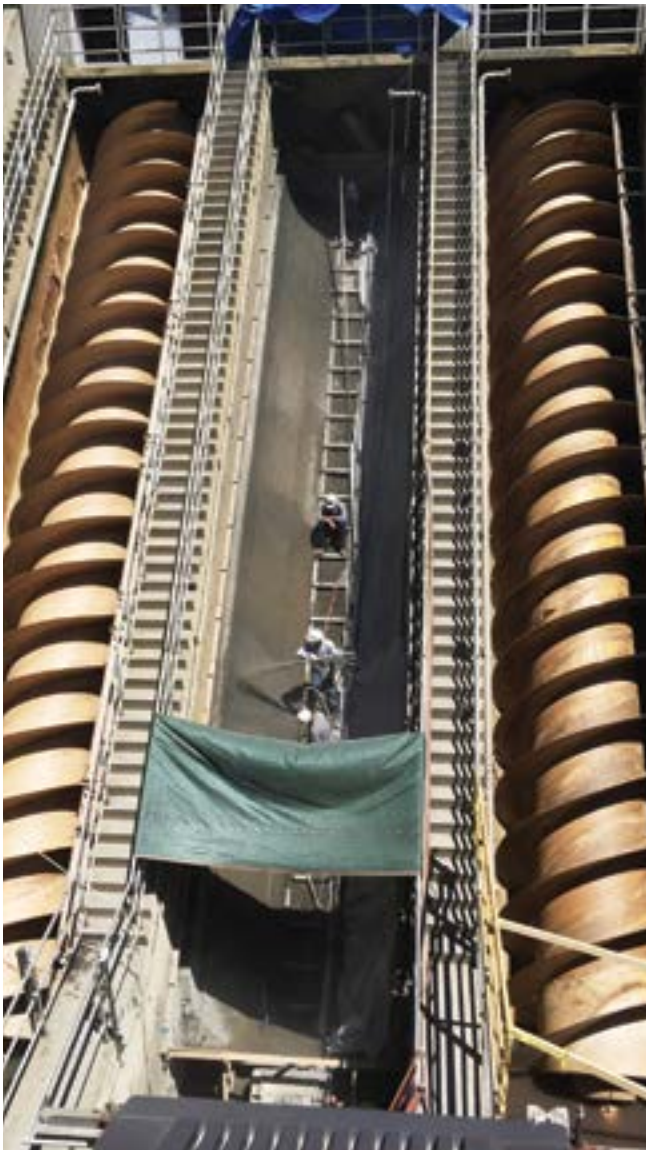
Fig. 5: Overview of shooting the basin with access down the middle

(0.9 m) gap in the middle to provide us an area to walk in for finishing (Fig. 5). SSG then proceeded down from there, occasionally jumping from one side to the other, and skipping small areas where it had guidewire supports. The checkerboard-like pattern kept things moving so overspray was not hitting the finishers and SSG could work in smaller more manageable areas to ensure accuracy. The overall shooting process took 5 days to complete for one screw pump shaft. SSG hung a rubble bucket from a telehandler and set it to bucket down into the hole right where the rebound accumulated, so rebound management was relatively easy and saved the crew from manually carrying buckets of rebound.
