# 2005 Outstanding Underground Project: The Center for National Response

by Henry A. Russell, Jr.

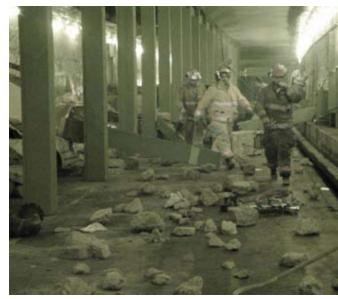
Collapsed tunnel training area

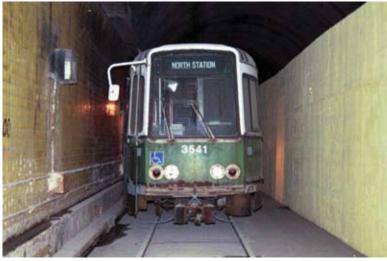
Subway section training area

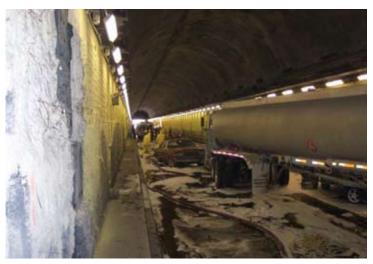
Highway incident training area

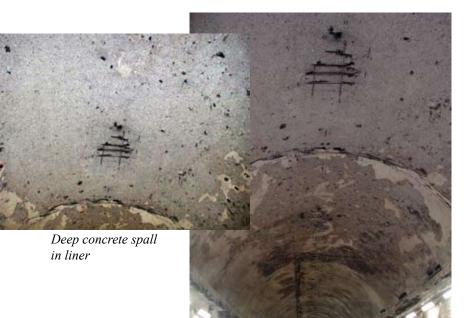
Typical structural damage from fire tests

During the test program, a fire pot was installed in the tunnel, affecting approximately 400 linear ft (122 m) of tunnel arch that has severe spalling and delamination due to the intense heat of the tests. In these areas, the tunnel arch has undergone severe stress as a result of the thermal activity, and the ultimate strength of the concrete is in question. The loss of cross section of concrete in the arch places unusual load on bedrock, which is one of the areas that required additional support during construction. The reinforcement that was exposed has not buckled or failed. This spalling has occurred in two distinct areas and must be repaired to maintain the long-term structural integrity of the tunnel. The best method to reinstate the tunnel lining in the arch is to apply wet-process shotcrete using fibers to provide additional strength. New reinforcing steel is also required and, in combination, will provide for a suitable long-term monolithic repair.

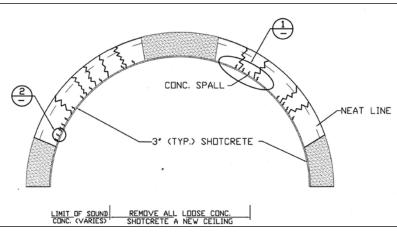
Typical tunnel liner shotcrete bands

The concrete arch cracking required the structural integrity of the arch to be restored. This required placing a series of reinforced shotcrete bands on the interior of the tunnel liner form springline to springline of the arch to transfer the compression load of the arch to the vertical walls of the tunnel.

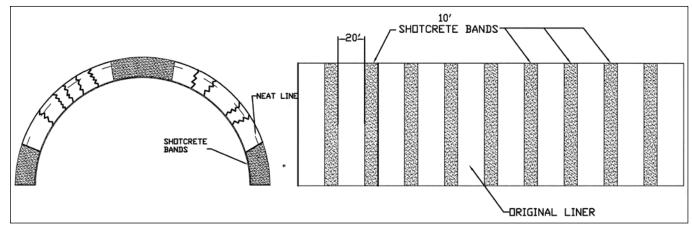
Layout of tunnel liner shotcrete bands
