## Tests of Corroded Steel Beams Restored with Guniting

### Beams with Plain and Reinforced Encasement Tested in Comparison with Bare Beams—Bond Found to Be Excellent

## Steel Viaduct to Be Reinforced by Encasement

Corrosion of Plate Girders Carrying High St. Over Railroad Tracks in Columbus Necessitates Strengthening

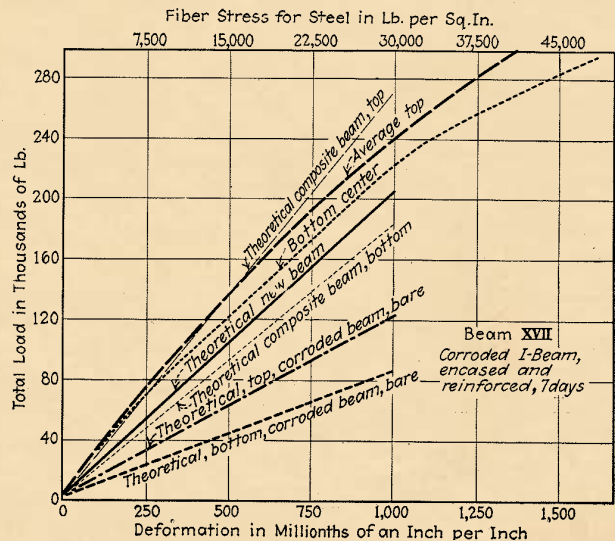
Fig. 3 shows the load-deformation curves for this same I-beam together with theoretical curves, for comparison. The unit stresses are computed on the basis of  $E = 30,000,000$  lb. per sq. in. The bottom readings were taken directly on the structural steel.

FIG. 3—COMPARATIVE STRESS CURVES, REINFORCED BEAM XVII

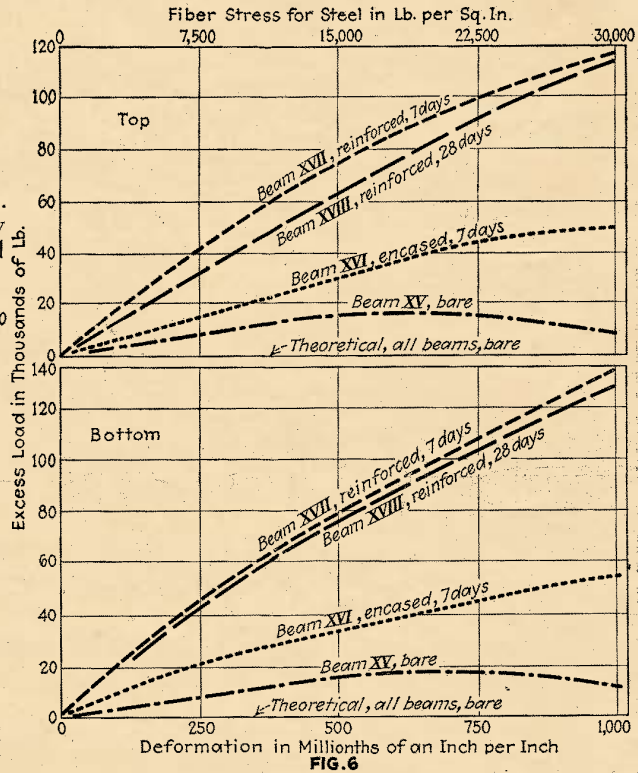
FIGS. 5 and 6—EXCESS-STRENGTH CURVES FOR I-BEAMS AND PLATE GIRDERS

Figs. 5 and 6 summarize the curves for all the tests. They show the excess-load curve for each test beam in comparison with that of its own theoretical bare corroded beam as computed from the caliper notes.

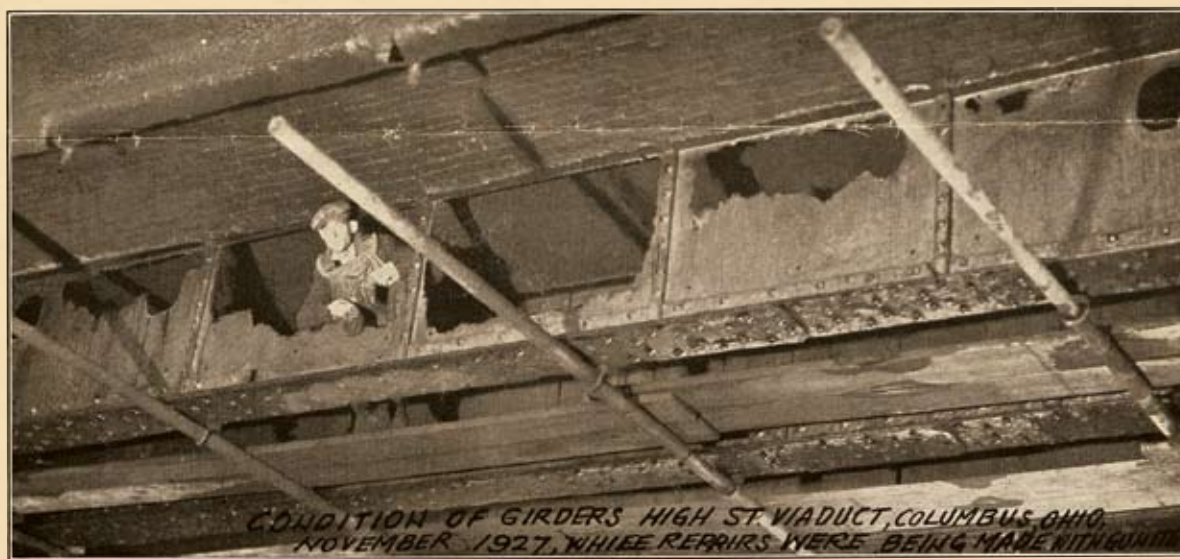
Fig. 1. Condition of girders, High St. Viaduct, Columbus Ohio, November, 1927, while repairs were being made with "Gunite"

steel has caused serious deterioration, resulting in heavy expense for maintenance. In 1912 a careful investigation showed that the flange plates and the stiffeners of many of the girders were greatly reduced in cross-section and the web members of some of the girders were rusted through. Following this inspection, the badly rusted girders were strengthened by the addition of new flange plates, stiffeners and web plates.

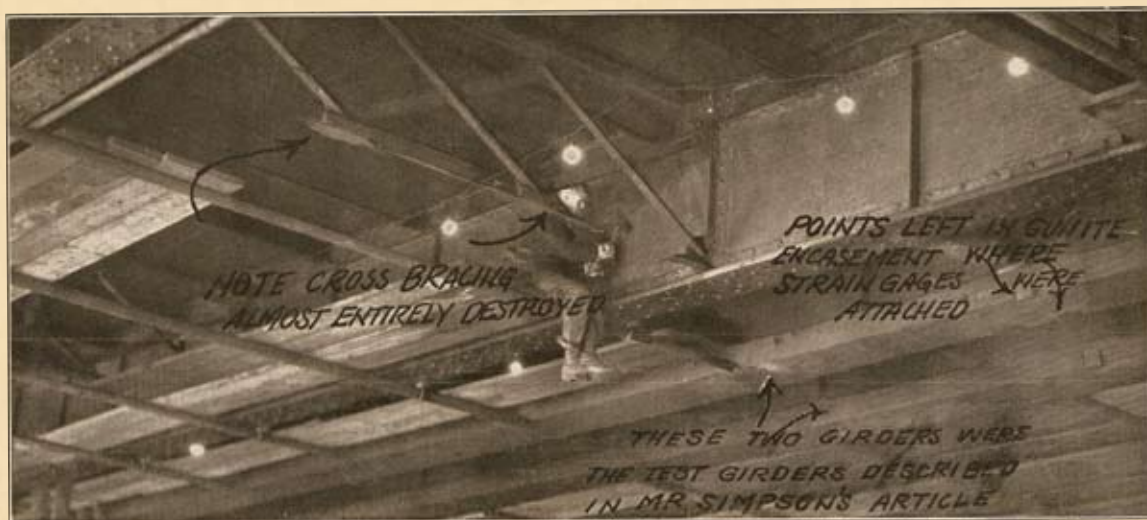
Fig. 2. Shows test girders described in Mr. Simpson's Article. Also note Cross Bracing almost entirely destroyed.

Notwithstanding the successful results of these tests at Ohio State University, it was felt that this method of strengthening should not be adopted for the High St. viaduct without some further investigation as to its effectiveness when applied to the field under adverse conditions. It was therefore proposed that some tests be made on two girders of the High St. viaduct, in order to check, if possible, the results obtained on the encased I-beams tested in the laboratory. An appropriation was secured to carry on this field test. Careful caliper measurements of the actual cross-section of the two girders were made at intervals of about 5 ft., and with these measurements as a basis the reinforcing and the gunite encasement were designed to provide the re-

quired strength. Before and after encasement a test load of motor trucks was placed over the two girders and the deflections and tension in the bottom flanges of these girders measured. The results showed that the reinforcement and encasement had stiffened the girders enough to reduce deflections under live-load about 11.6 per cent and reduce the live-load unit stresses about 13.5 per cent.
