Shotcrete for Structural Repair of Key Light Rail Facility in Boston

by Henry A. Russell Jr.

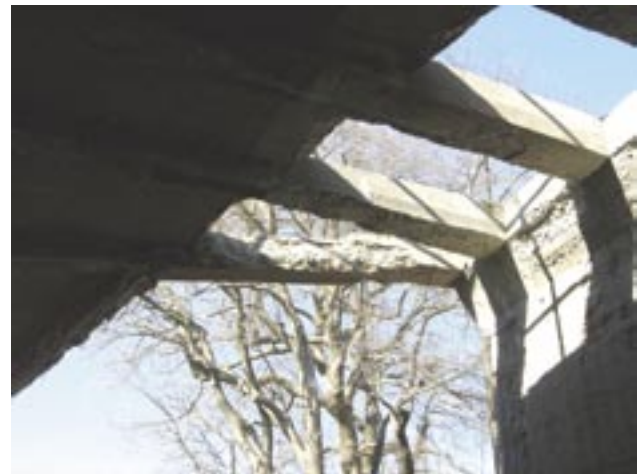
The inspection indicated that the structure was in very poor condition. In numerous places the reinforcing steel was exposed, and on the western side of the flyover the structural beams supporting the track had virtually lost their supporting seats. In addition to the severe deterioration of the floor beam concrete, the abutment retaining walls had extensive delamination and

Typical deterioration of the supporting floor beams on the western side of the flyover

Based on the restraints for rail operations, jogging path, and the cemetery, it was decided to repair the structure using a high-performance shrinkage-compensated, synthetic micro-fiber-reinforced, prepackaged shotcrete applied by the dry-mix shotcrete process. The selection of shotcrete over cast-in-place form and pour concrete was selected because clearances for the jogging path prohibited the use of forms. It was further decided to use hydrodemolition to remove the unsound concrete. The areas to be repaired were identified at the beginning of the project by sounding and were marked out with orange paint.

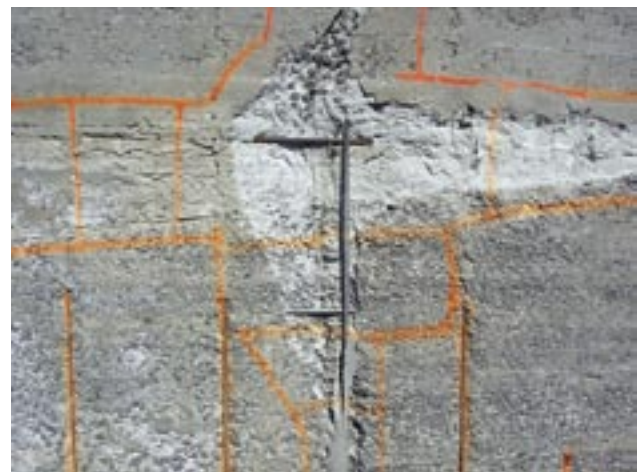
Typical cold joint with exposed reinforcing steel. Orange paint indicates limits of delaminations

spalling. The delaminations appeared to be concentrated in the vicinity of construction cold joints that had experienced leakage. At many of these locations, the reinforcing steel was exposed. Approximately 50% of the structure required repairs.

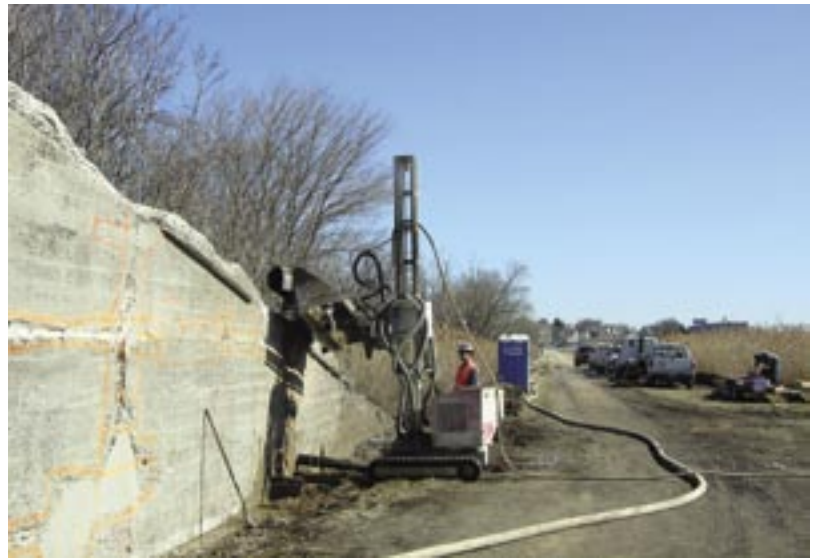
Hydrodemolition robot preparing to remove unsound concrete

Hydrodemolition using 30,000 psi (207 MPa) water pressure was selected due to the ability to control the removal of unsound concrete and minimize the period of time required for surface preparation. The specifications required the use of a robotic machine to remove the unsound concrete. The use of a robotic machine facilitates rapid concrete removal while minimizing the quantity of water required. In areas where the robotic machine was unable to reach, hand wand hydrodemolition equipment was used. The hydrodemolition equipment also removed all rust and scale from the existing reinforcing steel. The water used for the demolition was recycled and reused.

The robotic machine was calibrated on site to remove only the concrete with strength of less than 2000 psi (14 MPa). During the project, the extent of delaminations was greater than originally expected and, in some cases, repairs were as deep as 10 in. (254 mm).

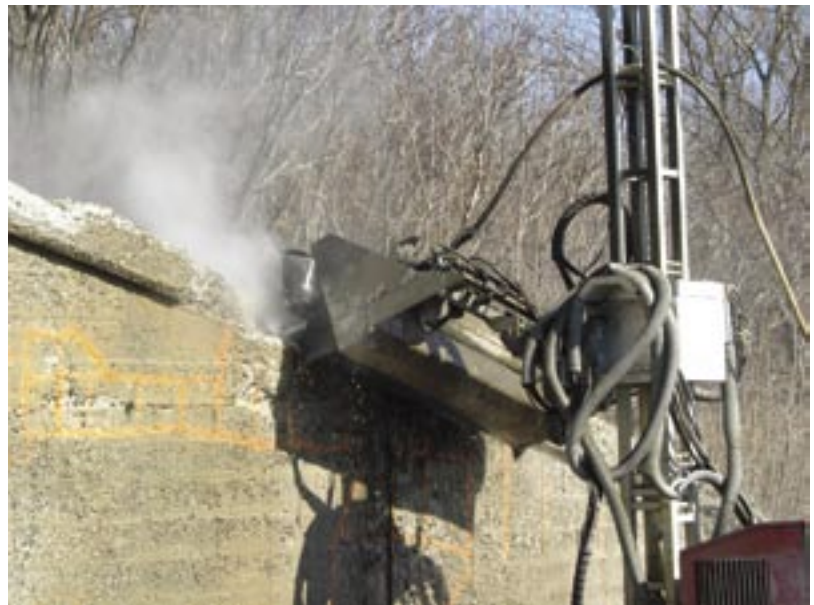
Hydrodemolition robot removing unsound concrete

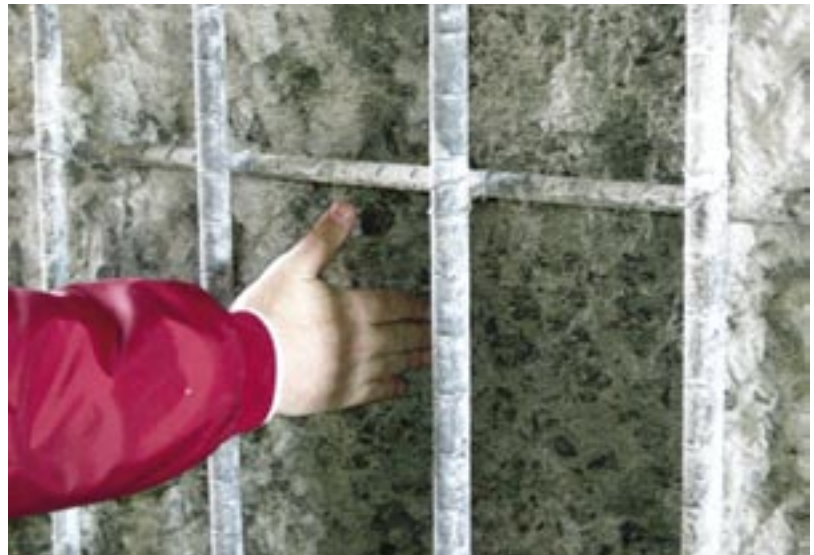
Deep repair after removal of unsound concrete

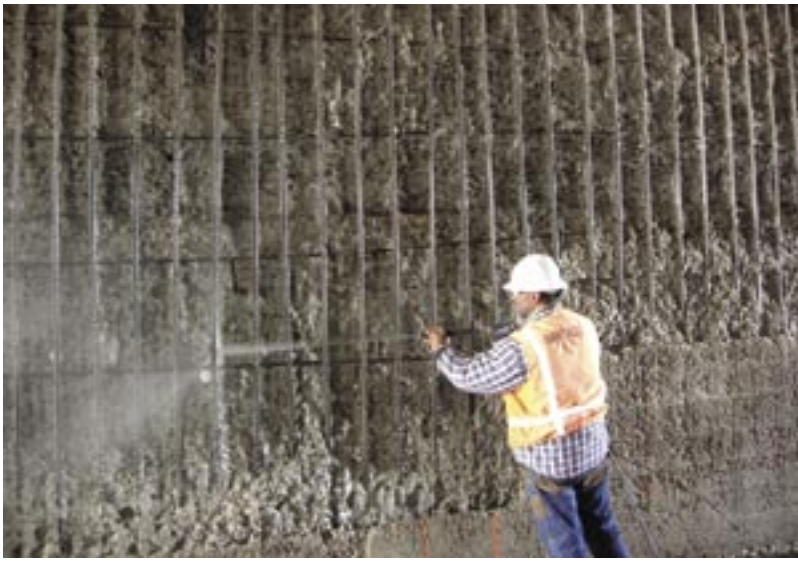
Final surface preparation

After hydrodemolition, the surface was cleaned with a high pressure power washer and the welded wire mesh and corrosion inhibitors were installed.

Proper surface preparation of the substrate was critical for proper bond of the shotcrete. The power washer was also used to premoisten the substrate. A dry process Reed Shotcrete gun with a 175 CFM compressor was used to apply the shotcrete. The majority of the work was performed from a man-lift.

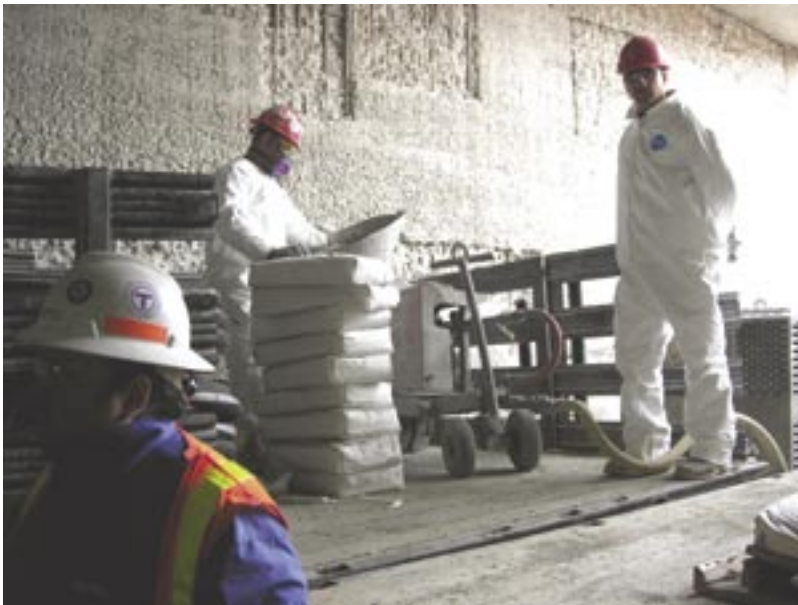
Shotcrete machine with prepackaged shotcrete

The design required strict quality control and a shotcrete that would be shrinkage compensated and produce a high compressive strength due to the rail loadings on the structure. A prepackaged shrinkage-compensated, synthetic micro-fiber-reinforced, cement-based shotcrete was selected for the project. The material had the qualities shown in Table 1.

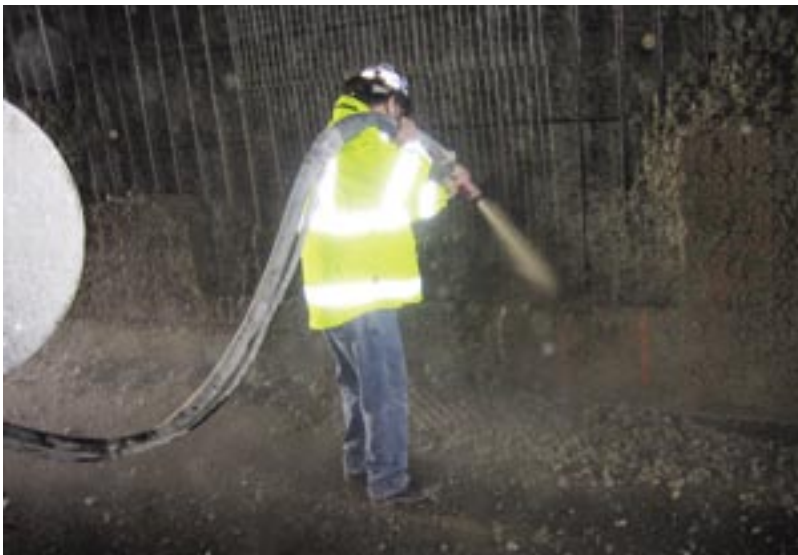
Installation of shotcrete over welded wire mesh at test section

creation of a galvanic cell between the new concrete and the existing structure. Therefore, the design required the use of galvanic corrosion inhibitors to be attached to the welded wire fabric approximately 30 in. (762 mm) on center around the perimeter of the repair and in the interior in areas of large repairs.

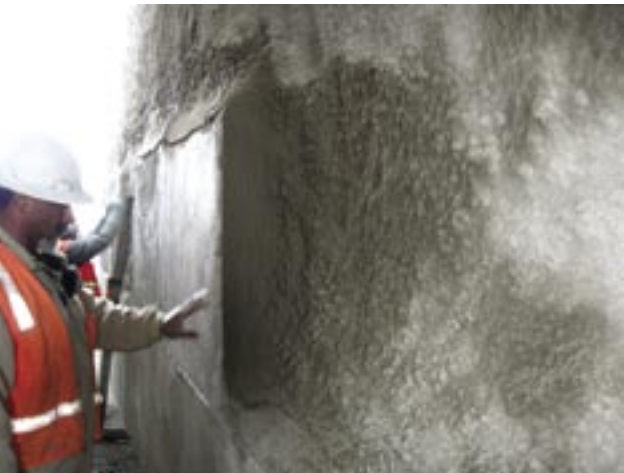
Final finishing of the shotcrete repair. Note the 8 in. depth
