Structural Shotcrete Overhead

by Warren Harrison

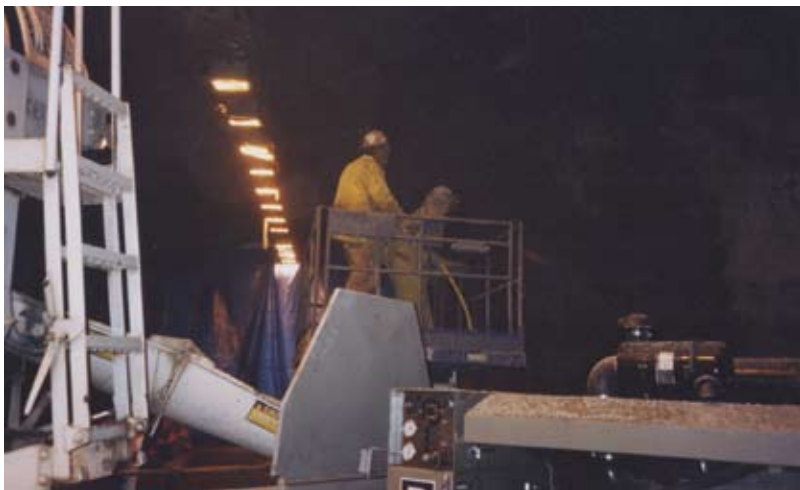
Shotcrete was used to repair existing highway tunnels on Highway 6, west of Denver, CO, for the Colorado Department of Transportation. Deteriorated portions of the tunnel were reinforced with rock bolts and then covered with 2 to 3 in. (50 to 75 mm) of steel fiber-reinforced shotcrete. This was done with the roadway shut down to traffic for a 2-week period during the shotcrete application. The surface was prepared using an air/water blowpipe to remove exhaust residue (Fig. 1).

Fig. 1: Colorado Dept of Transportation Highway 6, Denver, CO

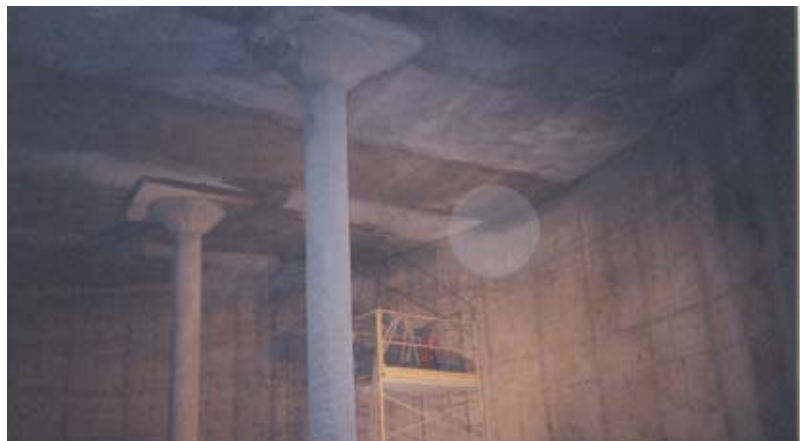
For the Eagle River Water District at Vail, CO, the roof of a water tank on the side of a ski mountain was repaired by shooting dry-mix shotcrete on the bottom side of the roof of a 50 ft (15 m) diameter by 20 ft (6 m) high water tank. The shotcrete was added to the roof to provide corrosion protection for the existing mat of reinforcing bar. Dry-mix shotcrete was used for this project, as no means were available for delivery of wet-mix shotcrete. A two-ton truck hauled bags of shotcrete material above the tank. The bags were lowered in a controlled slide down into the tank. Water was also trucked to the site. The roof was prepared by sandblasting the exposed reinforcing steel. Shooting wires were installed to help control the thickness of the shotcrete applied to guard against overstressing the roof by adding too much additional dead weight. After completion, the tank was disinfected and put back into use (Fig. 2).

Fig. 2: Roof of water tank, Vail, CO

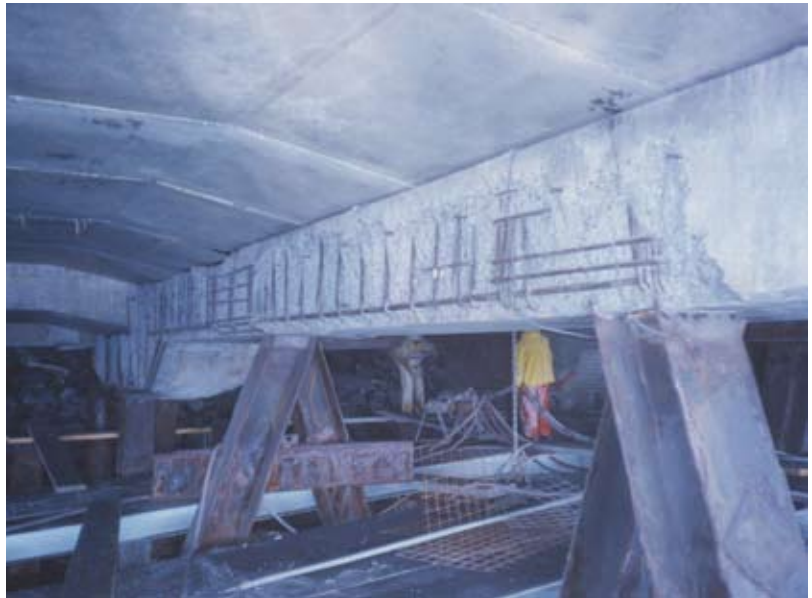
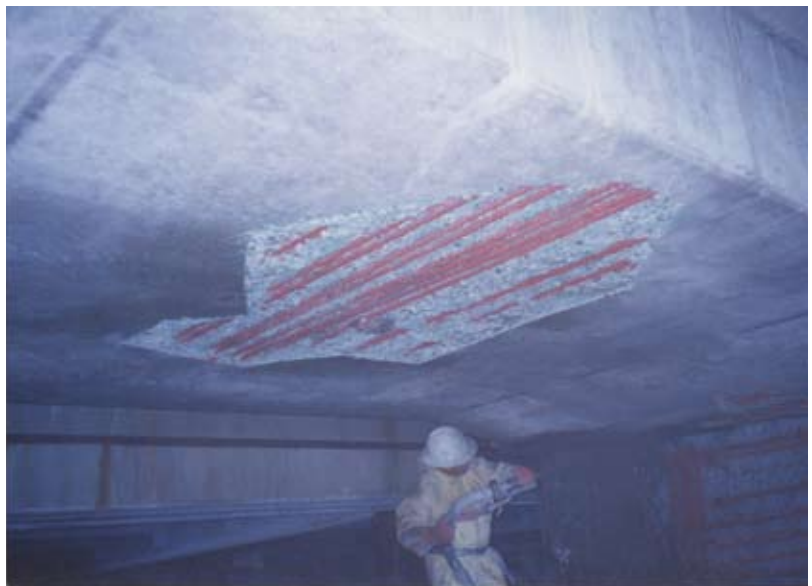
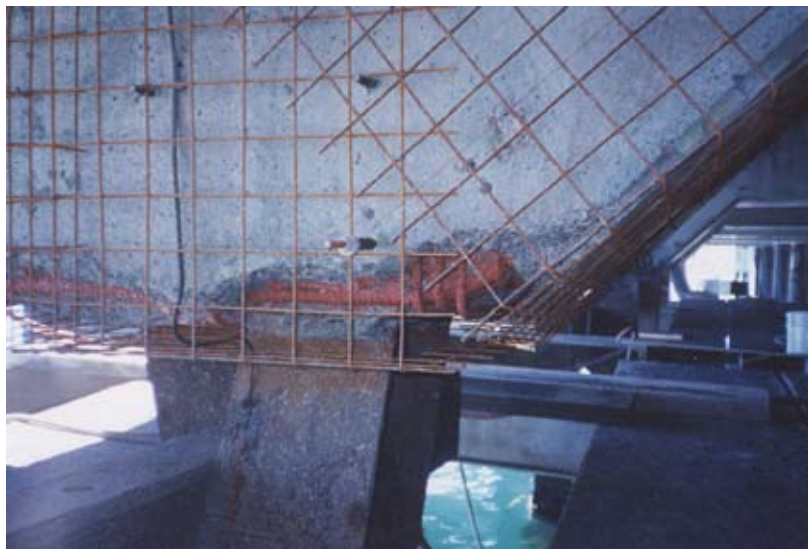
A container ship pier owned by the city of Kodiak, AK, was showing severe corrosion on 13 supporting girders. The repair scheme selected involved removal of deteriorated concrete down to the corroded reinforcing steel and sandblasting the reinforcing with a corrosion-resistant material. Next, the remaining sound concrete was sandblasted and a coat of a penetrating corrosion-inhibiting material (calcium nitrite) was applied. The surface was then reconstructed with new shotcrete containing silica fume and the corrosion inhibitor. This provided an additional protective cover of shotcrete 4 in. (100 mm) thick (Fig. 3 to 5).

Fig. 5: Container ship pier project, Kodiak, AK

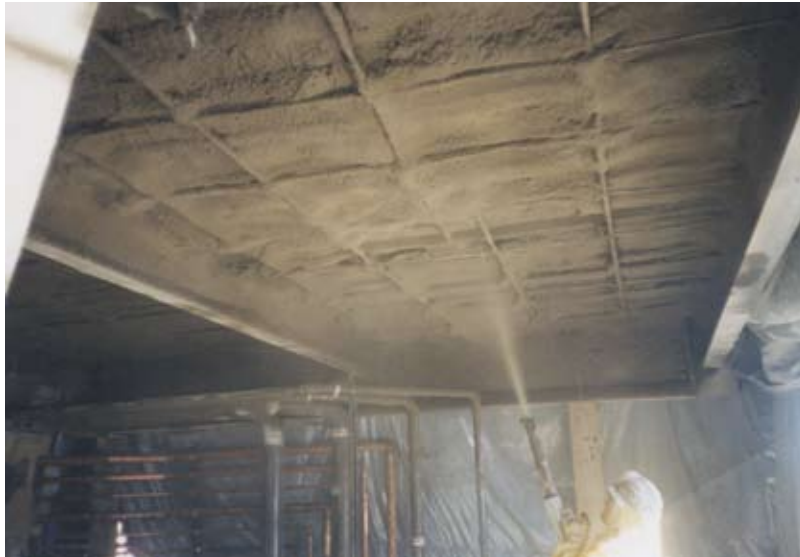
For the Pueblo Hospital in Pueblo, CO, we added 4 in. (100 mm) of shotcrete to a room ceiling, providing additional radiation shielding in the recovery area of a new hospital wing. The material was shot in the winter with dry-mix shotcrete. Adding diatomaceous earth to the pre-bagged dry-mix material enhanced the density (Fig. 6).

Fig. 6: Hospital roof, Pueblo, CO

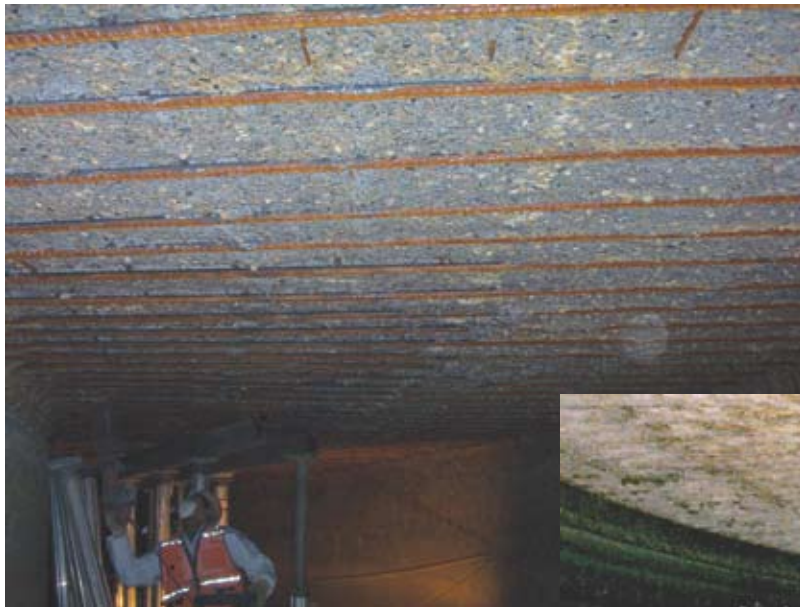
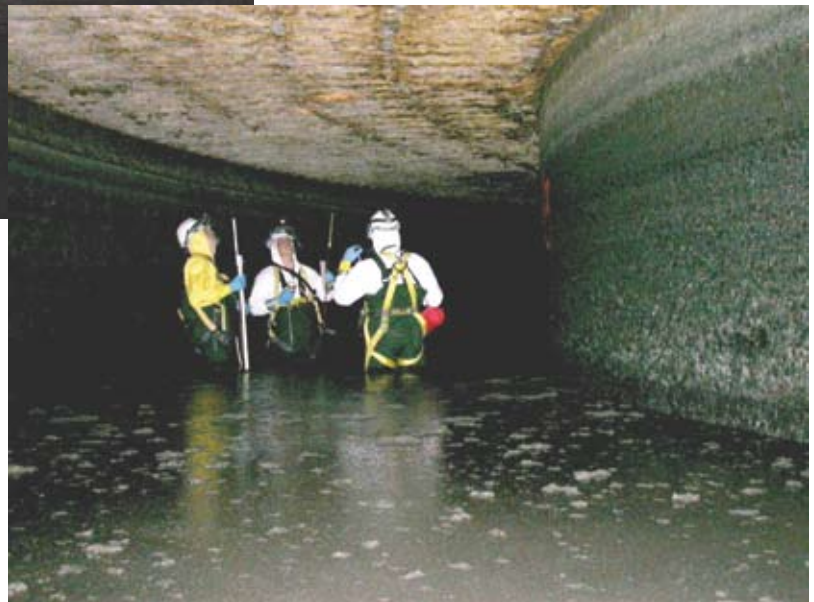
Fig. 7: Box tunnel roof repair

Another project required repairing nearly 600 ft (183 m) of a box culvert roof with 140 yd³ (107 m³) of shotcrete reinforced with wire mesh. Some areas had to be reinforced with No. 9 bars. Roof deterioration was caused by chemical attack from sewage. The repair had to restore the structural integrity of the box tunnel roof. The design engineer specified that the roof be covered with 2 to 6 in. (50 to 150 mm) of shotcrete. The shotcrete was placed by pumping from the surface down 20 ft (6 m), 250 ft (76 m) horizontally within the tunnel, and shot overhead. The shotcrete mixture was enhanced with silica fume to increase the material adhesion for shooting overhead (Fig. 7).
