# Outstanding Shotcrete Project Award Winner

## 2006 Outstanding International Project

# Reform and Expansion of Bridgetown Port

Bridgetown, Barbados, BWI

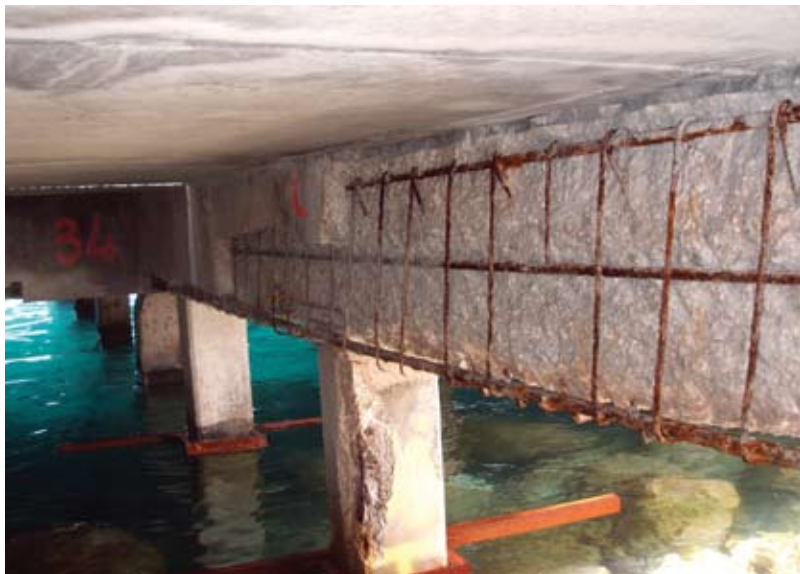
Continuous exposure to salt water had caused corrosion of the reinforcing steel and resulted in severe deterioration of the concrete throughout the facility (Fig. 1). Concrete removal exceeded 6 in. (150 mm) in depth in many areas. Delcan elected to specify shotcrete to replace the deteriorated concrete that was removed from berths, wharfs, and concrete dolphins. Delcan engineers were familiar with shotcrete from previous projects that

Fig. 1: Severely deteriorated concrete beams (after concrete removal)

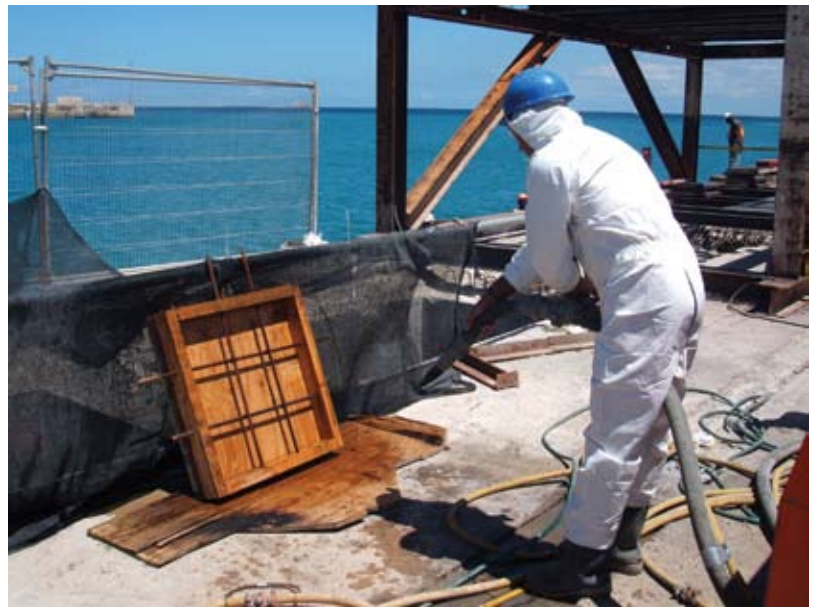
A shotcrete nozzelman, with years of experience on concrete rehabilitation projects, was brought in from the UK. He shot test panels, using the approved shotcrete mixture, under the supervision of both King and Delcan personnel. Test panels were evaluated by Delcan QC personnel and resulted in the nozzelman being approved to work on the project (Fig. 2).

*Fig. 2: Nozzelman preparing to shoot on-site test panels*

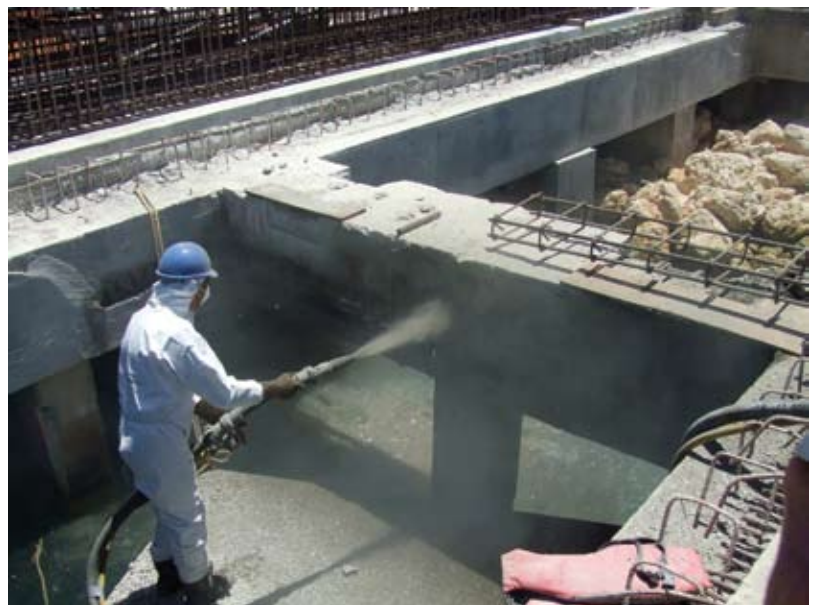
Concrete removal was conducted using a combination of air hammers and hydrodemolition. On the wharf rehabilitation section of the project, the nozzelman was able to access concrete beams and columns located under the concrete slab and the underside (soffit) (Fig. 3). The shotcrete hoses ran from the shotcrete machine, which was stored with the prepackaged materials on the top of the slab, to the nozzelman who was positioned below the slab, just above the surface of the water (Fig. 4).

*Fig. 3: The shotcrete hoses ran from the shotcrete machine, which was stored with the prepackaged materials, on the top of the slab to the nozzelman who was positioned below the slab, just above the surface of the water*

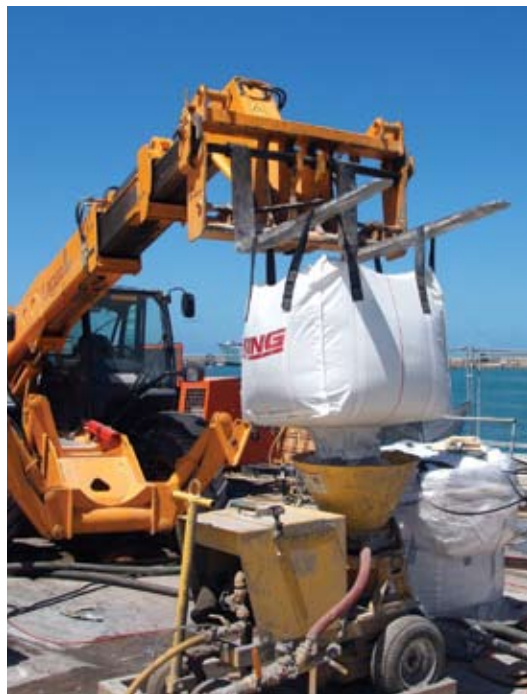
*Fig. 4: Shotcrete machine and bulk bags containing the preblended materials were positioned on the top of the slab while shotcrete was applied underneath*

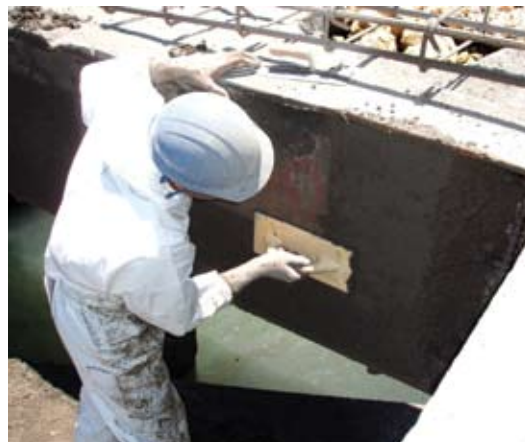
*Fig. 5: Finishing had to be completed quickly because of the affect that hot temperatures had on the plastic properties of the shotcrete mixture*

The anti-washout characteristics provided by the silica fume also allowed the nozzelman to shoot material until the tidal actions prevented him from continuing. Shotcrete eliminated the need for costly forming applications and allowed the general contractor, Lagan Holdings Ltd., to accelerate the repair process and meet the schedule demands. Finishing had to be completed quickly because of the effect that hot temperatures had on the plastic properties of the shotcrete mixture (Fig. 5). Curing procedures began as soon as possible after shooting to prevent surface cracking caused by drying shrinkage.

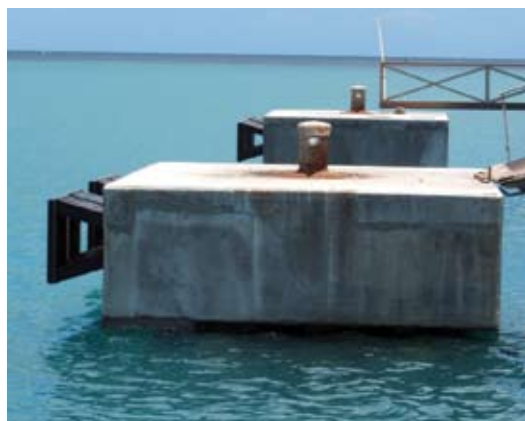
Large concrete dolphins, used to moor large cargo ships, also required substantial rehabilitation. Spalling, caused by corroding reinforcing steel, was extensive, and substantial amounts of concrete were removed. The flexibility offered by shotcrete again allowed Lagan personnel to store all materials on the surface concrete slab and run hoses to the nozzelman who stood on a floating raft to access the vertical sides of the dolphins (Fig. 6).

*Fig.6: Concrete dolphins after shotcrete was placed and finished*
