Shotcrete Repair of Auditorium Plaza Garage

by Mike Land and
Richard R. McGuire

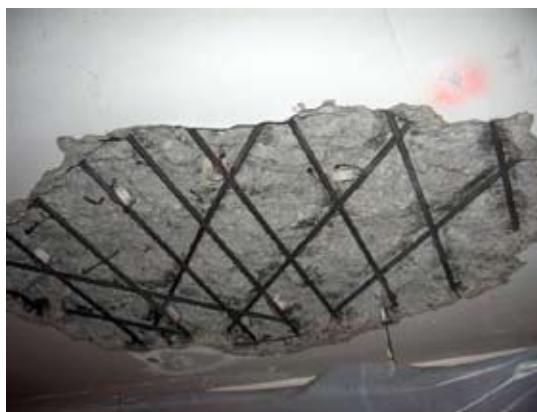
Prepared repair area with galvanic anodes

After the concrete was removed and the detail chipping complete, the repair areas were sandblasted with an emphasis on the heavily rusted reinforcement steel. The repair specifications called for a protective corrosion-inhibiting coating applied to all exposed steel, along with the installation of 13,500 galvanic anodes at 18 in. (457 mm) on centers. This is a great repair for reinforcing steel to slow down the deterioration process and extend the useful life of the structure. This presented a couple of technical challenges for the crew. The galvanic anodes had to be attached by small wires to the structural steel to exert a

slight electrical charge on reinforcing steel to be effective. The corrosion coating was an epoxy and would negate this electrical connection if applied before or on top of the anode wires. The crews had to predetermine all locations for anodes and mask off the connection locations before shooting the corrosion coating. After installing the anodes, the electrical charges were verified using voltage meters.

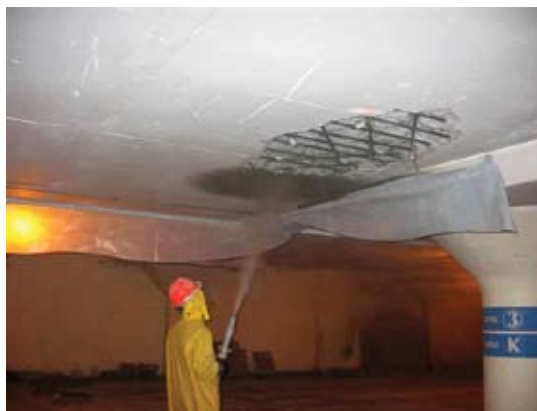
Dry-process shotcrete during placement overhead

The last step in the process was to install the shotcrete. The original specifications called for dry-process shotcrete using a prepackaged bag repair material. After reviewing the data sheets for these materials with the structural engineer, it was determined that most of the prepackaged bag materials have a silica fume admixture in them. Manufacturer's testing has shown that the presence of silica fume in the repair material increases resistance to the electrical current of the galvanic anodes. Mid-Co proposed an old-fashioned time-proven mixture design consisting of the bare essentials—portland cement and sand aggregate. The design was mixed at a ratio of four parts sand to one part portland cement by mass. This would meet or exceed the engineer's design criteria for compressive strength. Core testing of shotcrete panels verified the test results. Shotcrete test panels were shot every morning before production shooting for testing and documentation of shotcrete quality.

Mid-Co installed approximately 150 tons (136 tonnes) of dry-process shotcrete overhead into an area of approximately 20,450 ft² (1900 m²). The patching consisted of over 600 separate locations, and was spread out over 12 different quadrants. Some of the patches were over 500 ft² (46 m²) each, and required the shotcrete nozzlemen to shoot two and three patches at a time. This would allow the finishers enough time to screed and finish the bigger patches in phases. The shotcrete was finished with rubber floats to
