Shotcrete Shines in Parkade Repair

by Neil McAskill

In 2005, BC Ferry Services Inc. undertook a program to repair corrosion deterioration of the parkade slab at their Horseshoe Bay ferry terminal near Vancouver, BC, Canada. Although the cast-in-place slab was marginally protected by a deteriorated traffic membrane, the use of deicing salt on the slab during winter months resulted in significant chloride-ion contamination and corrosion-induced spalling of the soffit and delamination of the surface concrete.

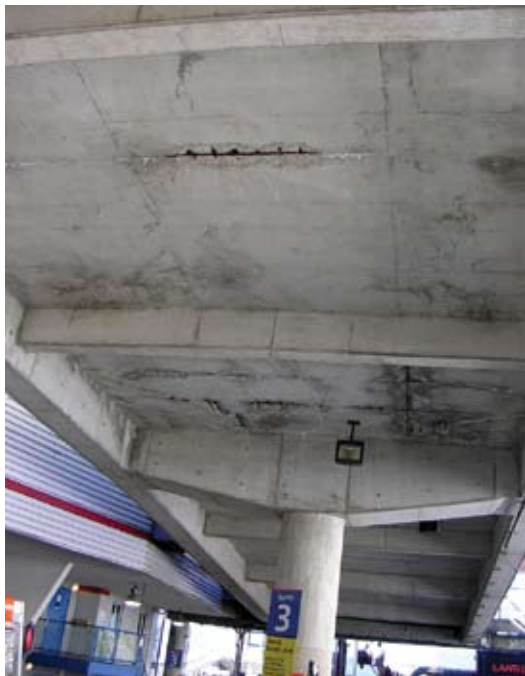
One of the repair areas prior to intervention. Note the extensive spalling

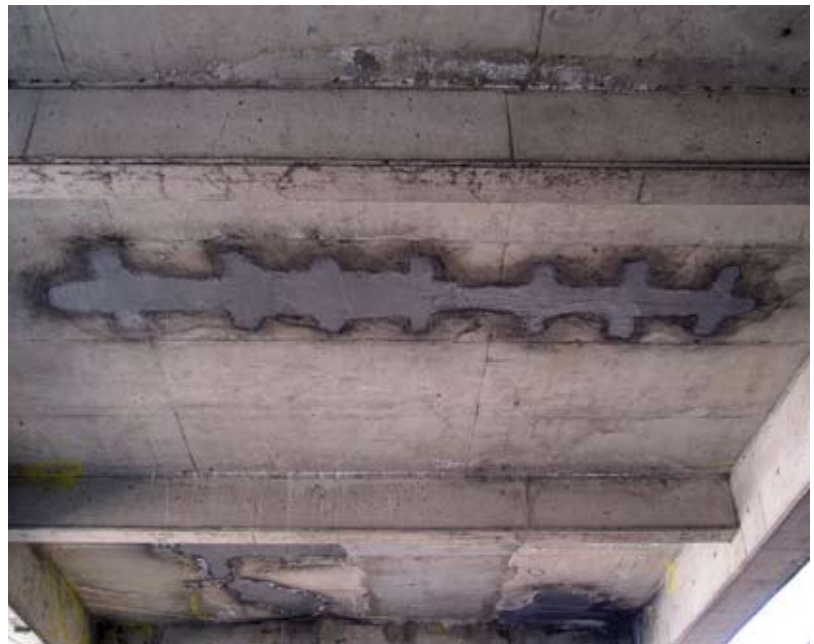
The same area shown in the first photo, after repair. The pattern of the shotcrete in the foreground is where additional concrete was removed to get sufficient development length for the new reinforcing steel that was added

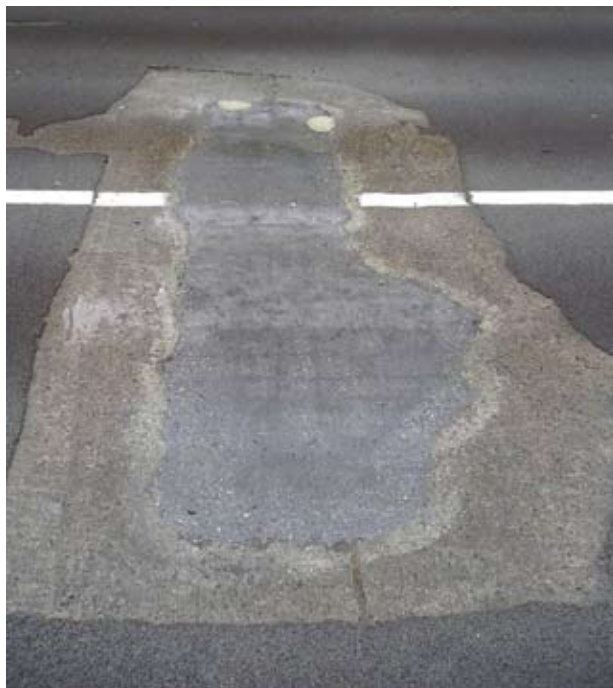
The top formed side of a typical through-patch. The light spots at the ends are where small voids were repaired

Quality control of the shotcrete application included inspection of the patches, particularly the upper surface where any shadows behind reinforcing steel would be noticeable, and extraction and testing of cores from test panels shot during the course of the work. In some cases, small voids were noted around the perimeter of the patches where there was a congestion of reinforcing steel. These areas were chipped out with 2.2 lb (1 kg) air hammers and patched with polymer concrete.

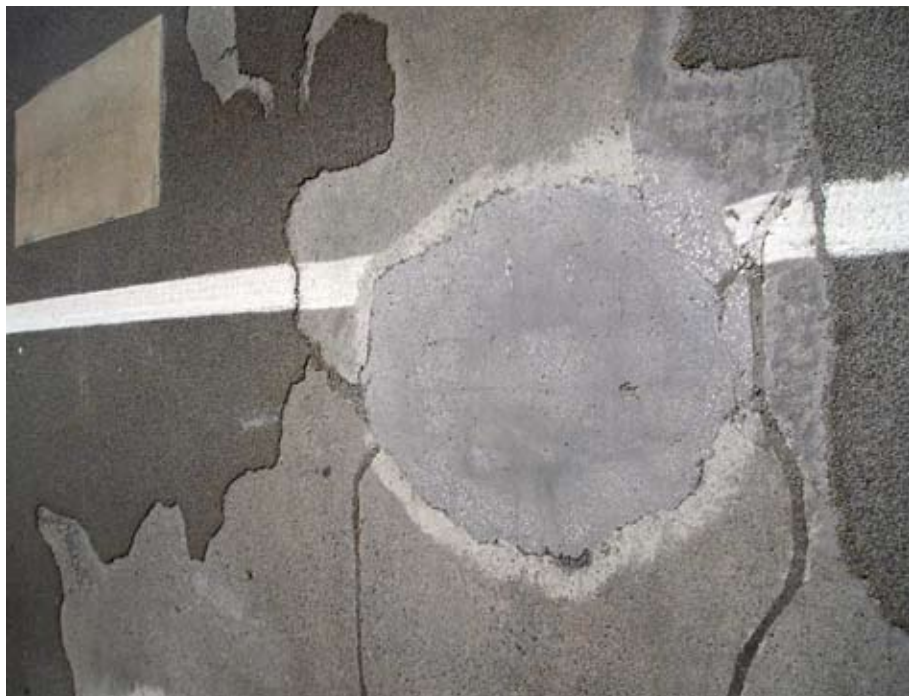
Another typical through-patch from the top formed side

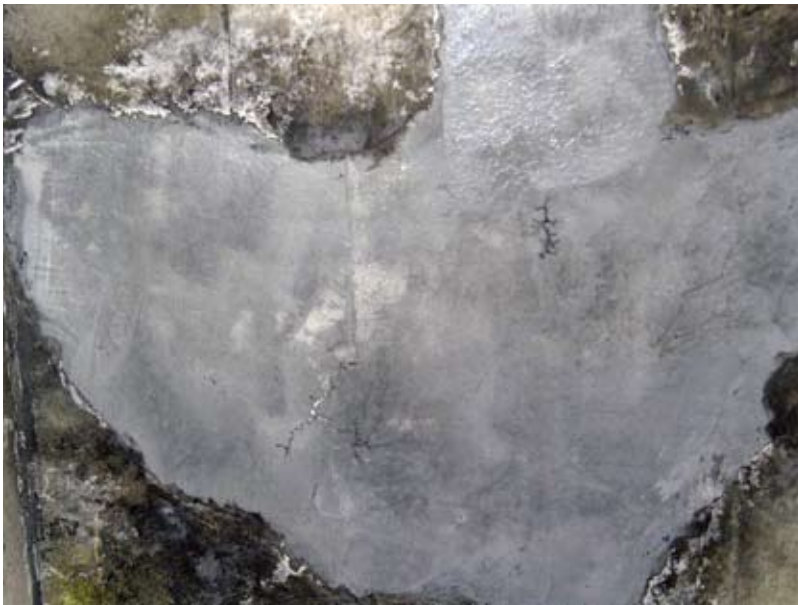
A typical patch from the bottom. Some minor restrained shrinkage cracking was noted in both the shotcrete and the cast-in-place patches
