Nondestructive Testing Verifies Quality of Repair

Assessing a Fire-Damaged Garage

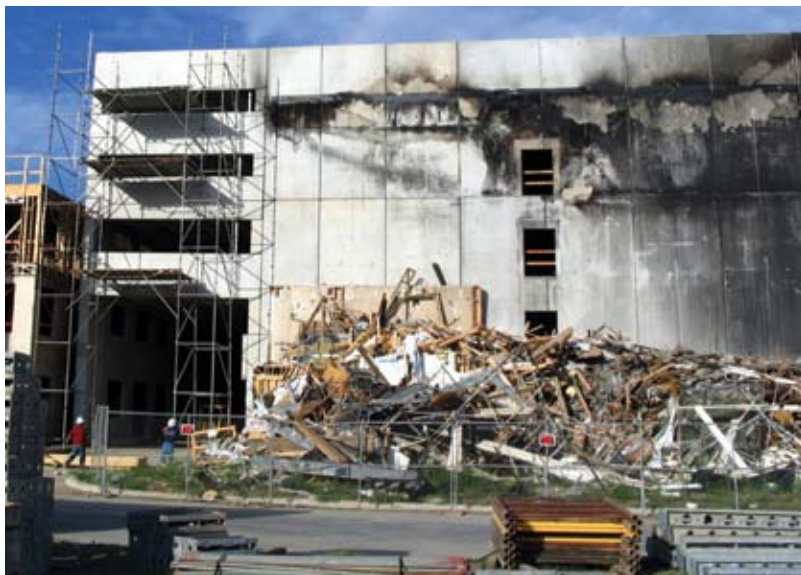
Overall view of garage wall at entrance. Debris is still in place at the time of the site visit, preventing visual inspection of exterior surfaces of lower panels. However, NDT proceeded as planned from the interior surfaces

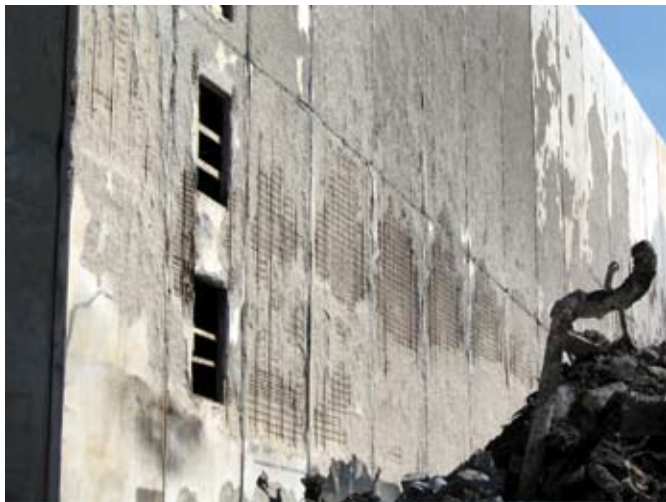
Overall view of portion of the garage where damage was severe and many panels were replaced. Only limited testing was conducted on these panels

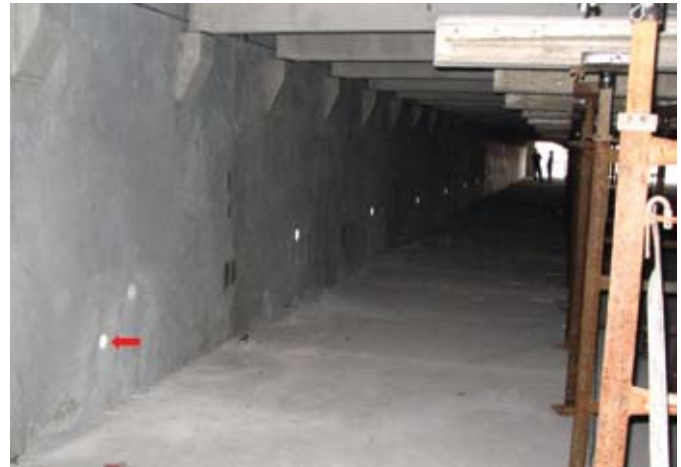
Overall view of typical interior panel faces. Core holes are visible. The inside faces of the panels were generally unaffected by the fire and provided an excellent surface to send and receive impulse signals

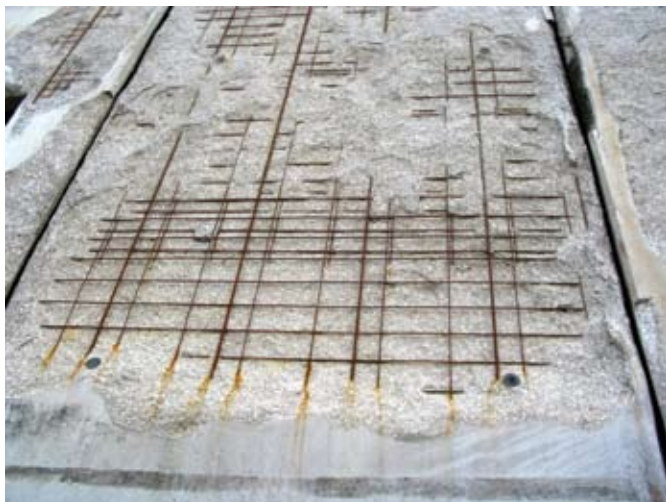
The garage was approximately 120 x 260 ft (37.5 x 73 m) in plan and contained six levels of parking. The garage walls consisted of 8 in.-thick (200 mm) precast concrete panels. The garage was surrounded by wood-framed condominiums that were still under construction when the fire occurred. The fire resulted in considerable cracking and spalling of the concrete at the exterior face of the precast panels.

The panels were precast of normalweight concrete about 2 to 3 months before the fire. At this early age, the panels still retained considerable internal moisture, and this moisture, when exposed to the fire's intensity and speed, contributed to the severe spalling exhibited by the structure. The garage walls were two panels high. The lower-level panels were reinforced with two layers of 4 x 4 in. (100 x 100 mm) W3/W3 WWF, and the upper level panels were reinforced with one layer of 12 x 6 in. (300 x 150 mm) W3/W5 WWF. The reinforcing bars were 60 ksi (414 MPa) grade bar.

Common degree of damage suffered at the precast panel exterior face due to fire. Spall depths of up to 2-1/2 in. (6 cm) exposing steel were not uncommon

of elasticity, and perform petrographic examinations. Finally, mechanical properties of the reinforcing steel were tested in accordance with ASTM A 370 “Standard Test Methods and Definitions for Mechanical Testing of Steel Products.” The combination of NDT and destructive laboratory testing yielded enough information for the team to develop the repair approach with full confidence. The repair plan addressed the need for surface preparation, removal of reinforcing steel in heavily spalled areas, and procedures to achieve adequate bond of the shotcrete repair material.

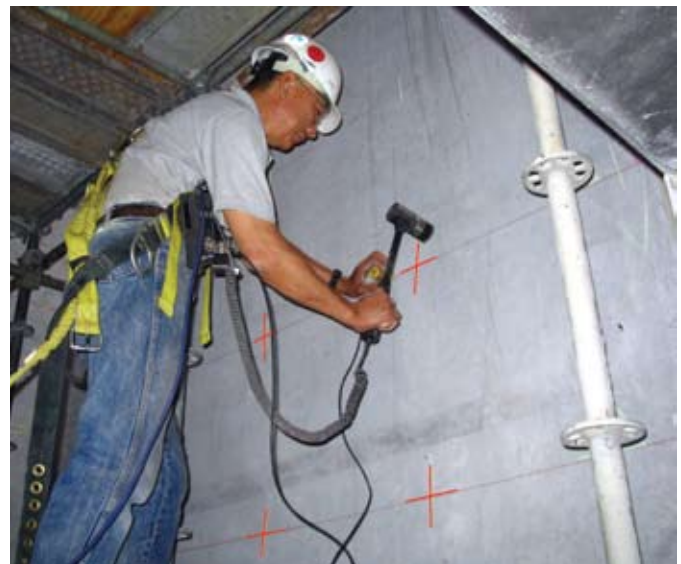
Impulse-response testing on the inside surface of the panel

The I-R method uses a low-strain impact to send a stress wave through the tested element. The impactor is usually a 2.2 lb (1 kg) sledgehammer with a built-in load cell in the hammerhead. The response to the input stress is normally measured by a velocity transducer (geophone). Both the records for the hammer force and the geophone velocity response are processed in the field computer to obtain a transfer function, referred to as the mobility of the element under test. The test graph of mobility plotted against frequency over the 0 to 1 kHz range contains information on the condition and the integrity of the concrete in the tested elements.

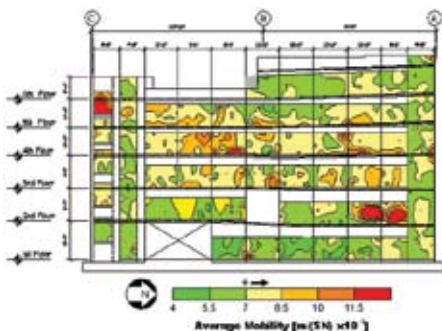
I-R plot of panels showing numerous areas of distress (yellow, orange, and red). Testing was performed on the inside surface prior to any repairs

The post-repair impulse-response test was performed after the repairs to the panels were completed. The impulse-response test was performed at the same test point locations of the previous test so as to compare the pre- and post-repair results. The post-repair results showed that the high mobility values recorded before the repairs (areas noted in yellow, orange and red on the pre-repair plot) were

no longer present, indicating that the repairs were satisfactory. The two I-R plots depict the mobility of the wall before and after the repairs.

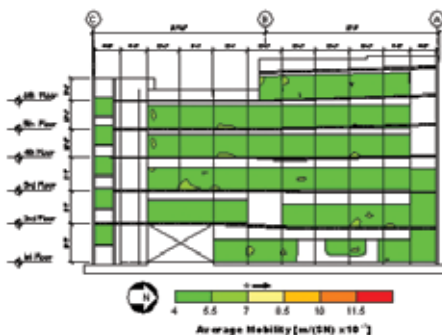
I-R plot of the panels after the repairs were performed. Plot showed uniform average mobility values. The high mobility values recorded before the repairs were no longer present, indicating that the repairs were satisfactory
