What's Wrong with This Picture?

by Ray Schallom III

Technical Tip

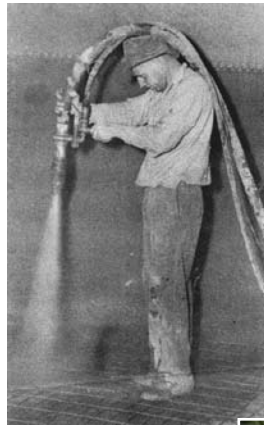
1. Clue: Safety and Application

1. The nozzleman is missing a respirator, safety glasses, gloves, and hearing protection. He is also holding the shotcrete hose incorrectly.
2. The nozzleman is not wearing gloves, a hard hat, safety glasses, or proper clothing to protect his skin from the shotcrete. The scaffold is not tied or anchored to the structure, there are no back rails in place, and he is standing on a plank of 2x4s with no fall protection. He is not holding the hose correctly due to the lack of scaffold boards.

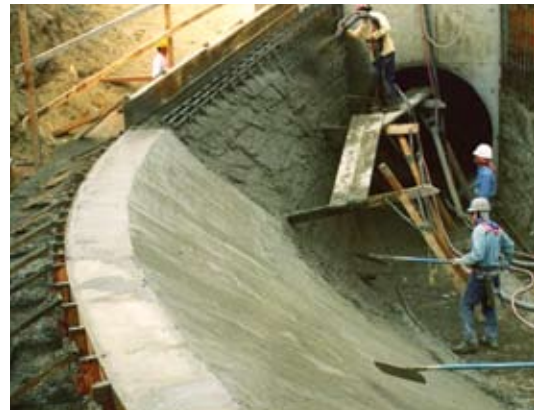
3. Clue: Safety

3. The nozzleman is not wearing safety glasses or a dust mask. The scaffold has no safety back rails or toe board, and no fall protection is present. The shotcrete hose is also not secured (could pull the nozzleman off the scaffold).

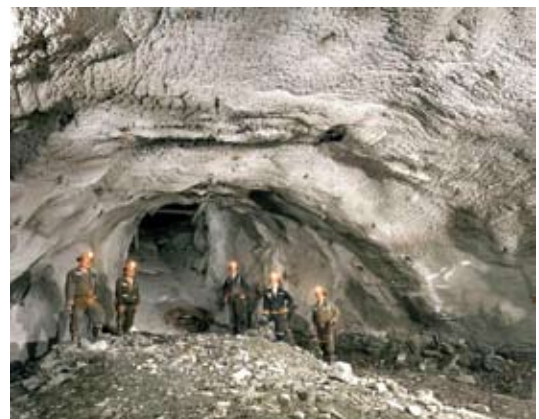
4. Clue: Application

4. This mine represents poor application (surface bond and compaction). The shotcrete placed overhead in this mine was shot at an angle. The ripples in the shotcrete indicate the direction it was shot.

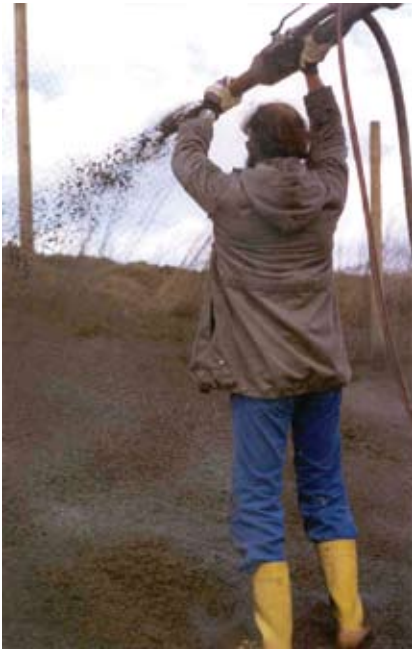
5. Clue: Safety and Application

5. Poor material velocity. The nozzleman is holding the shotcrete hose in an unsafe manner. ASA recommends holding the hose between the legs for stability. The nozzleman is not wearing a hard hat, safety glasses, or a dust mask.

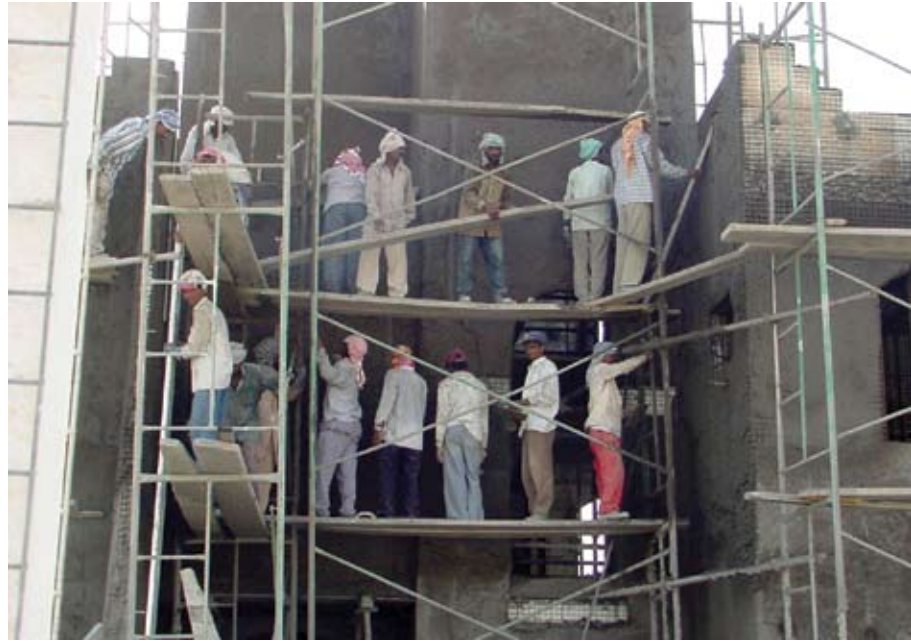
8. Clue: Safety

8. There are too many men on the scaffold boards. The scaffold boards are cracked and have a broken end. There are no back rails or toe boards. The crew is not wearing any fall protection, safety glasses, hard hats, or hearing protection.

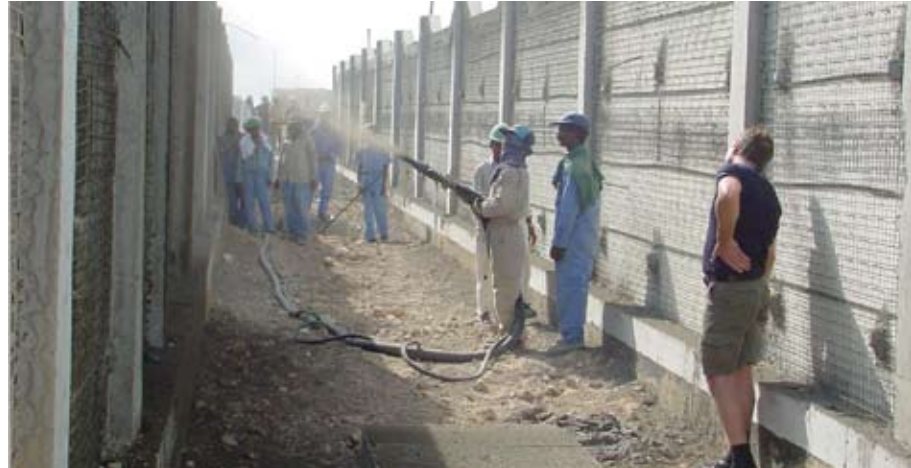
9. Clue: Safety and Application

9. The nozzleman is not wearing a dust mask, safety glasses, or a hard hat. He is too far from the shooting surface and is not shooting perpendicular to the receiving surface. The helper behind the nozzleman is not wearing a hard hat, safety glasses, hearing protection, or a dust mask. The helper to the right of the nozzleman is not wearing safety glasses or a dust mask. The observer is missing a hard hat, safety glasses, earplugs, and protective clothing.

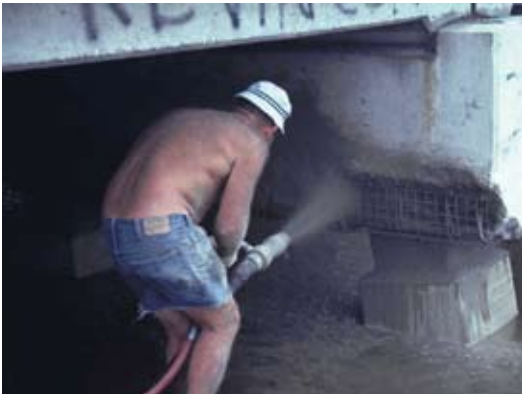
7. Clue: Safety and Environmental

7. Lack of protective clothing, inadequate scaffolding, no hard hat, no gloves, no ear protection, and no respirator. No platform to collect the rebound and overspray from entering the water below.

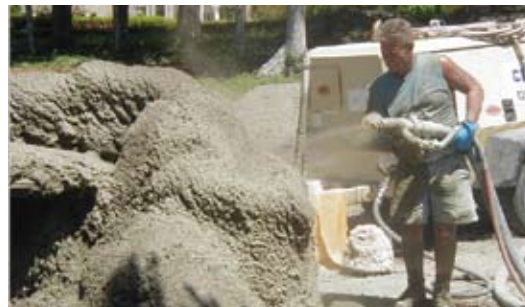
10. Clue: Safety and Application

10. Shotcrete is being placed at the wrong angle causing the rolling effect. The nozzleman is not holding the hose correctly and is missing safety glasses, a dust mask, a hard hat, and the proper clothing to protect his skin from contact with the shotcrete.

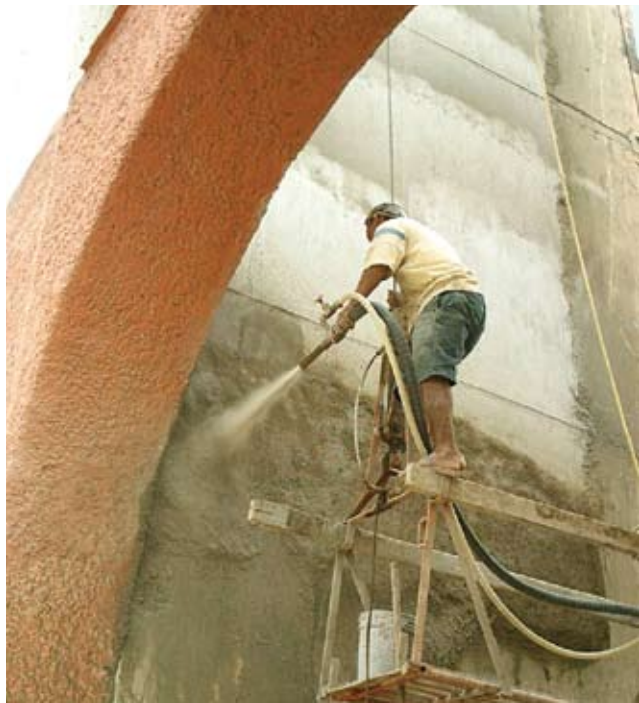
11. Clue: Safety

11. The nozzleman is not wearing a hard hat, gloves, safety glasses, work boots or proper clothing to protect his skin from the concrete. He is standing on the back rail and has no fall protection and no toe board in place (OSHA violation).
