# Outstanding Shotcrete Project Award Winner

2008 Outstanding Repair & Rehabilitation Project

## Manchester Terminals, LLC, Dock Rehabilitation

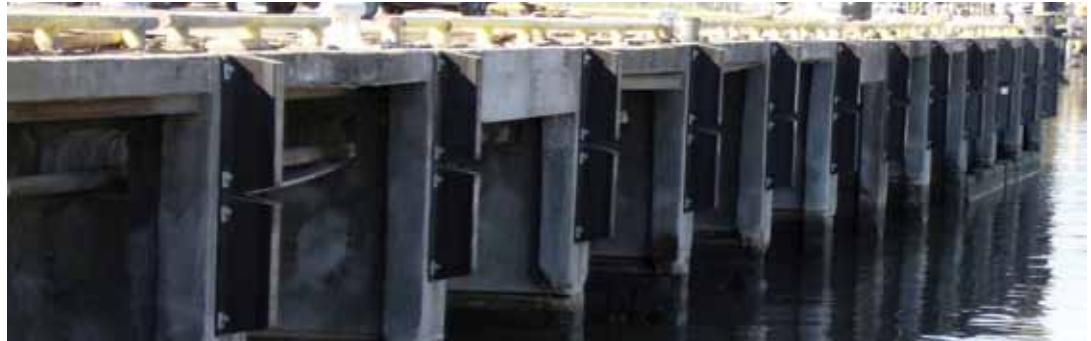
*Finished product*

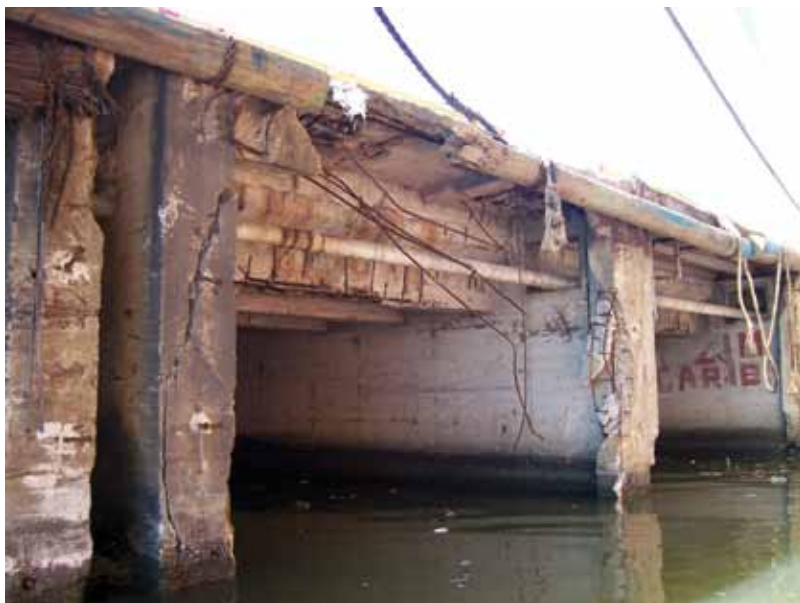
*Typical damage due to environmental effects on concrete*

All loose and unsound concrete was removed by pneumatic chipping and steel reinforcement. Surface preparation was accomplished by concrete. A corrosion inhibitor was applied to the reinforcing steel prior to the application of shotcrete. A minimum 2 in. (50 mm) clearance was used throughout the process to ensure proper encasement of the steel.

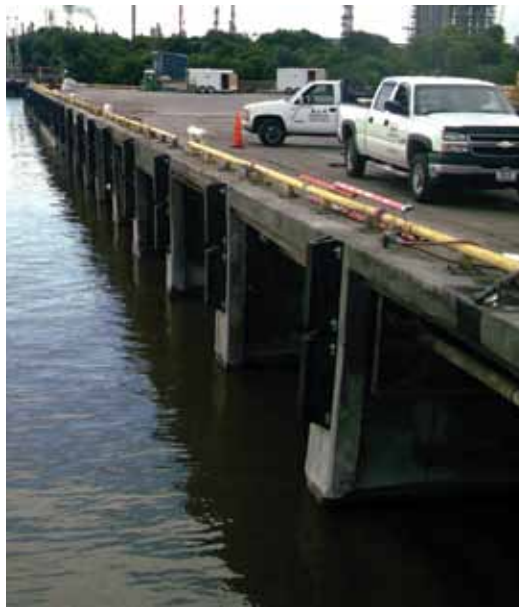
*B & A Contractors, Inc., uses a bolted rubber bumper system to protect Manchester Terminals dock system from future damage resulting from ship strikes*

The flexibility of shotcrete allowed us to immediately mobilize our operations to the newly-damaged site. Within a matter of weeks, we were able to repair and reopen the damaged area. In contrast, it was estimated that form-and-pour repairs would have taken significantly longer and forced both the previous work area and the emergency repair area to stay closed to ship traffic throughout the process. It was at this point that the owner truly came to appreciate the value of shotcrete. The owners embarked on a full-scale rehabilitation of the entire dock system, adding an estimated 21,000 ft<sup>2</sup> (1951 m<sup>2</sup>). The total dock rehabilitation included the repair of all support columns and beams, as well as a large number of spall repairs to the underside of the deck floor. Additionally, the owner opted to install a state-of-the-art fender system to help prevent future damage.

Shortly after the completion of the dock face repairs and installation of the new fender system, another large fully-loaded ship “bumped” the dock. To the owner’s amazement, the only visible damage was to the bolts anchoring the fenders. In fact, the steel bolts bent to the point that the ends were touching the shotcrete surface of the dock. No damage was present on or around the shotcrete repair. This incident proved the importance of shotcrete to this project and caused the owner to have a newfound trust in this method of repair.

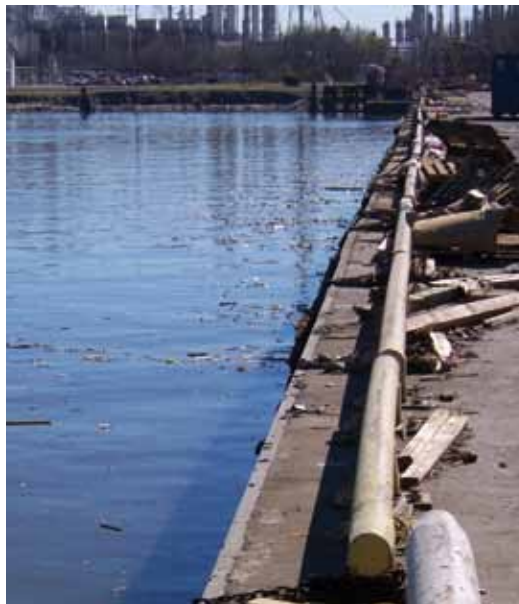
*Typical state of the dock system prior to repairs*

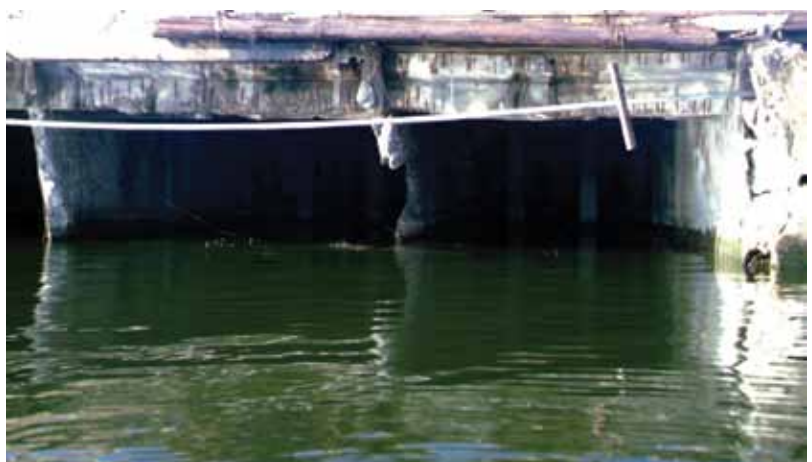
*Typical damage to Manchester Terminals prior to shotcrete application*

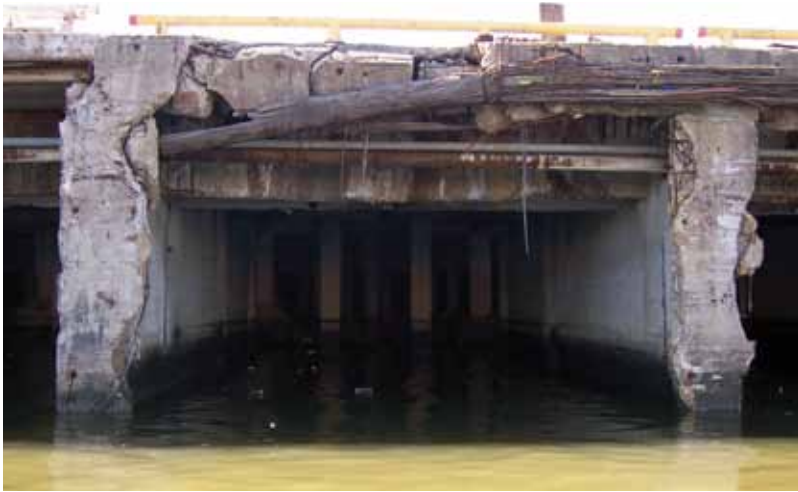
In the summer of 2006, our company was presented the challenge of restoring the largest independently-owned shipping terminal in Houston, TX, to its original state. Built in 1926, Manchester Terminals had seen its share of spot repairs. This hurricane-rated concrete facility, however, never had full-scale rehabilitation. At first sight, this project seemed to be an impossible task. The 1500 ft (457 m) international shipping facility showed significant damage and deterioration to over 90% of its existing concrete supports. Entire columns were missing in some areas, and

*Damage as seen in over 90% of support columns prior to repair*

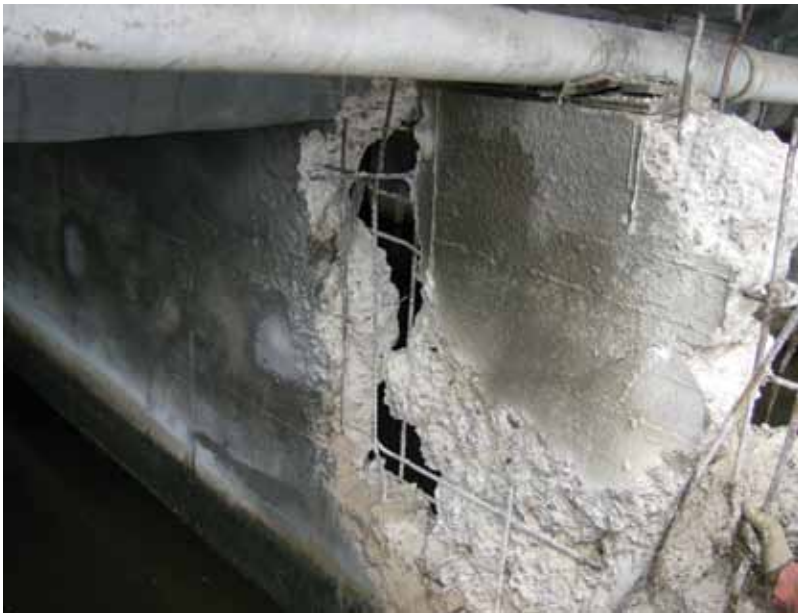
*Using pneumatic tools, deteriorated concrete was removed, allowing for shotcrete repairs*

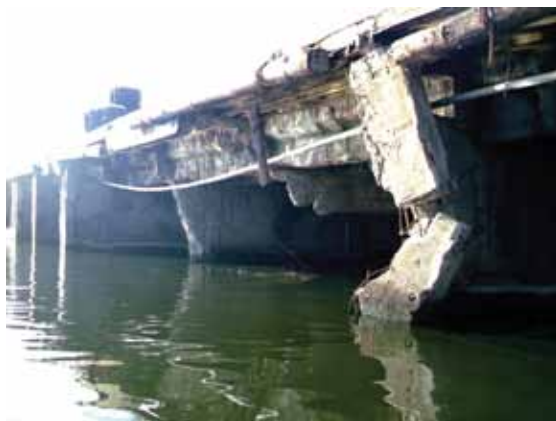
Our company was faced with an additional challenge shortly after beginning the shotcrete operations. A loaded ship struck the dock, causing significant damage. The damage could have shut down that portion of the dock, significantly limiting the owner's ability to meet the demands of signed contracts for ships en route to the facility.

*Using one-sided form technology, damaged support members were rehabilitated to their original state after being struck by ships*

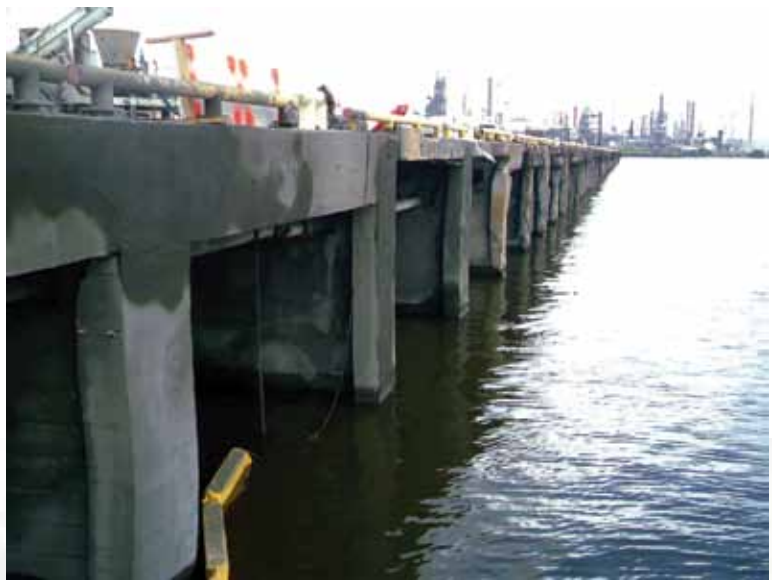
*Manchester Terminals dock begins to find new life as shotcrete application progresses*

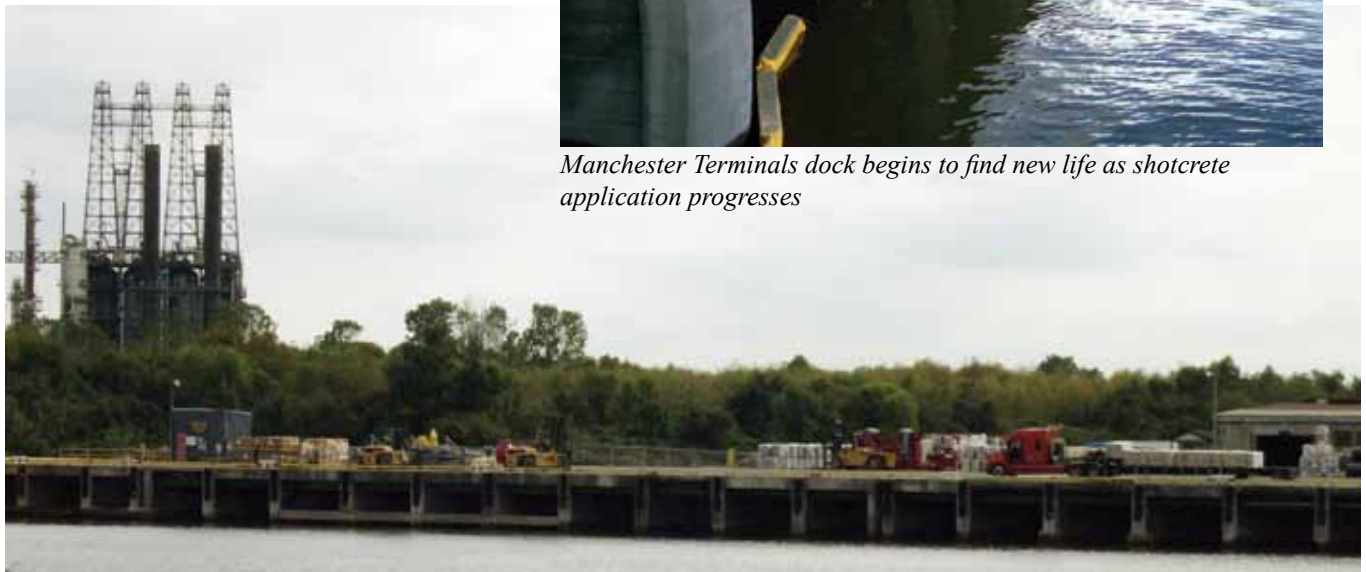
*Finished product from a distance*
