Waterproofing—Is it Necessary in Pool Construction?

By Jerry B. Werner

Pool & Recreational Shotcrete Corner

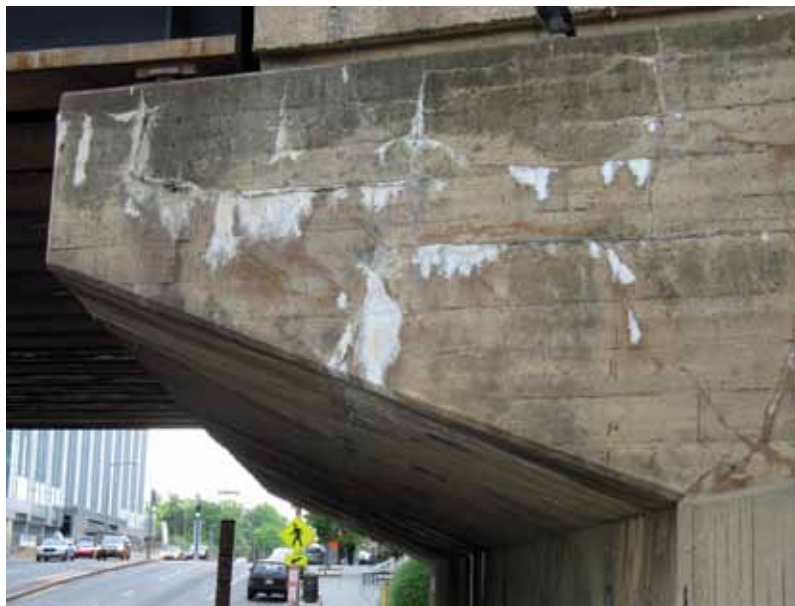
Bridge abutment deterioration

To say that reducing the ingress of water in concrete is not required is to ignore the history that we see every day. Over 30 years ago, concrete bridge structures across the U.S. were reported as being structurally deficient. To date, not much has been done to resolve this problem.

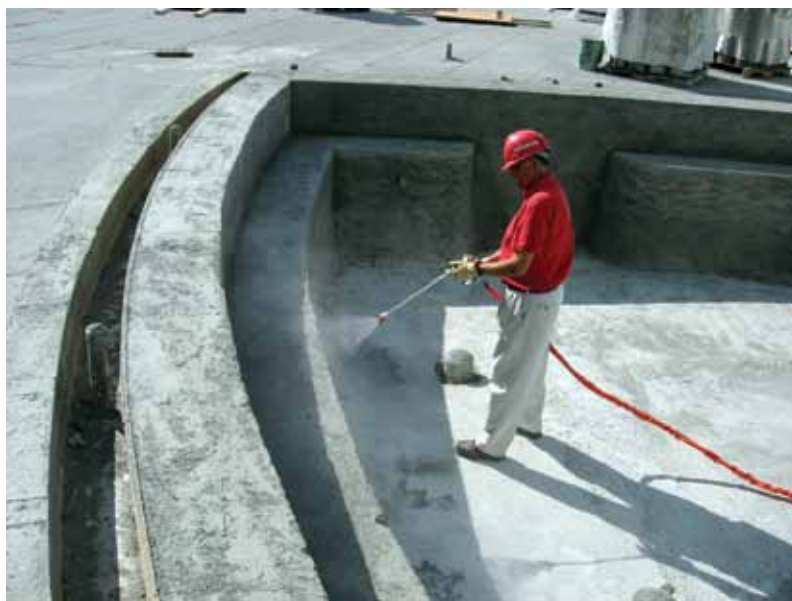
Applying sealer to pool on 14th floor condo

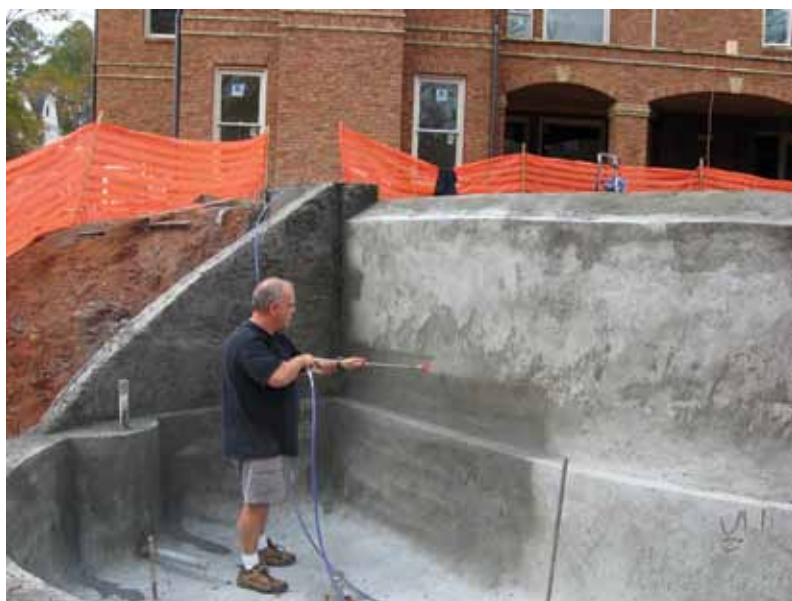
Vanishing edge sealer application

What are the proper methods, then, to address all the issues that will provide proper protection of the concrete and reinforcing bar, and prevent efflorescence problems? We have to understand that water comes from the pool, from rain, and from the ground. In a vanishing edge condition, water flows over the top of the weir and sometimes results in efflorescence from the grout on the

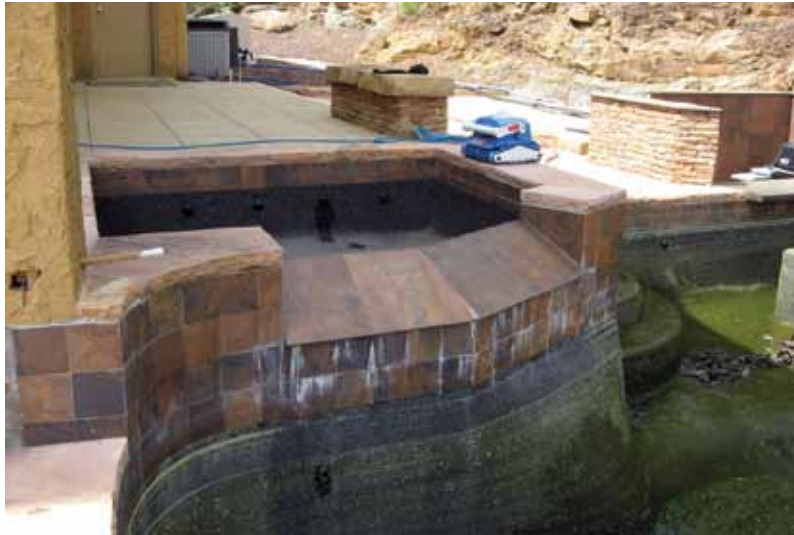
Efflorescence spa

Efflorescence is an indicator and is the first sign that you are experiencing water intrusion problems. It occurs when moisture that has migrated into the shell wall or mortar and grout dissolves soluble salts in a cementitious mixture and then deposits the residue upon evaporation onto the exposed surface. It will occur very quickly and become a continuous problem for you and your client. To remedy these potential troubles of deteriorating concrete, rusting reinforcing bar, and efflorescence—not to mention leaching chemicals from your pool into the groundwater supply—you need to consider some type of protection beyond quality construction. Quality construction should include a review of the waterproofing needs of your project.

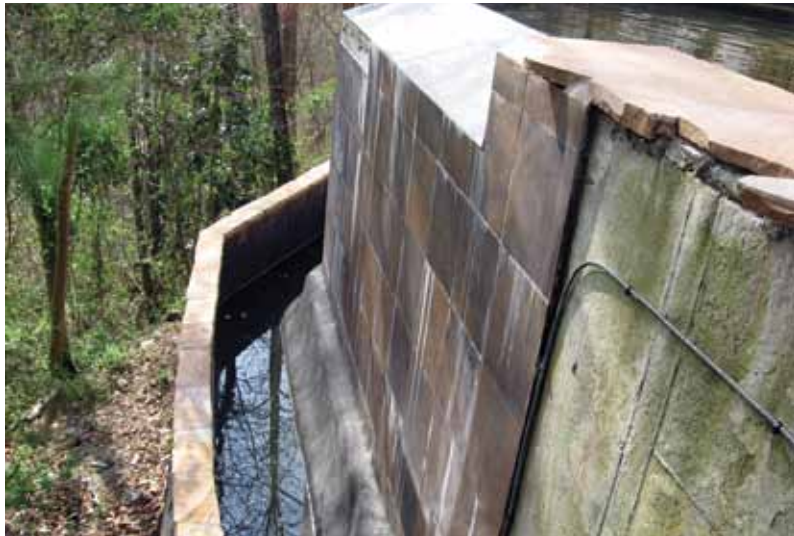
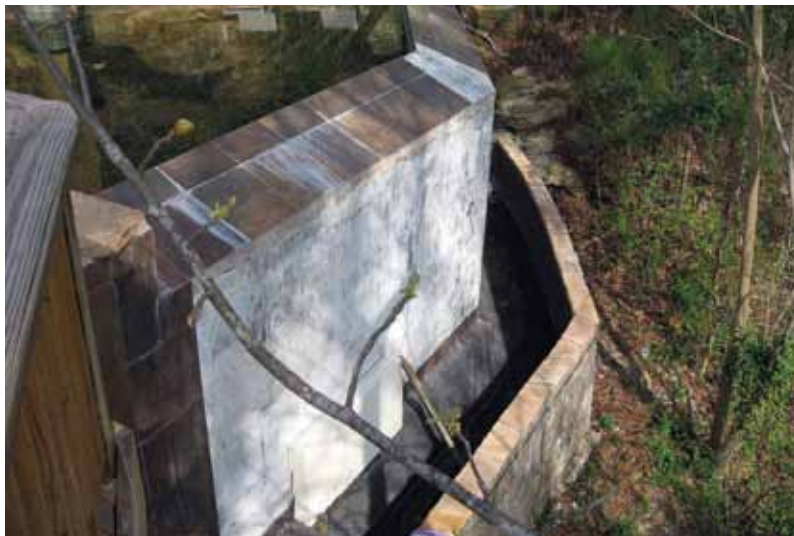
Efflorescence vanishing edge

Efflorescence vanishing edge (another view)

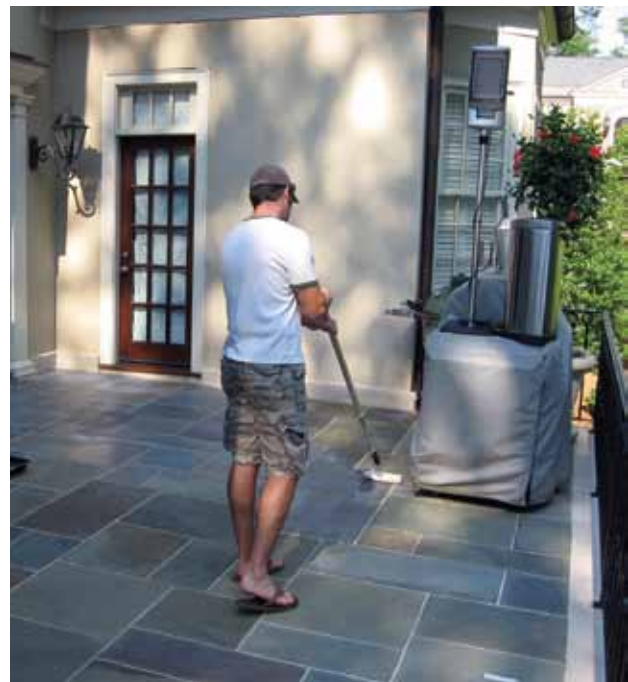
Patio protection

surface of a tile application. Therefore, we have to match sealing methods with the conditions that we want to prevent. It is not just something that you apply to the inside of the pool. Sealers must also be considered for patios, stone features, and waterfalls. Water that penetrates through a patio can find its way to the back of the shell wall and tile through the groundwater supply. If stone and copings are left untreated, moisture intrusion and thermal changes can result in spalling. This can also be exasperated in salt-generated pool systems. All of these conditions can be mitigated, however, by proper sealing methods.
