## Rankin Bridge

By Dennis Bittner

# Shotcrete Corner

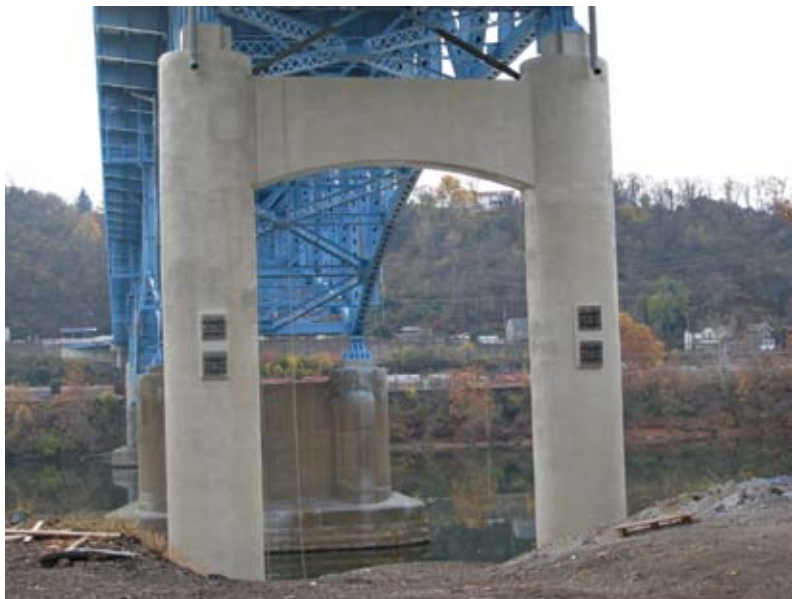
*Piers after application of an epoxy coating*

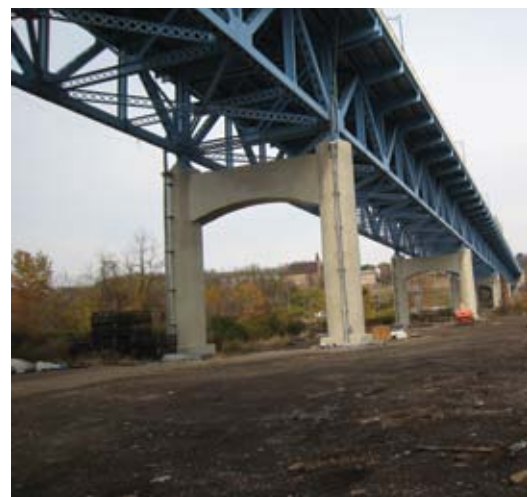
*After completion of the project, the structure looks like a new bridge*

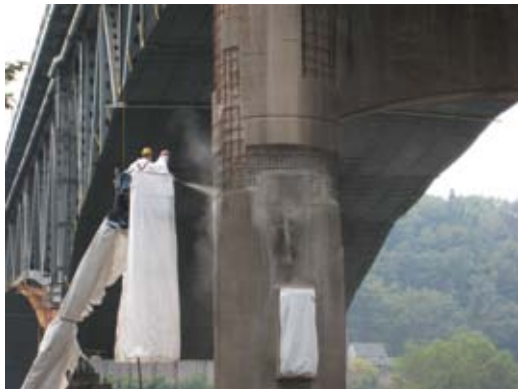
*Shotcrete applied at full depth over reinforcing bar and mesh*

First, the piers were prepared. All loose, unsound materials were removed, exposing sound concrete. During the demolition phase, the areas were pressure washed to remove any fractured concrete. Sometimes neglected, proper substrate preparation is essential to any type of concrete repair. All embedded reinforcement exposed by the demolition and surface preparation was sandblasted clean. Deficient reinforcement was removed and replaced. Next, the shotcrete was installed. All shotcrete was applied using a predampener in the shotcrete delivery system. Predampening greatly reduces dust, allows the material to begin to hydrate, and helps ensure proper hydration of the product. Excess material was trimmed to match the original round face of the large piers. Immediately after finishing, the

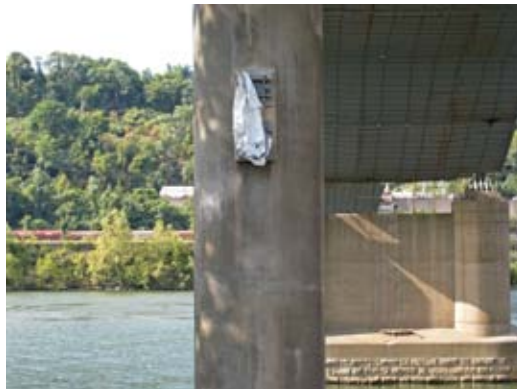
*Large, round piers can be brought back to their original shape using shotcrete*

This project was a prime example of the advantages of the shotcrete process over the traditional form-and-pour repair method. There are often concerns about the ability to match the shape of round bridge piers on large patches with the shotcrete process. On the Rankin Bridge, the original shape of massive piers was replicated. The speed of the shotcrete installation versus forming contributed significantly to the timely completion of the project between August 2008 and November 2010. Shotcrete can offer large dollar savings over traditional form-and-pour repairs. Currently, an estimated 26% of bridges in the U.S. are considered “structurally deficient or obsolete.” Twelve percent of U.S. bridges are in such bad condition that they need annual inspections to remain in service. The cost estimates for these repairs vary greatly, but most put the cost of necessary bridge repairs in the U.S. at hundreds of billions of dollars. Cost savings through the use of shotcrete repair methods would allow the federal, state, and local governments to stretch their limited infrastructure repair dollars
