## 2010 Outstanding Repair & Rehabilitation Project

# Concrete Arch Bridge No. 6.45 over 31st Street, Queens, NY

By Tommy Pirkle and Arden "Morris" Boddie

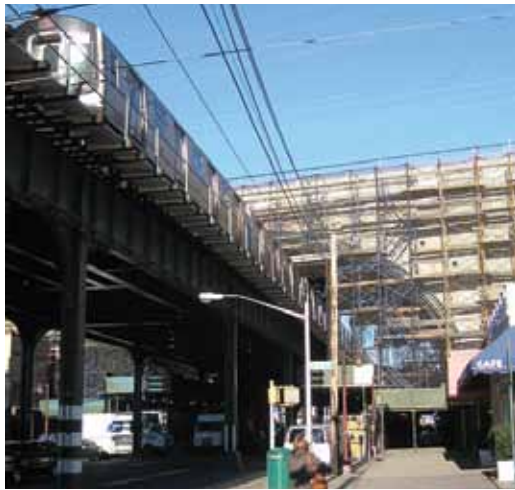
*As a safety precaution, stage scaffolds and netting were erected long before the work started to protect the subway tracks and, more importantly, the pedestrians on the station platforms and sidewalks below*

Amtrak had little choice but to rehabilitate this 94-year-old structure, as falling chunks of deteriorated concrete were becoming a major structural and safety concern. As a safety precaution, stage scaffolds and netting were erected long before the work started to protect the subway tracks and, more importantly, the pedestrians on the station platforms and sidewalks below.

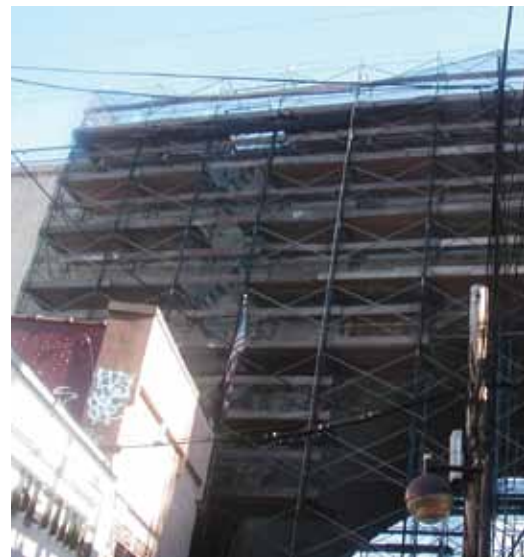
*Scaffolds were erected over the elevated subway tracks and 31st Street*

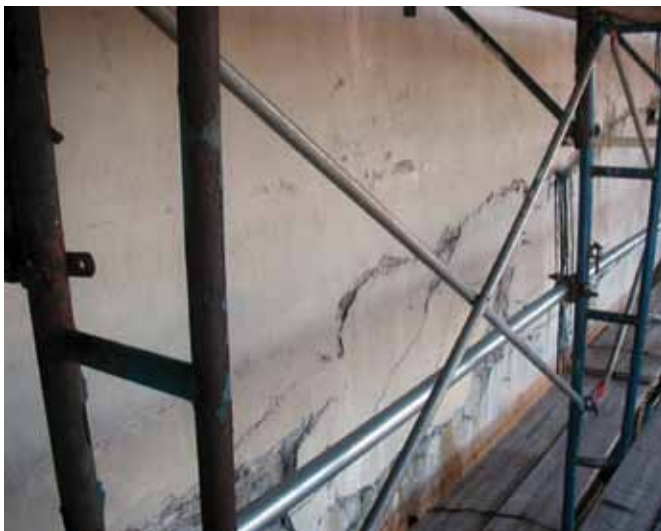
*Typical minor concrete spalling*

The General Contractor, ECI Building Corp of Elmont, NY, performed most of the surface preparation, starting with the north side of the structure. The substrate was sounded and marked and any deteriorated concrete was removed with pneumatic chipping hammers. Many repairs exceeded 12 in. (300 mm) in depth with continuous infiltration of groundwater. Weep pipes were installed to relieve the water pressure and a highly accelerated dry-mix shotcrete material was locally applied to divert the water to a central downward flow. The substrate was then hydroblasted to remove all existing coatings, contamination, and graffiti and “roughen” the surface to a minimum of 0.25 in. (6 mm) amplitude. L-shaped No. 3 dowels were installed 36 in. (900 mm) on center (OC) and coated 4 x 4 in. (100 x 100 mm) x D2.9 x D2.9 welded-wire reinforcement was attached to the dowels.

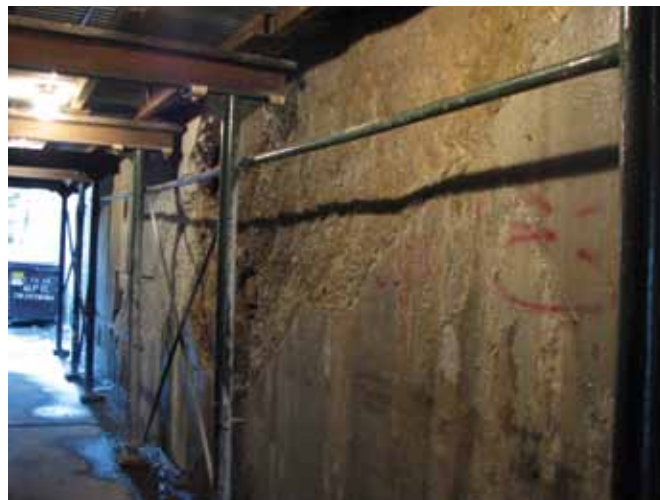
*Typical severe concrete spalling with continuous groundwater infiltration*

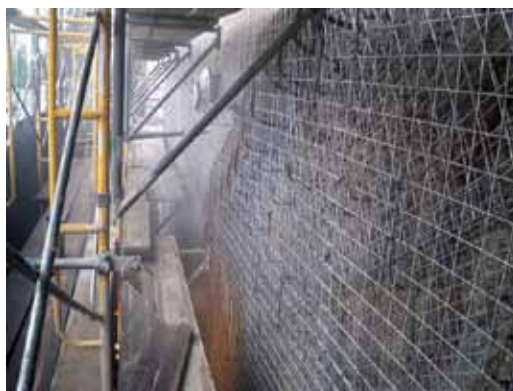
*Double and triple mats of 4 x 4 in. (100 x 100 mm) welded-wire reinforcement installed in severely deteriorated locations*

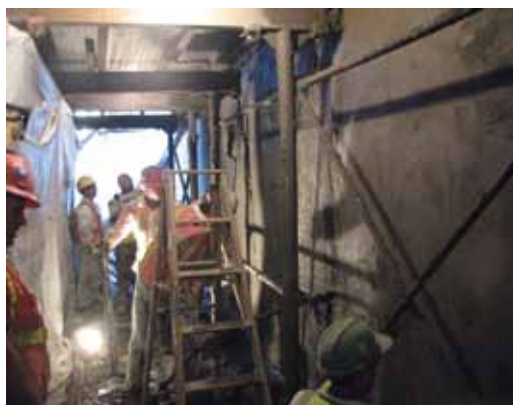
*Wet-mix shotcrete was the only acceptable method the engineer would entertain to minimize and control the dust and rebound*

The specifications required a minimum 4000 psi (27.5 MPa) prepackaged, fiber-reinforced shotcrete material. The engineer specified wet-mix shotcrete as the only acceptable method

to minimize and control the dust and rebound. Dry-mix shotcrete was not an option for the overlay. The shotcrete Subcontractor, East Coast Shotcrete of West Orange, NJ, elected to use King Packaged Materials Company's MS-W1 Shotcrete, which was submitted to the project engineers for approval. Before beginning the shotcrete process, six 30 x 30 x 6 in. (760 x 760 x 150 mm) preconstruction test panels and three mockup panels were shot by two different ACI Certified Nozzlemen and by the job-site Supervisor (also an ACI Certified Nozzlemán). Six cores were extracted from each panel and a 28-day compressive strength (ASTM C42) revealed that all cores exceeded 6000 psi (41.4 MPa). Flexural strength testing (ASTM C78), which was also a requirement, was performed, and the results exceeded the minimum strength by an average of 25%. The mockup panels represented the final finish and color of the bridge. Six different shades of coating were applied to the mockup panels for the owner's selection of the color and acceptance of the finished shotcrete texture.

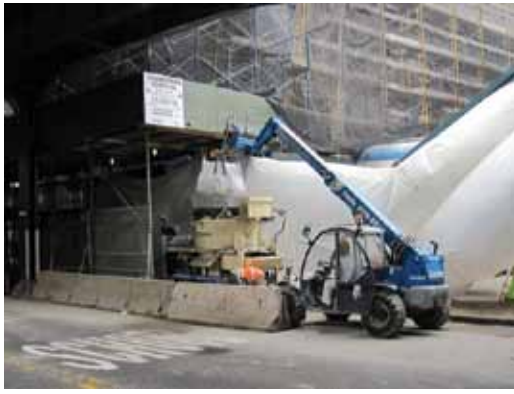
*A self-contained machine was selected—one that far exceeded the necessary requirements for mixing volume and pumping distance and was capable of mixing bulk bags*

With the material submitted and approved, the next decision was to determine the type of equipment to use. Transit trucks for mixing were considered, but a mixer/pump combination machine was preferred because it would allow for total control of the mixture. A self-contained machine called MR-IT by Allentown Shotcrete Technologies was selected—a durable and reliable self-contained mixer-pump combination that was capable of mixing the full contents of the 1100 lb (500 kg) bulk bags in one batch and exceeded the necessary requirements for pumping distance. An off-site test was conducted with the pump for material compatibility and training of company personnel to properly operate and maintain the pump.

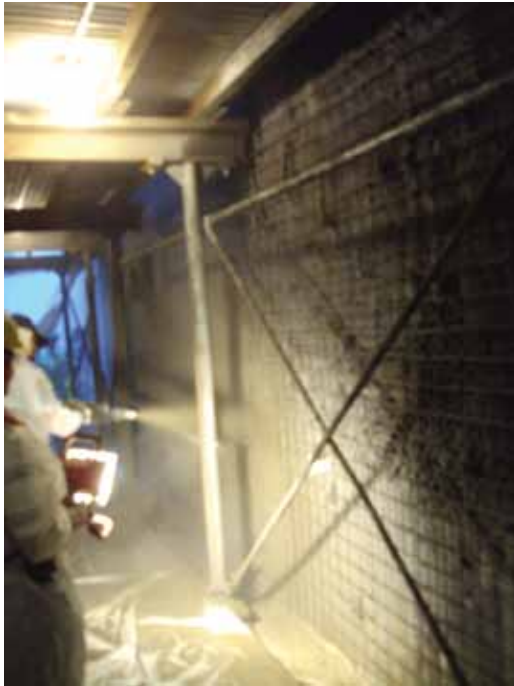
*Prepackaged fiber-reinforced wet-mix shotcrete was applied*

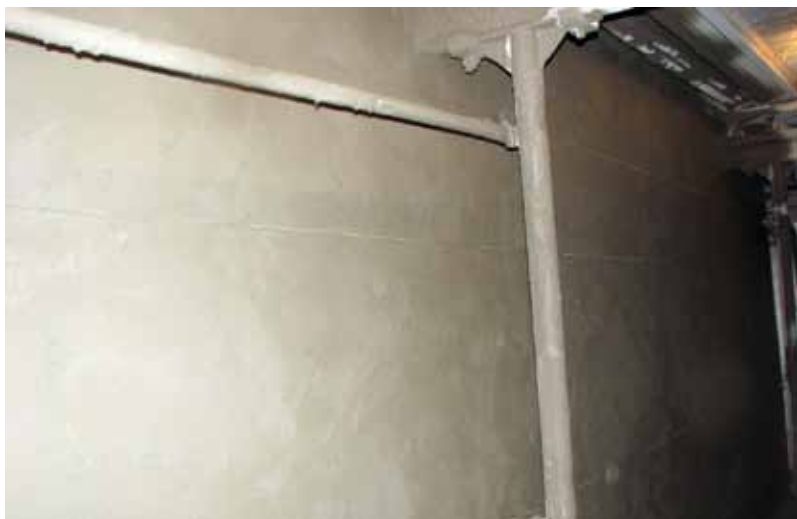
*The uniformed float finish provided an excellent textured surface for the coating adhesion*

An often overlooked but significant factor in providing a long-life facility is preparing the structure for preventive maintenance. The uniformed float-finished shotcrete provided an excellent textured surface for the adhesion of the coating for protection against the elements.

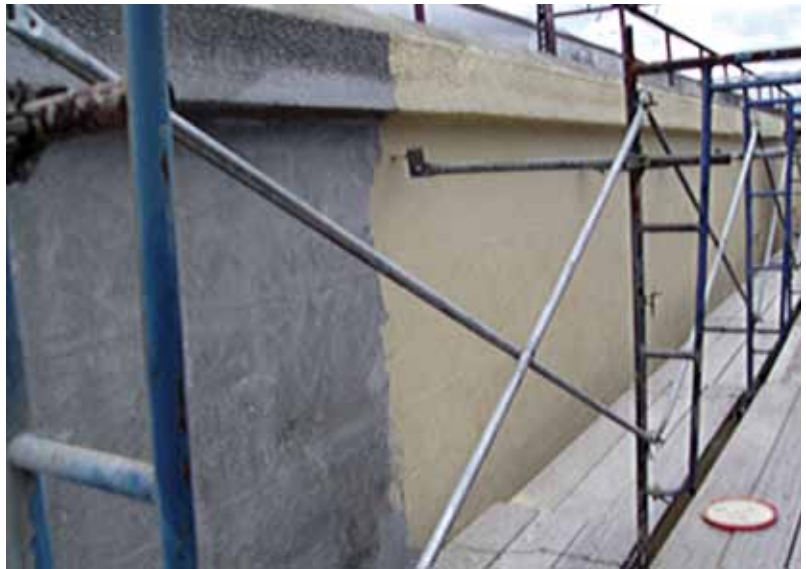
*Two coats of a water-dispersed, acrylic, anti-carbonation coating were applied*

Twenty-eight days after placement of the shotcrete, the structure was lightly pressure washed and two coats of a bone-colored, water-dispersed, acrylic, anti-carbonation coating were applied with rollers.

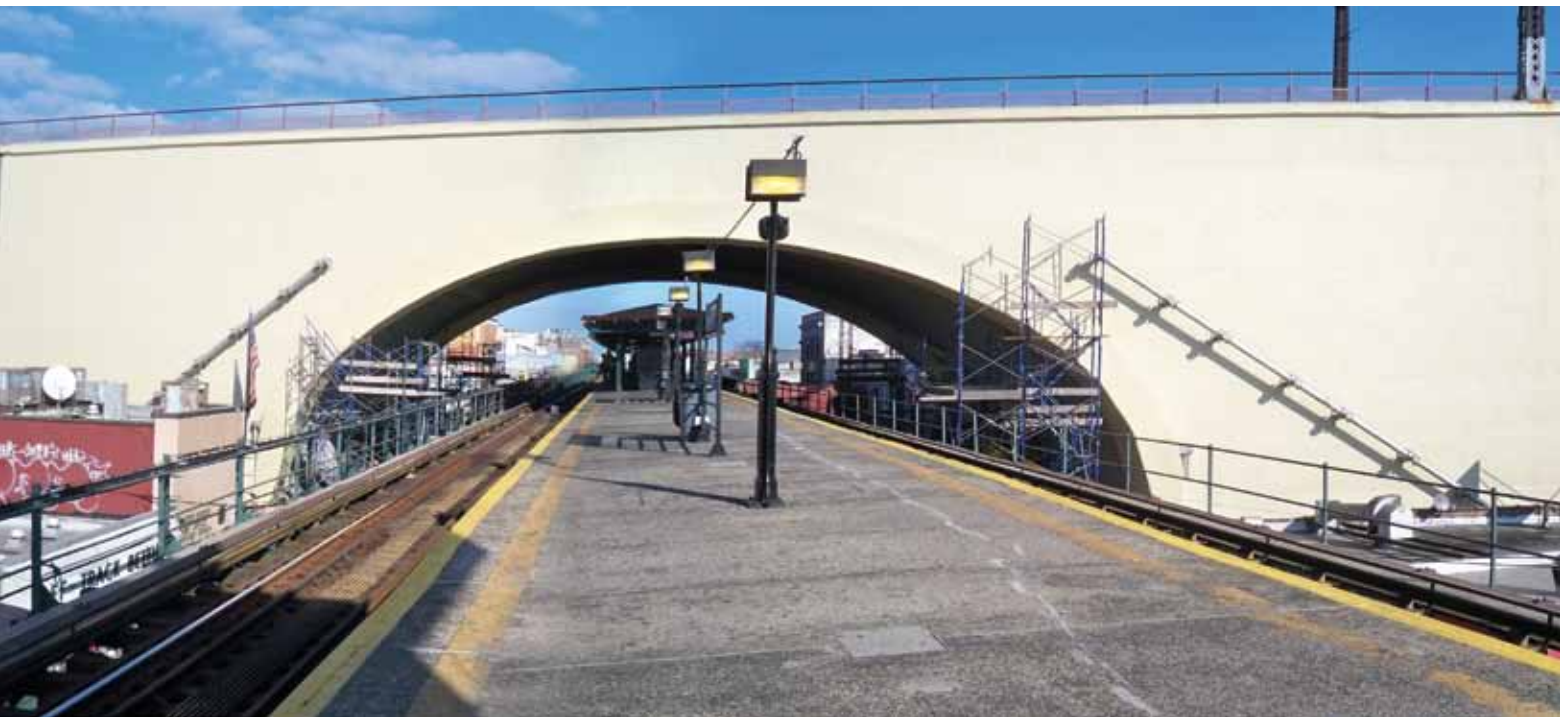
*View of completed project from Ditmars Boulevard Subway Station*
