Chetogeta Mountain W&A Railroad Tunnel

By Edwin Brady

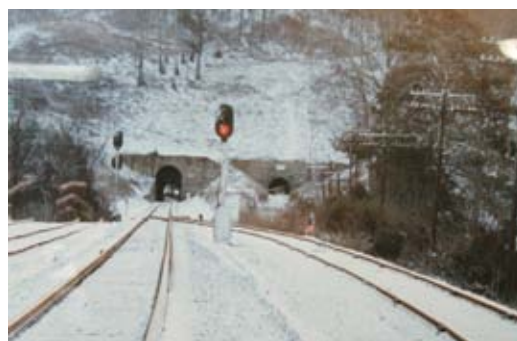
Fig. 2: Original tunnel built in 1850 (right) with "new" tunnel built in 1928 (left)

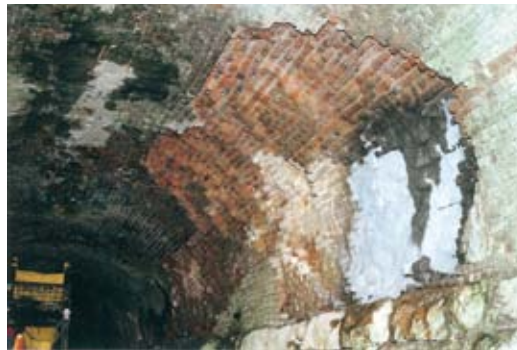
- Extensive water infiltration had resulted in the failure and collapse of large areas of the brick arch;
- A large number of failed mortar joints had allowed bricks to fall out; and
- Other areas of the tunnel had experienced distortions of the cross section due to sustained earth pressure.

Fig. 4: Large repair area prior to shotcrete

Repair of areas where the brick arch had failed (Fig. 4) were patched with a prepackaged silica

fume-enhanced dry-process shotcrete. Gunitite microsilica (MS) with alkali-resistant (AR) glass fibers from Quikrete was used. Approximately 60 yd³ (46 m³) of shotcrete was placed (Fig. 5) through an Allentown GRH600 to an average thickness of 10 in. (250 mm), with some areas being over 2 ft (0.6 m) thick. Scaffolding was erected on a 20 ft (6 m) trailer with an air compressor and generator beneath the working deck to allow for easy mobilization throughout the tunnel. Bulk bags (3000 lb [1360 kg]) of the pre-packaged shotcrete material were emptied into a portable hopper set over the shotcrete machine.

Shotcrete offered the only feasible means to make these repairs. It would have been cost-prohibitive to manufacture brick to match the original construction, not to mention the tremendous task of attempting to place them into these irregular repair areas. With shotcrete, these repairs were very straightforward and efficient in producing a structurally sound repair. It fully bonded to the substrate and was able to be finished to the exact profile of the existing tunnel surface.

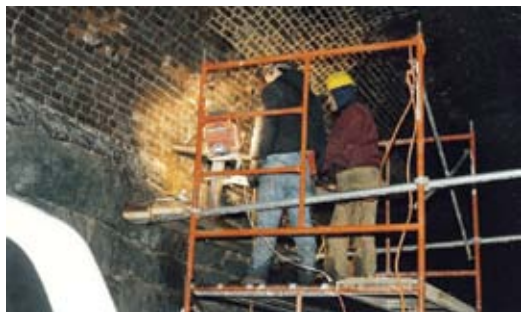
Fig. 3: Trailer-mounted core-drilling setup for drilling holes for drainage pipes. Also note the freshly repointed brick mortar joints

Grout Classic as manufactured by Green Mountain International. Small-diameter holes (3/8 in. [10 mm]) were drilled through the mortar joints (Fig. 3), and then plastic packers were installed to inject the grout. HPCG expands when in contact with water. This produces a flexible closed-cell foam that not only seals but also fills voids and provides stability to the aging and deteriorating brick arch. Upon completion of the injection grouting, the plastic packers were broken off flush with the surface of the mortar; Miller Rochester Restoration repointed approximately 12,000 ft² (1100 m²) of the brick arch with a custom-formulated mortar made with vertically hydrated lime and a local sand matching what was originally used in 1850.

To prevent the buildup of hydrostatic pressure behind the brick arch and limestone walls, perforated drainage pipes were installed on approximately 10 ft (3 m) centers along the springline of both sides of the tunnel. These drainage pipes were 2 in. (50 mm) polyvinyl chloride (PVC) with a perforated section wrapped with a nonwoven geotextile fabric to prevent sediments and soil from entering the pipes. Three inch (75 mm) diameter holes were cored through the brick arch, allowing the drainage pipes to be placed and then sealed at the surface of the brick with the HPCG. A total of 280 drainage pipes were installed.

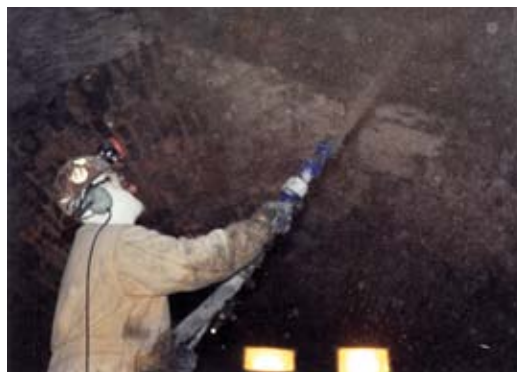
Fig. 5: Shotcrete being placed

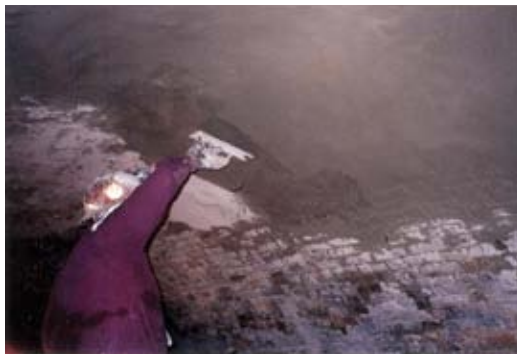
Fig. 6: Shotcrete being cut back to finish grade

After the shotcrete was placed, it was cut back by hand (Fig. 6) to about 3/8 in. (9.53 mm) deeper than the face of the adjacent brick. Overspray was washed from the surface of the adjacent brick and a plaster coat of custom-colored mortar was placed over the shotcrete flush to the face of the original brick. “Fake” mortar joints were struck into the plaster and a black “wash” was applied to more closely resemble the “sooted” surface of the original brick after years of smoke from steam locomotives (Fig. 7).

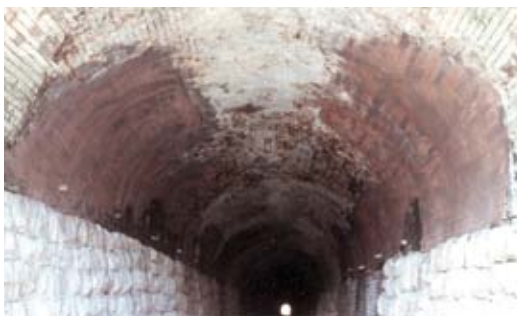
Fig. 7: Completed repair
